**AVIATION OCCURRENCE REPORT**

**COLLISION WITH TREE**

**RAINBOW AIRWAYS INCORPORATED  
CESSNA A185E SKYWAGON C-FVZM  
NOGANOSH LAKE, ONTARIO  
14 AUGUST 1994**

**REPORT NUMBER A9400213**

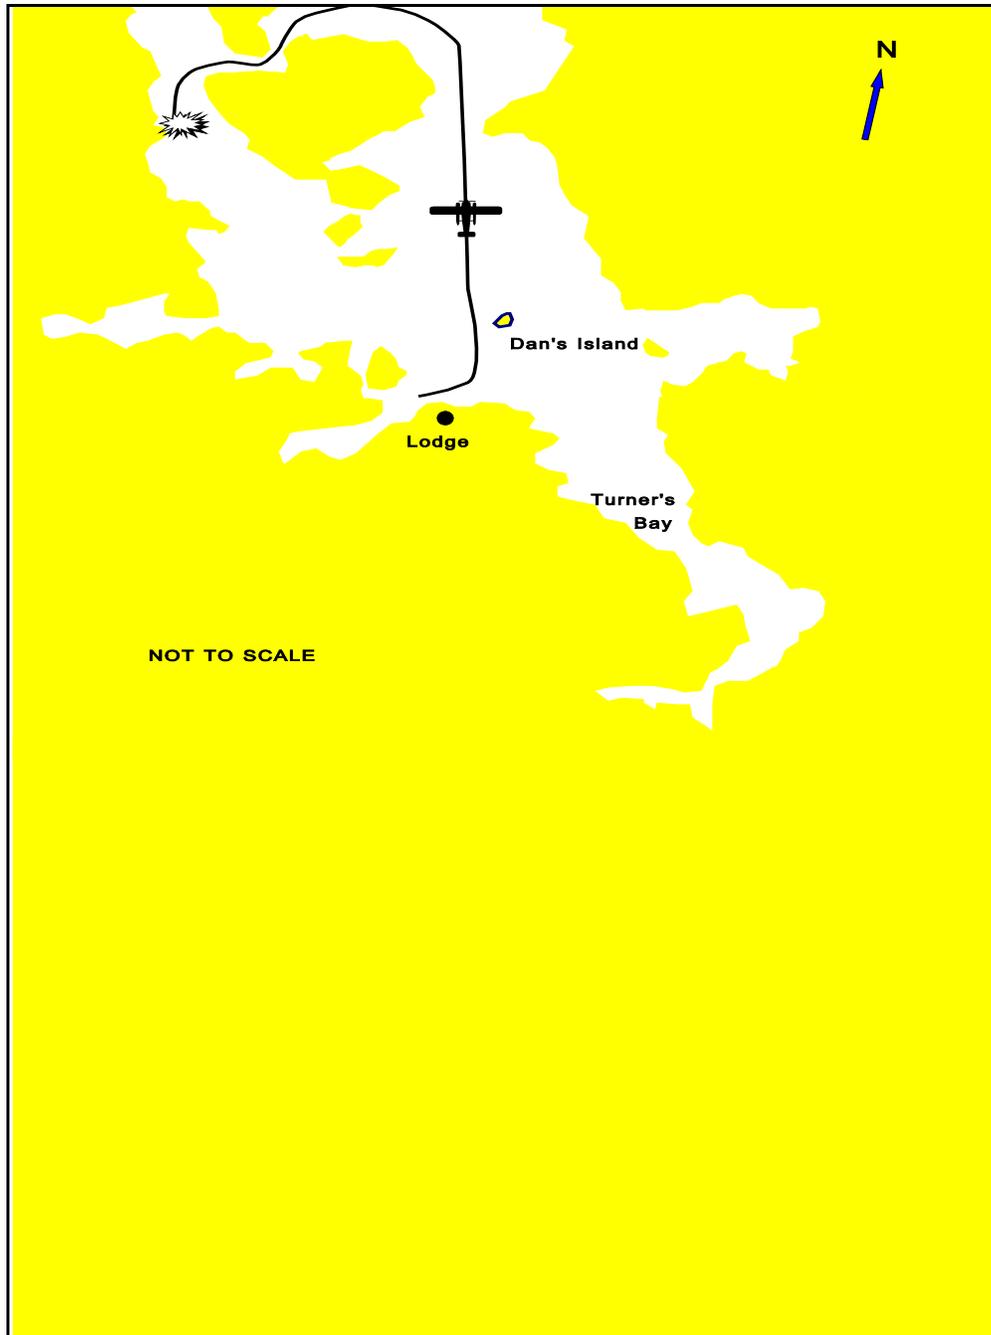
*Appendix A - Take-off and Flight Path*

Approximately 4,000 feet north of the south end of Turner's Bay is an island known locally as Dan's Island. Pilots taking off to the north use this island as their reject take-off point. On the day of the occurrence, the pilot did not taxi south into Turner's Bay, but began his take-off run from a point only slightly south of Dan's Island, leaving approximately 4,200 feet available to perform the take-off run and climb. The shore on all sides of Noganosh Lake quickly rises more than 50 feet above the lake and is covered by approximately 45-foot-high trees.

In considering the lift-off point, the terrain ahead of the aircraft after lift-off, and the aircraft climb performance, the pilot likely had three possible options. First, he could set the aircraft back down on the water and attempt to slow or stop the aircraft before reaching the shoreline. Second, he could turn to the left and attempt to negotiate the passage to the northern section of the lake while airborne. Or third, he could turn the aircraft further to the left to negotiate the passage between the island and the shoreline while airborne.

The continued turn to the left required a steep left turn, followed by a steep right turn and a second steep left turn to negotiate the passage. The fact that the pilot was able to successfully manoeuvre between the island and the shoreline suggests that there were no controllability problems with the aircraft. The steep bank angle required to execute the turns around the island would have precluded any appreciable altitude gain, thus preventing him from climbing above the terrain. When the aircraft emerged from the passage between the island and the shoreline, there was insufficient open space to climb above the rising terrain ahead. A skidding turn at impact was probably a result of excessive left rudder input, most likely made in an attempt to increase the rate of turn to avoid the collision with the trees.
