AVIATION OCCURRENCE REPORT

COMPONENT FAILURE / LANDING GEAR TORQUE LINK

**CANADIAN REGIONAL AIRLINES
FOKKER F28-MK1000 C-FCRK
CALGARY INTERNATIONAL AIRPORT, ALBERTA
01 NOVEMBER 1995**

REPORT NUMBER A95W0202

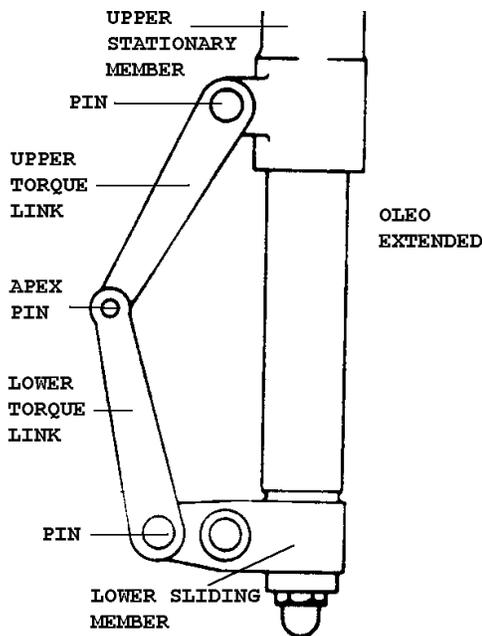
In normal operation, any torsional loads on the lower oleo sliding member from the wheel assemblies on the dual axles are transferred through the torque links (T/Ls) to the stationary upper oleo member. The T/Ls prevent rotation about the vertical axis to maintain wheel alignment in the fore-and-aft direction throughout the vertical range of oleo travel. In maintaining proper wheel alignment, the T/Ls stabilize any torsional oscillations (shimmy). By their design, T/Ls have their maximum mechanical advantage and control when the oleo is compressed, and minimum advantage when the oleo is fully extended.
