AVIATION OCCURRENCE REPORT

CAPSIZING AT TAKE-OFF

CESSNA U206F C-GNUG
RIVIÈRE DES PRAIRIES, QUEBEC
20 JULY 1996

REPORT NUMBER A96Q0114

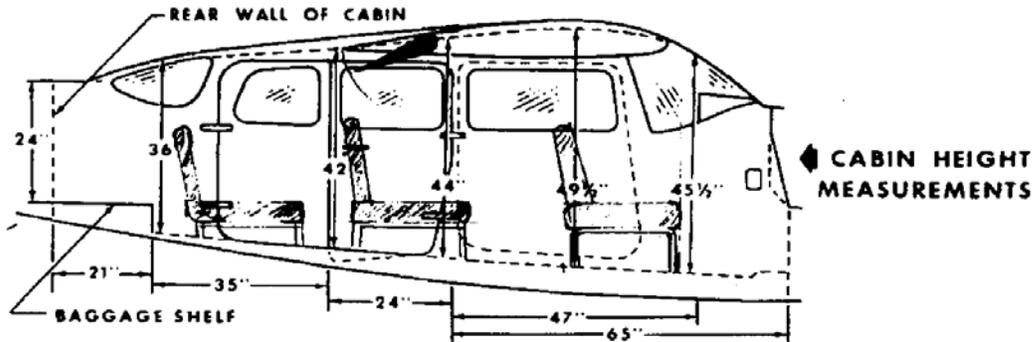
FLAPS AT 20 DEGREES

When the flaps are extended to 20 degrees, the forward leaf of the cargo door on this type of aircraft can open only about 8 cm, and this makes it difficult to fully open the aft leaf of the cargo door. Pilots and operators of this type of aircraft are aware of the difficulty, but it is not mentioned in the aircraft owner's manual. In this accident, there was no evidence found that the two leaves were opened, despite the evidence that the forward leaf of the cargo door was forced from the inside.

The system for opening the two leaves of the rear cargo door is complex and difficult to operate under normal conditions, but opening the leaves is even more difficult if the flaps are extended for a take-off or landing. This makes the rear cargo door practically unusable, and as a result, the left front main door is the only usable emergency exit for all occupants.

7. Opening the leaves of the rear cargo door of a Cessna U206F is complex and difficult if the flaps are extended to 20 degrees; it is even more difficult when the seaplane is submerged and overturned.
