AVIATION INVESTIGATION REPORT

ENGINE POWER LOSS AND FORCED LANDING

CESSNA 172N C-GZLJ

TORONTO/BUTTONVILLE MUNICIPAL AIRPORT 2 nm SSE

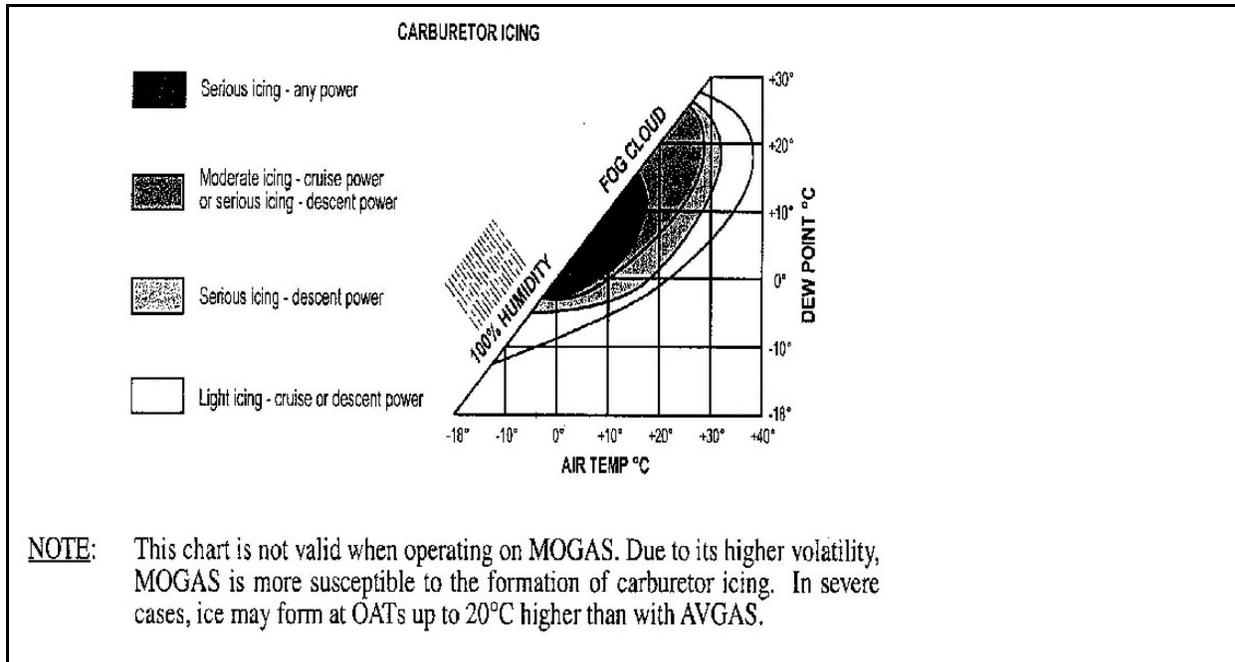
Appendix A—Carburettor Icing Chart²

The carburettor icing graph (Appendix A) was referenced as a guideline to find out if icing conditions existed for the flight. By intersecting the temperature and dew point values on the graph, it was determined that moderate icing conditions existed at the time of the flight. It was also found that the operator's maintenance personnel encountered carburettor icing during full-power ground runs with similar aircraft.

Weather was a factor in this occurrence, because the ambient temperature and dew point values were in the range where moderate carburettor icing could occur. After the engine began to lose power, the pilot applied carburettor heat as per normal procedures, but did not allow enough time for the warmer air to clear any ice that had formed. Further loss of power after carburettor heat application should have been anticipated. Engine performance continued to degrade as more ice accumulated.

1. Ambient temperature and dew point conditions during the flight most likely resulted in carburettor icing, which caused the engine to lose power.
2. When the engine began to lose power, the pilot applied carburettor heat, but noted it resulted in a further decrease in engine power and selected the carburettor heat off. The heat was not on long enough to remove any ice.
