AVIATION INVESTIGATION REPORT

A04P0397

RISK OF COLLISION

NAV CANADA
VANCOUVER INTERNATIONAL AIRPORT,
BRITISH COLUMBIA
29 OCTOBER 2004

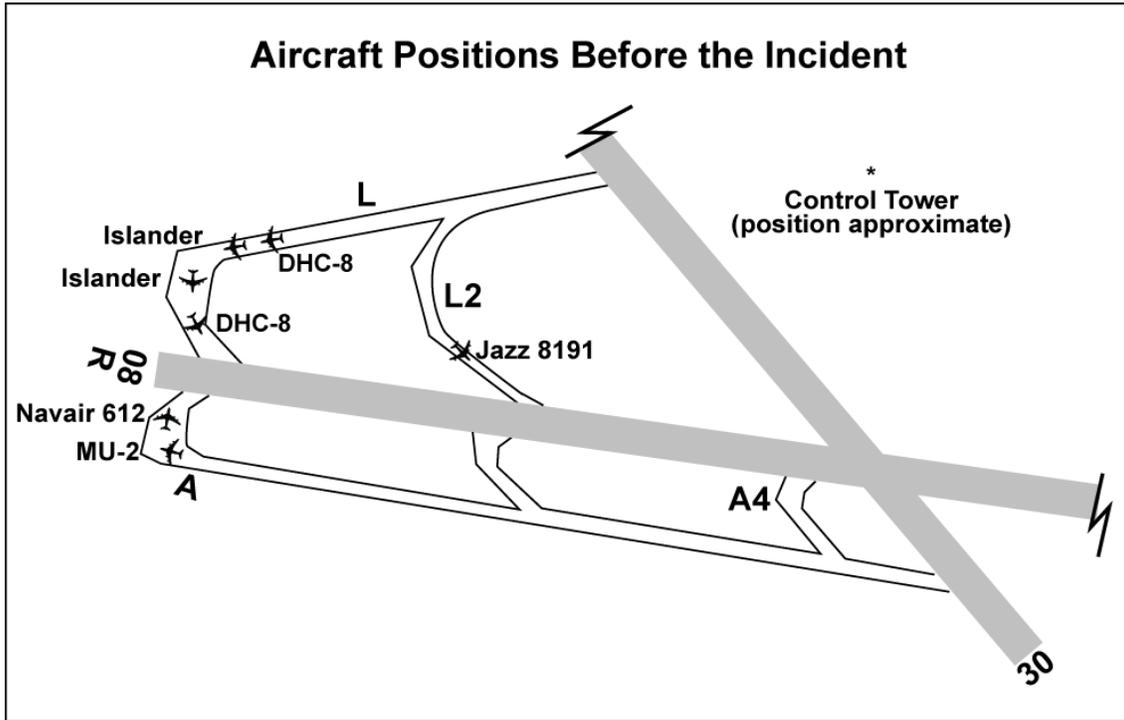
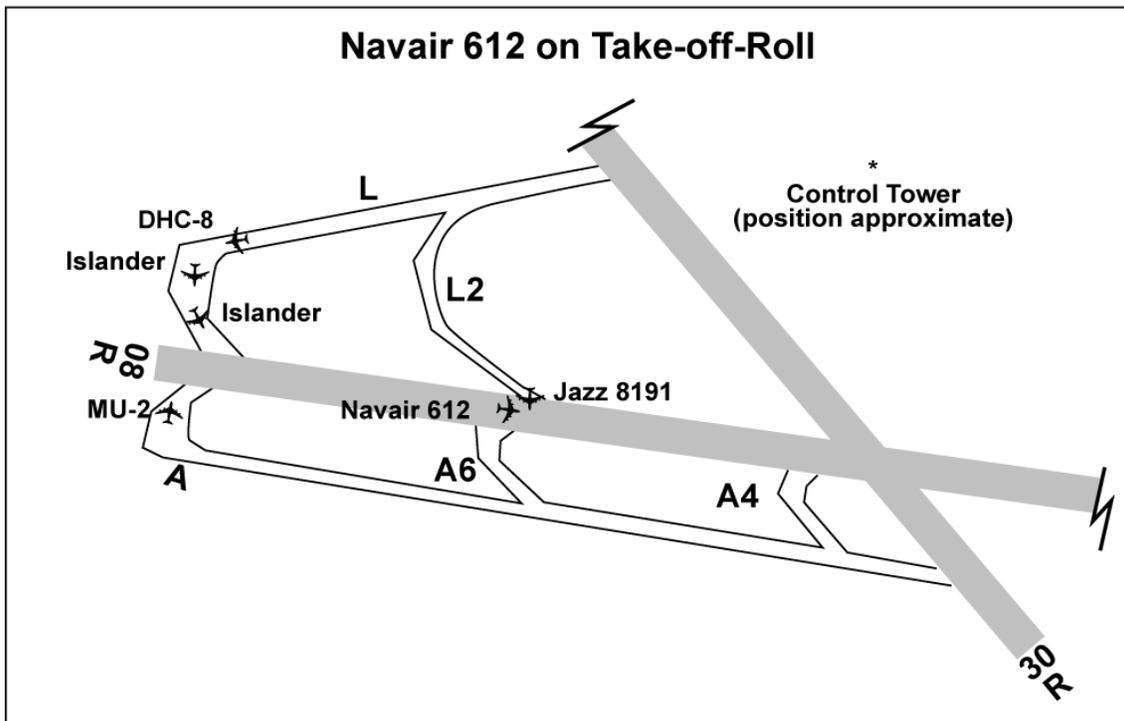
Appendix A – Aircraft Positions

At the time of the occurrence, two arriving aircraft were on final for Runway 08R, and seven aircraft were waiting to depart on Runway 08R (see Appendix A – Aircraft Positions). Aircraft departing on Runway 08R can approach the threshold from either Taxiway A on the south side of the runway, or Taxiway L on the north side. Jazz 8191, one of the waiting aircraft, was on Taxiway L2, on the north side farther down the runway. Of the other six aircraft, four were on Taxiway L (a DHC-8, two Islanders, another DHC-8) and two were across the runway on Taxiway A (the Islander [Navair 612] and a Mitsubishi MU-2).
