AVIATION INVESTIGATION REPORT
A05P0080

IN-FLIGHT FIRE

NAVAIR CHARTER, INC.
PIPER PA-31-350 C-GVCP
19 WING COMOX, BRITISH COLUMBIA
22 APRIL 2005

Report Number A05P0080

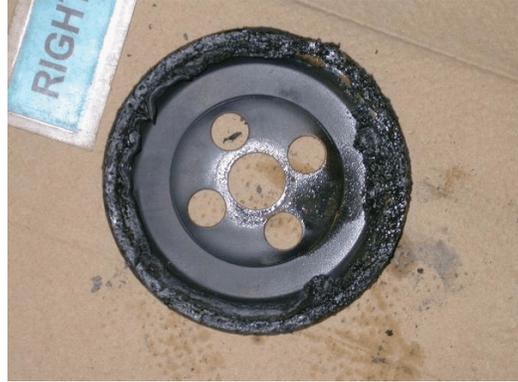
The oil filter was removed to gain access to the converter plate. During removal, it was noted that the oil filter gasket, which was subjected to a similar heat stress, was basically undamaged. The converter plate hold-down bolt required less than usual torque to remove. Once the plate was removed, it was evident that the converter plate gasket was extremely deteriorated (see Photo 1). This deterioration would account for the reduced hold-down bolt torque.

Photo 1. Right-engine converter plate gasket

Because of the unrepresentative damage to the right-engine converter plate gasket, these components were removed from both the left and right engines and examined using Fourier Transform infrared spectroscopy. From that examination, the composition of the left-engine converter plate gasket was identified as an acrylonitrile-butadiene copolymer known as NBR or nitrile rubber. This gasket meets the standards of the appropriate Lycoming converter plate gasket (part number 06B23072). However, the deteriorated gasket taken from the right engine was found to be made of an ethylene-propylene-based elastomer known as EDPM or Dutral; this composition does not meet the standards of the current Lycoming component.

Based on the fire pattern in the accessory section of the right engine and on the inspection and testing of involved components, it was apparent that an oil filter converter plate gasket had failed, allowing pressurized engine oil to spray into the engine compartment. The engine oil ignited, likely on contact with hot turbo-charger/exhaust components.

3. The improper oil filter converter plate gasket in the right engine compartment failed, allowing pressurized oil to spray into the engine compartment and ignite on contact with hot turbo-charger and exhaust components.

During the course of this investigation, Transport Canada confirmed, after consultation with the U.S. Federal Aviation Administration, that the intent of Airworthiness Directive (AD) 2002-12-07 was to include "ALL rebuild or overhauled engines." Effectively, the intent was to broaden the "Applicability" section of the AD to ensure that all affected (old-style) gaskets identified by P/N LW-13388 be removed from service, purged from the system, and replaced with new gaskets identified by P/N 06B23072, in accordance with Part II or Part III of Textron Lycoming Supplement 1 to Mandatory Service Bulletin (MSB) 543A.

- a. complied with all the requirements stated within the AD;
- b. incorporated Lycoming MSB 543 latest issue; and
- c. ensured that inventories of spare parts have been purged of any converter plate gaskets identified by P/N LW-13388.
