**AVIATION INVESTIGATION REPORT  
A05W0222**

**ENGINE TORCHING**

**ALASKA AIRLINES INC.  
BOEING 737-900 N317AS  
CALGARY INTERNATIONAL AIRPORT, ALBERTA  
30 OCTOBER 2005**

Report Number A05W0222

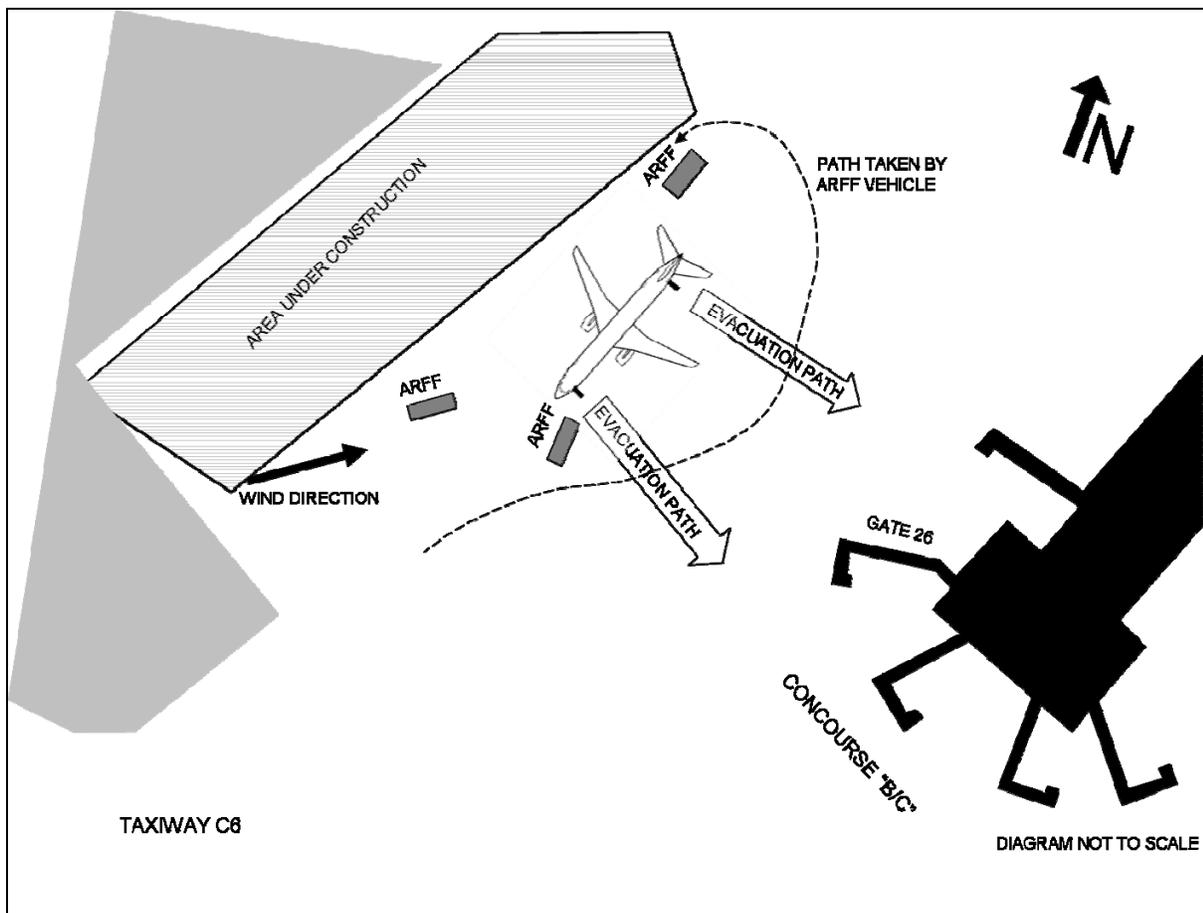
had not been completed by the flight crew to the point of left engine shutdown. Although the engine was shut down 15 seconds after the evacuation order, the deployed slide flapped off the ground momentarily in the coasting airflow from the left engine as it spooled down.

Figure 1. Vehicle and passenger routes

1. When the evacuation order was given, the evacuation checklist was not complete and, consequently, the left engine was not yet shut down. When the aft, left door was opened and the slide deployed, engine airflow could have resulted in injuries to passengers attempting to use the slide.
2. The closed cockpit door likely reduced the effectiveness of communications between the cabin and flight deck crews, and prevented the pilots from directly assessing the amount of smoke in the cabin.

Alaska Airlines Inc. revised the company's training program to ensure that flight crews fully complete the emergency evacuation checklist before ordering an evacuation.

Operations personnel from the Calgary Airports Authority and tenants of the Calgary International Airport discussed the hazards and mitigations associated with operation of ground vehicles in the proximity of deplaning passengers during emergency situations.

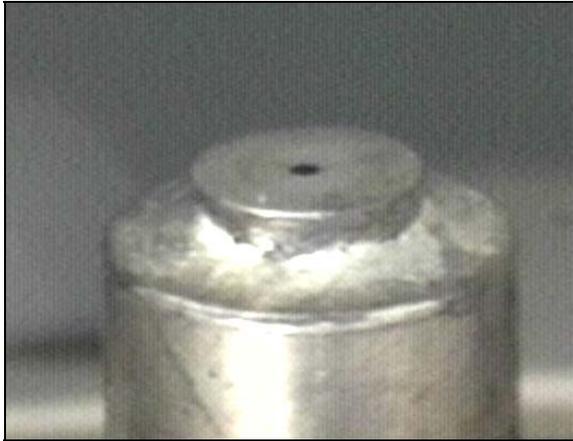
**Photo 1.** Nozzle with a normal profile

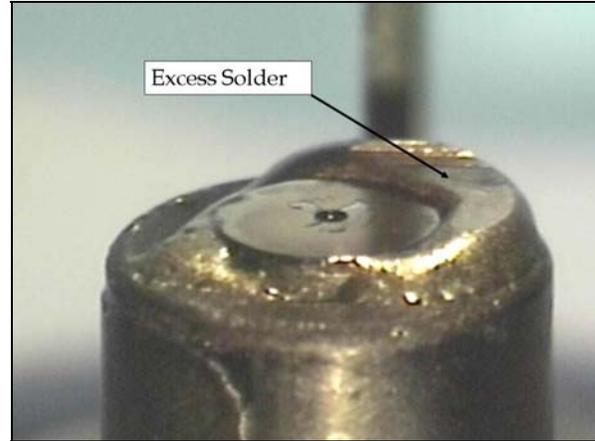
During disassembly and visual inspection of the FMV EHSV jet pipe, excessive solder was discovered on the diverter jet nozzle/feedback spring collar joint, with the solder protruding beyond the jet pipe nozzle (see Photo 2). The solder joint between the feedback spring collar and the jet pipe nozzle should be a fillet with no solder above the height of the jet pipe face (see Photo 1). The required air gap between the nozzle and the receiver ranged between 0.0005 and 0.0008 inch. The air gap on the affected nozzle was reduced by the excessive solder to between 0.0001 and 0.00048 inch. A 73-micron fuel filter allowed for passage of particles no greater than 0.0003 inch through the first stage.

**Photo 2.** Nozzle from occurrence EHSV

The reduced clearance between the nozzle and the receiver in the FMV EHSV resulted in an area that would be susceptible to binding due to particle contamination. It was possible that small foreign particles could pass through the 73-micron filter and temporarily interfere with the free movement of the nozzle. To account for the high fuel flow during the engine start, the

nozzle was held in a position where it would direct most of its flow into the receiver port responsible for commanding high fuel flow. This resulted in the start fuel flow exceeding the normal start parameters by a factor of 10. Subsequent examination of other units submitted for inspection and overhaul after the occurrence did not reveal any similar manufacturing flaws; therefore, it is likely that this was an isolated event.

1. Excessive solder on a jet pipe nozzle in the overhauled electro-hydraulic servo valves (EHSV) reduced the clearance area so that particle contamination allowed binding, resulting in a nozzle position that commanded excessive fuel flow.
2. The manufacturer's quality assurance monitoring did not detect the excessive solder on the jet pipe nozzle, allowing the nozzle back into service.

Honeywell International Inc. inspected all electro-hydraulic servo valve (EHSV) units returned for overhaul since the occurrence. By 15 June 2006, 117 returned valves had been inspected with no anomalies detected. The overhaul process was subjected to an internal quality review, and changes were made to prevent a recurrence. As well, the following processes were put in place:

- training was conducted for all soldering operators and inspectors;
- peer audits were scheduled quarterly;
- a quality inspection point was added for all overhauled spring solder joints;
- process verification audits were scheduled on an annual basis; and
- rejected and reused components were to be completely segregated during disassembly, cleaning, and reassembly.

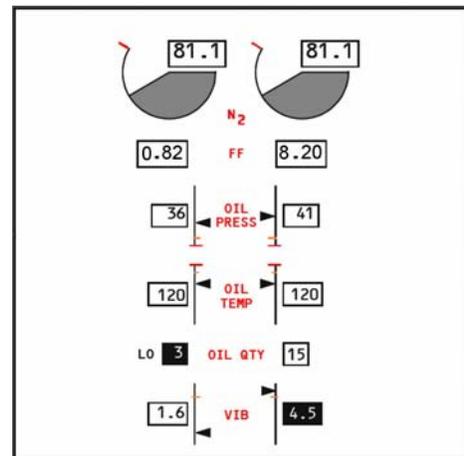
The N1, N2, and EGT displays in the occurrence aircraft consist of combined digital and stylized analog round gauges, which allow for easy identification of rate of change and differences between the engines. In addition, exceedence of normal ranges is presented by changes in gauge colour and/or digit colour. Similar trend information and colour coding is featured on presentations for oil pressure, temperature, and engine vibration on combined digital and analog vertical tape displays. The presentation of engine oil quantity is in digital format, with colour change to signify low quantity. Fuel flow indications are in digital format only, with no colour change (see Figure 3).

Figure 3. Secondary engine display

A combined digital and analog format for the fuel flow display may have made it easier for the flight crew to identify the abnormal fuel flow during the start of the right engine. The crew's attention was focused on N2, EGT, and oil pressure until the engine stabilized at idle, and this, combined with the type of fuel flow gauge display, explains how the abnormal fuel flow might have been missed.

1. It is possible that the digital display format for fuel flow had a bearing on the flight crew's ability to detect the abnormal fuel flow during the start of the No. 2 engine.
