## **AVIATION INVESTIGATION REPORT**

**A07A0096**

### **ENGINE FAILURE / FORCED LANDING**

**AYRES S-2R C-FBED**

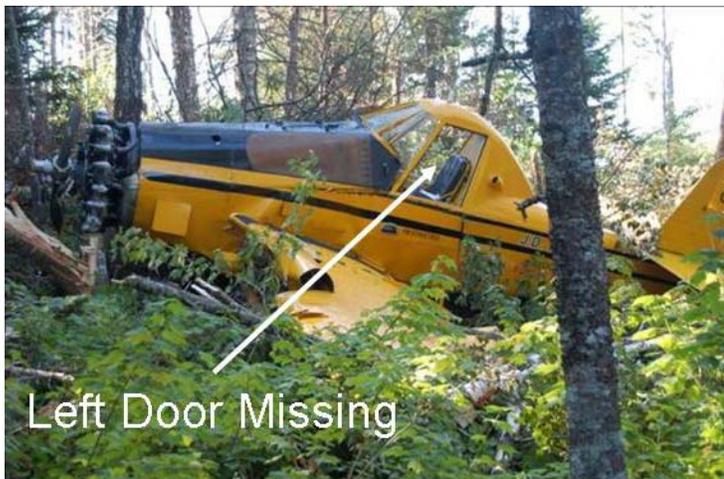
As the aircraft entered the trees in a right-wing-low attitude, it began to decelerate and yaw further to the right. Several large trees were broken off in the accident sequence, which caused damage to both wings, the tail section, fuselage, empennage, propeller, and engine. The pilot, who was wearing a four-point safety harness, was not injured. The cockpit integrity was not compromised.

**Photo 2.** Aircraft final position

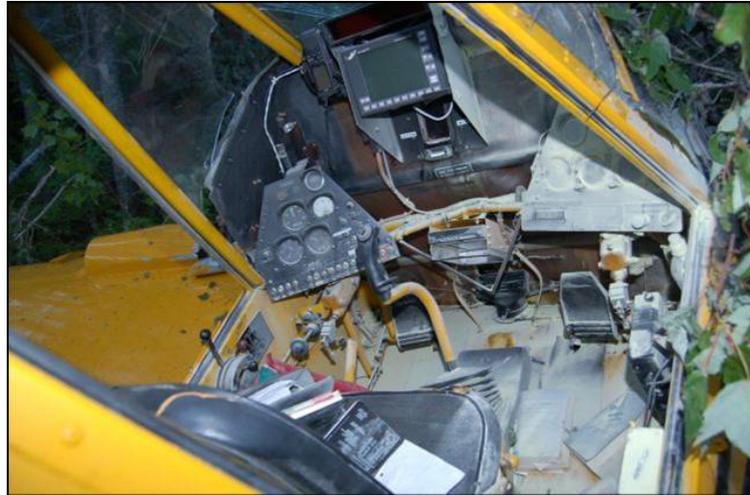
**Photo 3.** Cockpit integrity
