AVIATION INVESTIGATION REPORT
A07P0209

TAIL ROTOR DRIVESHAFT FRACTURE

**BLACK TUSK HELICOPTERS
BELL 214B1 (HELICOPTER) C-FWQU
RAMSAY ARM, BRITISH COLUMBIA**

02 JULY 2007

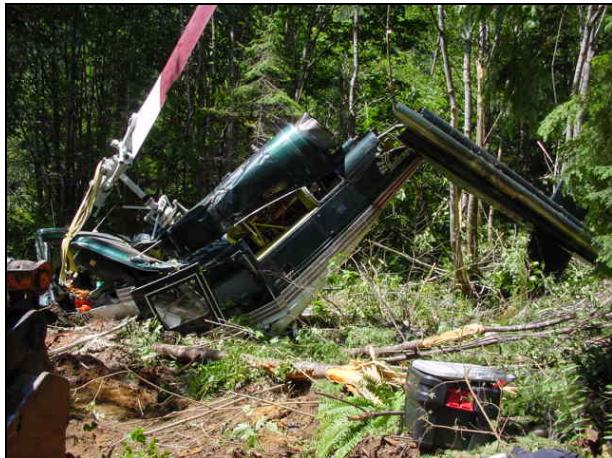
Photo 1. Bell 214B1 wreckage

An examination of the wreckage at the site revealed that the No. 3 shaft in the tail rotor driveshaft assembly (TRDS) had fractured 18 inches behind the forward coupling, causing loss of drive to the tail rotor. This resulted in the gearbox warning lights illuminating, the rapid rotation to the right, and the loss of directional control.

Scoring and abrasion damage had occurred to several sections of the top of the tail boom beneath the TRDS. The tail boom had broken in two parts at impact, with the break slightly forward of the broken shaft. (See Photo 1 and Photo 2)

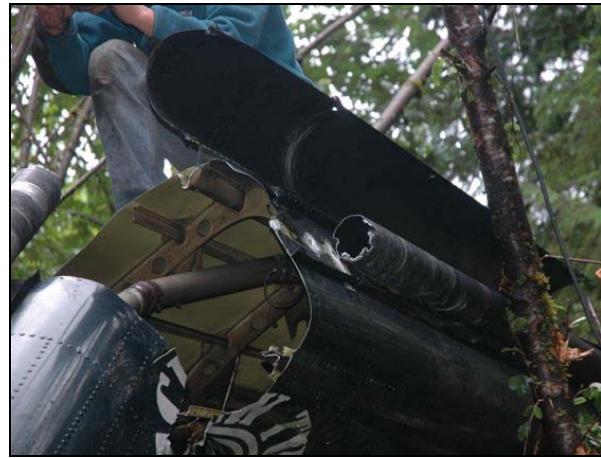
Photo 2. Fractured tail rotor driveshaft

The TRDS shaft then began to strike the top deck heavily, cutting into the frames, causing heavy scoring of the shaft, and leading to rapid weakening and fracture of the driveshaft at the point of heaviest scoring. At the same time, the shaft struck the top deck so violently that it abraded the rivets and skin, leaving traceable metal flow on the contact areas. The two large cavities created exhibited diagonal cracking, further characteristics of tail boom twisting in that area. That the tail boom was distorting at this stage in the sequence of events is further demonstrated by the multiple contact sites on the tail boom top deck.

In summary, it was a combination of TRDS bending/misalignment and tail boom twisting/distortion that allowed the subject shaft to come into heavy contact with the tail boom top deck skin. That contact precipitated a vibration that amplified rapidly and led to the substantial circumferential scoring and cutting at the fracture point.

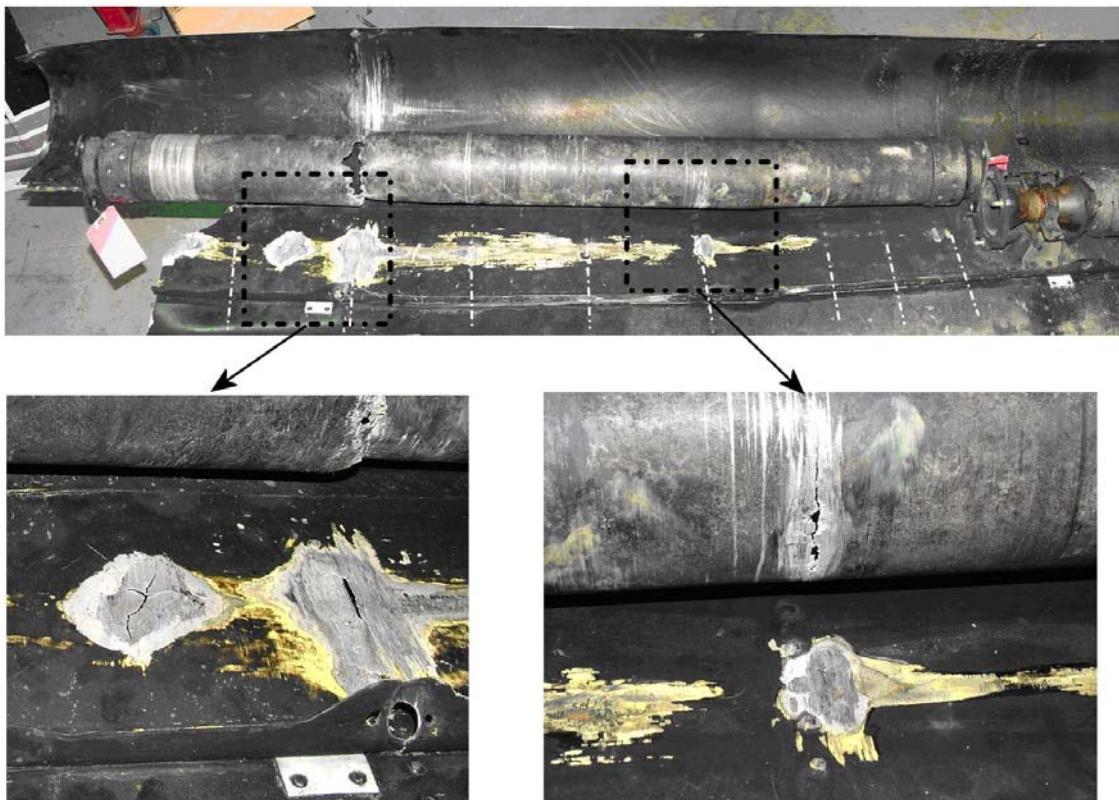
Photo 3. Tail boom and TRDS damage

The tail boom was attached normally when the helicopter struck the terrain, and the forces of impact fractured the tail boom about 36 inches from the forward end (see Photo 1). The fracture surfaces are all due to overload and consistent with heavy downward tail boom contact with the ground.

The top of the tail boom was severely damaged by the No. 3 shaft of the TRDS. Rotational damage that could have only occurred before the shaft broke is seen in several places on the tail boom skin directly below the TRDS, particularly in the areas where frame bulkheads and stiffeners were located. The driveshaft fractured over a bulkhead (see Photo 3). Damage also occurred when the fractured ends of the shaft whipped around inside the TRDS cover. This confirms that damage occurred both before and after the shaft fractured. The flailing of the broken shaft at the main transmission end created sympathetic misalignment with the No. 2 (short) shaft and caused scoring and perforation of the tail boom and fuselage top deck skins below it.

Also noted on top of the tail boom were several distinct areas of paint degradation that appeared to be the result of exposure to high heat. Research of the engine exhaust efflux pattern showed that the hot exhaust gases impinge on the tail boom in the areas noted.

As a result of the investigation into this Bell 214B1 accident, Black Tusk Helicopters has voluntarily chosen to replace its Bell 214B1 tail boom skins every 5000 flight hours. Similarly, Transwest Helicopters will replace its tail boom skins every 3000 hours.

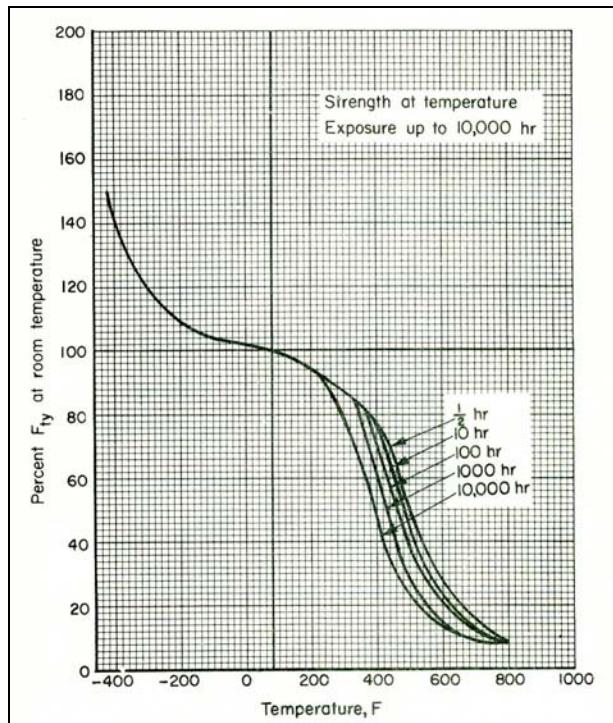
Figure 1. Effect of temperature on elevated temperature yield strength of 2024-T3, T4 aluminium (Ref: MIL-HDBK-5)

The coupons showed significant changes; the room temperature tensile strength was only 83 per cent of the standard value and the conductivity had been altered. These results are consistent with prolonged exposure to elevated temperature.

The 2024 series of aluminium alloy has material properties that tend to degrade as a result of exposure to elevated temperatures. For example, at elevated temperatures these alloys have reduced yield strength as shown in Figure 1. Furthermore, the time exposed to higher temperatures has a cumulative effect, reducing yield strength even further. In addition to reduced yield strength, exposure to elevated temperature reduces the modulus of elasticity, a measure of stiffness. For example, in the range 400 to 499°F (204 to 259°C), the temperatures measured during the temperature survey, the modulus of elasticity drops to about 81 per cent of its room temperature value.

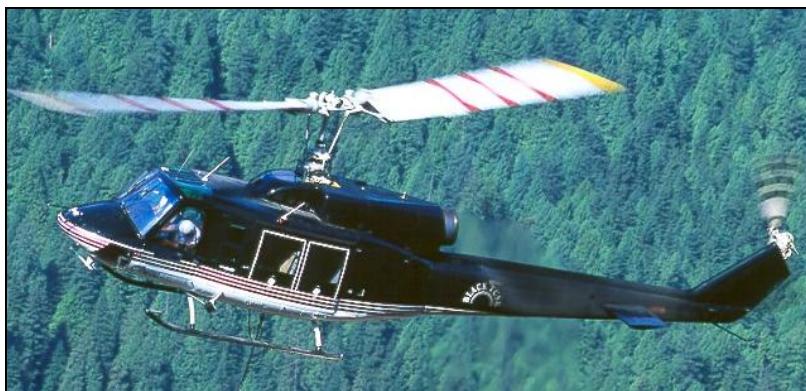
Photo 4. Exhaust path in hover (source: Black Tusk Helicopters)

As a result of the TSB's preliminary findings of the tail boom skin weakness, a temperature monitoring trial was conducted. Temperature-sensing decals were applied to identical locations on the tail booms of three Bell 214B1 helicopters carrying out vertical reference operations in British Columbia (BC) and recording of the decals was carried out by field maintenance personnel. The results of the trial showed that the tail boom was constantly exposed to exhaust gas temperatures between 204 and 259°C (400-499°F) in the areas that coincided with paint destruction by heat seen on the accident tail boom. Photo 4 shows the engine exhaust gas path flowing over the tail boom.

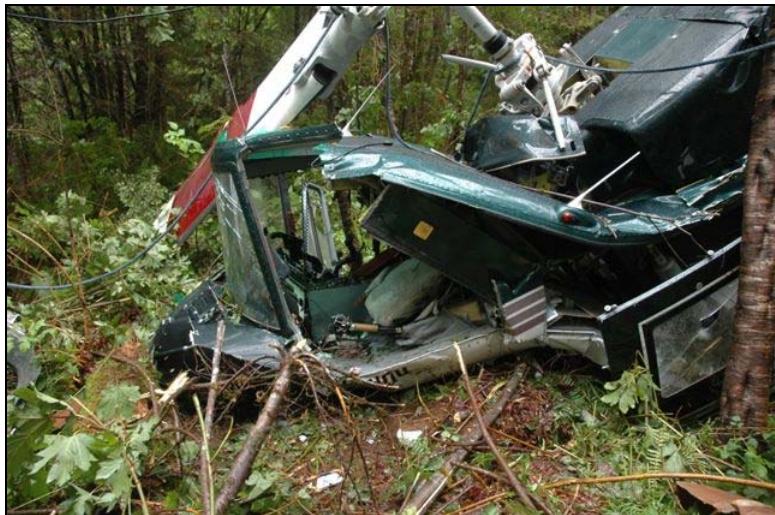
Photo 6. Crushed cabin

Impact forces were severe, the level of airframe destruction was high, and the occupiable volume for the rear cabin was significantly reduced (see Photo 6).

The cockpit area was also crushed, with the left side sustaining far more damage than the right side. It is this level of damage that caused the pilot in the left seat to receive serious injuries and the co-pilot to receive minor injuries.

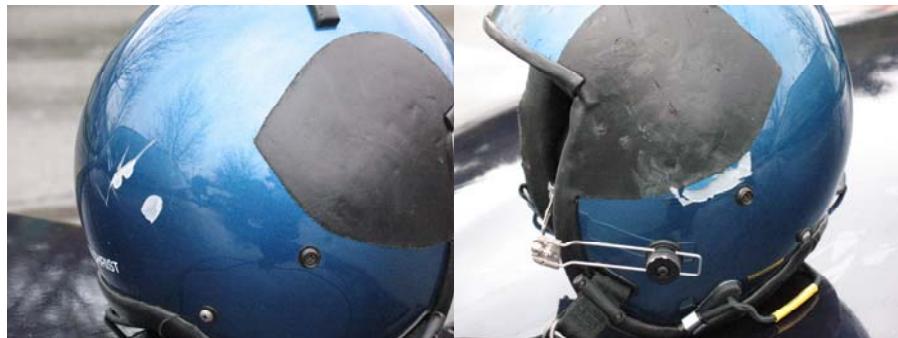
Photo 7. Pilot helmet damage

The impact damage to the flying pilot's helmet shows that the helmet prevented more serious head injuries (see Photo 7). Had he been able to wear the available shoulder harness, the injuries he did receive would likely have been less severe.
