AVIATION INVESTIGATION REPORT

A08A0007

HARD LANDING – POWER RECOVERY AUTOROTATION

**UNIVERSAL HELICOPTERS NEWFOUNDLAND LIMITED
EUROCOPTER AS 350 BA ASTAR (HELICOPTER), C-FHHH
MOUNT PEARL, NEWFOUNDLAND AND LABRADOR**

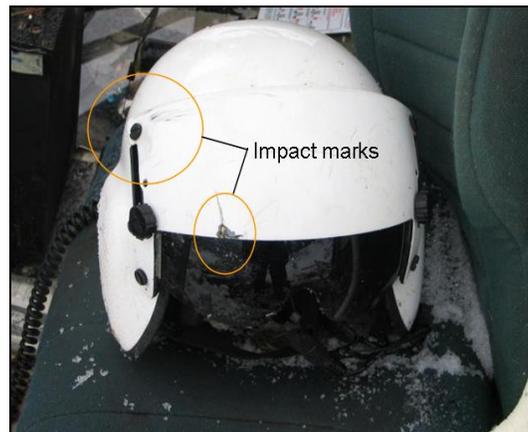
Photo 1. Pilot's helmet

The training pilot was not wearing a helmet ⁵. He sustained severe facial and head injuries. The other pilot was wearing a helmet and did not incur head injuries; scarring on his helmet indicates contact with the helicopter structure during impact sequence (See Photo 1).

The pilot wearing his helmet did not receive head or facial injuries. The training pilot was not wearing a helmet and incurred severe facial injuries; the use of a helmet would likely have reduced the severity of his injuries.

The company has implemented a policy of cost sharing and interest-free loans to facilitate flight helmet purchase by the company's pilots. Many pilots have taken advantage of this offer and more pilots are now wearing helmets during flight operations.

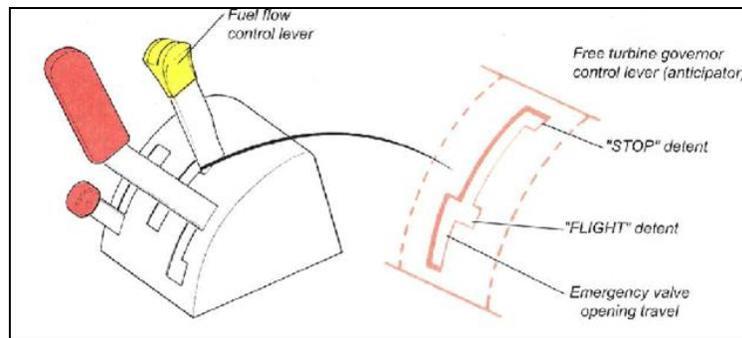
Figure 1. AS 350 BA Fuel Flow Control Lever

The procedures for conducting practice autorotations on the AS 350 depend on the model and are specified in the appropriate rotorcraft flight manual (RFM). The accident aircraft was equipped with a FFCL on which there is no idle stop position (See Figure 1). More recent models of the AS 350 are equipped with a twist grip that incorporates an idle stop position.

For FFCL-equipped models, the AS 350 RFM does not approve engine power reductions in flight because there is a risk of retarding the lever beyond the self-sustaining power regime.

While in cruise, the training pilot retarded the FFCL with the intent of stabilizing the Ng at 70 per cent. Given that there is no flight idle detent on the FFCL quadrant, the training pilot had to monitor the Ng gauge until the target value was reached. Following the reduction of engine power, while attempting to evaluate the actions of the pilot, the training pilot may not have been monitoring the Ng gauge closely enough. Because there is no physical stop between the flight detent and the stop detent (see Figure 1), it is possible that the FFCL was inadvertently set at or accidentally moved to a position that caused the engine to spool down.

The RFM warning about reducing the FFCL in flight is not included in its section on autorotations. The lack of explicit instructions prohibiting the use of FFCL for power recovery autorotations may have led the UHNL training pilots to assume that the FFCL can be used. It seems UHNL training pilots adapted the power recovery autorotation procedure for a twist grip throttle/collective, which allows for throttle use during power recovery.

- Shoulder harness – addressed to all pilots, advising that the use of the shoulder harness is mandatory.
- Autorotation in AS 350-series helicopters – addressed to all pilots, advising them that unless intending to do a full-on practice autorotation, manipulation of the throttle in flight is not authorized. This includes power recoveries and surprise autorotations.
- Autorotation rpm verification – addressed to all pilots and maintenance engineers, instructing them to record all required parameters, such as weight, altitude, temperature, speed, and NR [rotor rpm], anytime autorotation rpm verification flights have been conducted.

Eurocopter has developed a proposed supplement for the AS 350 rotorcraft flight manual (RFM) that deals with engine emergencies training procedures. The proposal provides explicit instructions on the procedure to be followed for practice autorotations, for both fuel flow control lever (FFCL) and twist grip engine controls. Regulatory approval is pending.

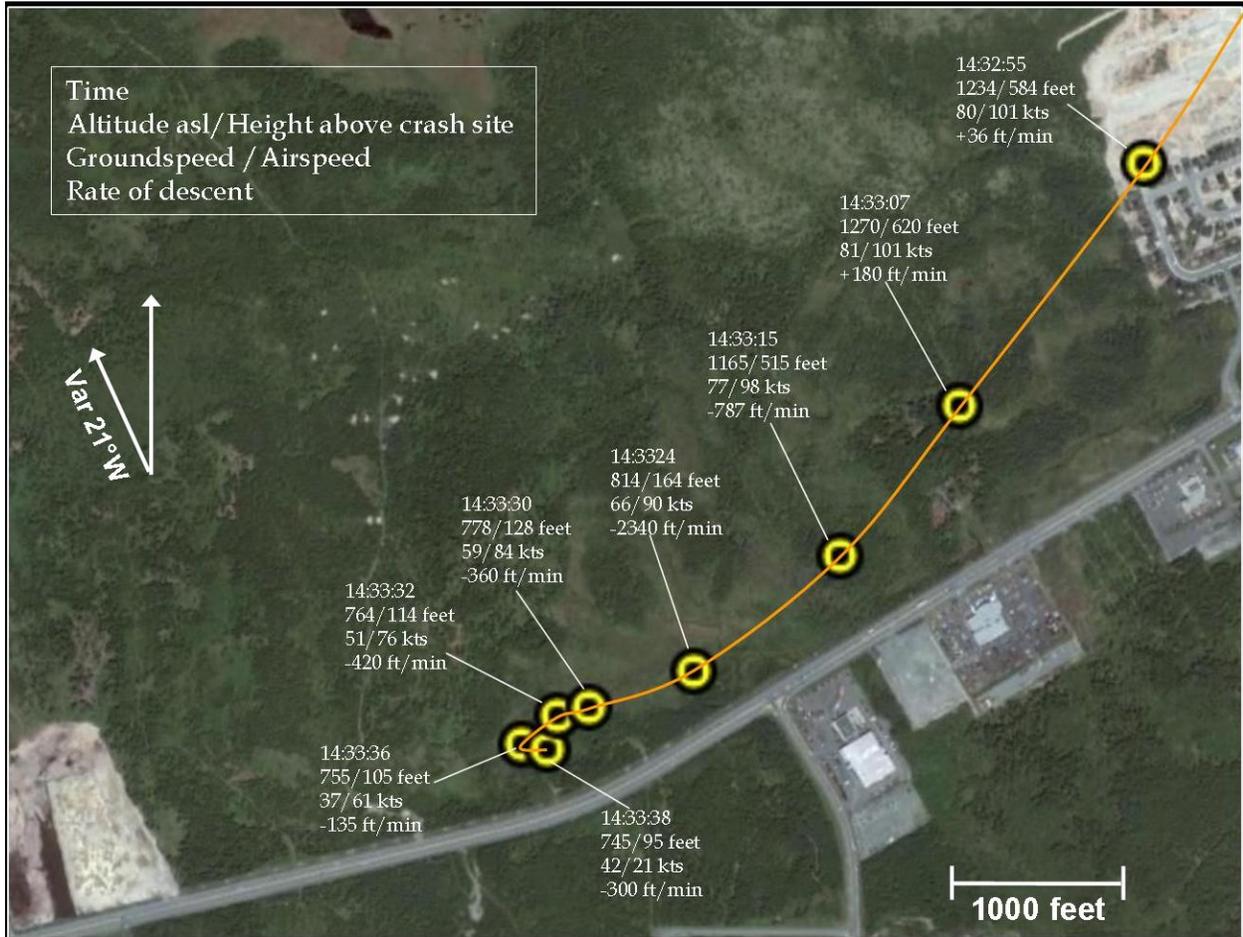
Appendix A – GPS track of the power recovery autorotation

From the data extracted from the helicopter's global positioning system (GPS), airspeed at the top of the autorotation was approximately 100 knots. At the time collective pitch was increased to execute the go-around, the airspeed was 90 knots. The recommended speed for executing autorotations is 65 knots, which gives the best rate of descent speed for the AS 350. Speeds higher than that induce higher rates of descent.

By the time the pilots realized that engine power was not recovering, they overshot the bog. They then executed a 180-degree steep turn in an attempt to return to the bog for a forced landing, which exposed the helicopter to a 25-knot tailwind landing. The autorotation was flown at a higher-than-recommended airspeed which, coupled with the steep turn, increased the rate of descent. This high rate of descent could not be arrested prior to contact with the ground because of the low-energy state of the main rotor.

⁹ At 1433:30, the sink rate decreased from 2340 feet per minute to 360 feet per minute (see Annex A).
