**AVIATION INVESTIGATION REPORT  
A08C0145**

**ENGINE FAILURE - FORCED LANDING**

**GOGAL AIR SERVICES LIMITED  
NOORDUYN NORSEMAN MK V C-FECG  
SNOW LAKE, MANITOBA, 15 nm N  
06 JULY 2008**

Report Number A08C0145

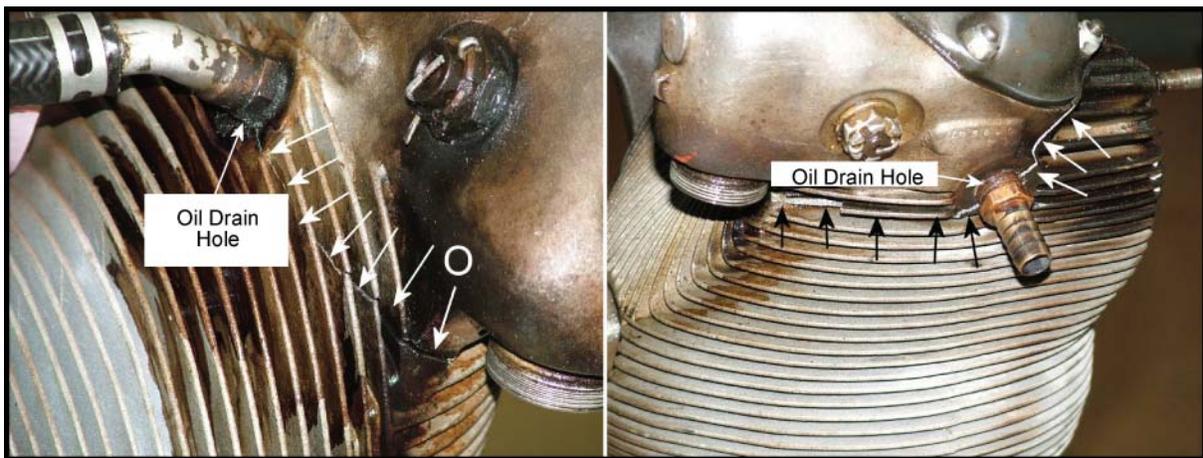
The cylinder was removed from the engine and sent to the TSB Engineering Laboratory for analysis. The valve operating mechanism, bearing clearances, and valve pushrods were examined and found to be within acceptable serviceability limits. The crack on the number 2 cylinder was found to extend from the oil drain hole on the inboard side through to the oil drain hole on the outboard side and up into the valve cap flange area (See Photo set 1).

**Figure 1.** Extent of exhaust ear failure; the "O" points to the area of crack origin

The failure and separation of the number 2 cylinder exhaust ear prevented the exhaust valve from opening. The hot exhaust gases migrated back into the induction system through the opening of the intake valve, causing a disruption in the fuel/air mixture to the remaining cylinders and resulting in a loss of engine power.

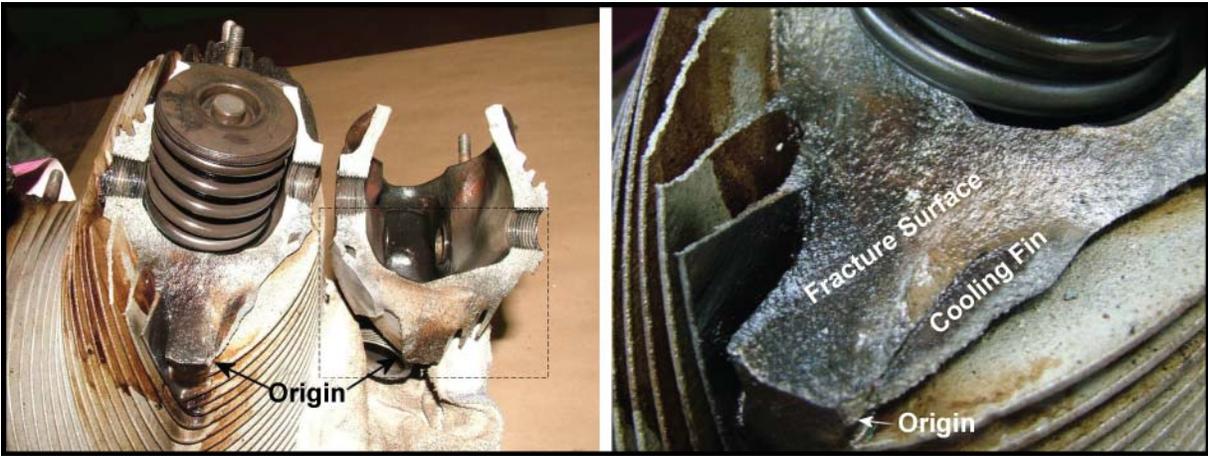
The cylinder fracture was examined under a scanning electron microscope (SEM). Casting porosity and heavy oxidation were found in several areas of the fracture surface and in the origin area of the failure. Beach marks were found that indicated that the fracture and failure occurred as a result of fatigue. The origin of the fatigue was co-located in an area of geometric stress concentration, at the corner where the cooling fin attaches to the cylinder (see Photo set 2).

**Figure 2.** Origin of crack located on a sharp radius corner of the cooling fin

The normal operation of the pushrod provided the cyclic tension load needed to promote the growth of the fatigue crack. The cluster of casting porosities at the corner of the cooling fin was most probably present since the cylinder was first cast, indicating that the fatigue process started when the cylinder was first put into service. The majority of the crack's fatigue lifetime occurred at lengths below the threshold of detectability and did not reach detectability until late in the fatigue lifetime. The severe extent of the corrosion, staining, and rub on the fracture surface indicated that the fatigue crack had been present for a considerable time prior to failure. Due to pounding of the surfaces nearest to the origin, however, it was not possible to quantify the time it took to grow from detectability to failure.

The number 2 engine cylinder exhaust ear failed under fatigue in an area of casting porosity and geometric stress concentration. The casting porosity was likely introduced during manufacture of the cylinder some 50 to 80 years prior. The time in service of the cylinder could not be established because there is no requirement to track the cylinder's total accumulated usage. Numerous repair shop markings on the cylinder skirt and ear area suggest that the cylinder had high-time hours in service. The area of fatigue was subject to normal operational loading that took years to initiate and manifest the crack. The severe extent of the corrosion, staining, and rub on the fracture surface indicated that the fatigue crack had been present for a considerable time prior to failure. Because the crack was not detected by liquid penetrant inspection during cylinder overhaul 595 hours prior to the occurrence flight, the development of the crack to the detectable stage likely occurred after that time. The casting porosity, age of the cylinder, and its high time in service were major contributing factors in its eventual failure.
