**AVIATION INVESTIGATION REPORT  
A09C0017**

**COLLISION WITH TERRAIN AT TAKE-OFF**

**TRANSWEST AIR LIMITED  
DE HAVILLAND DHC-6 SERIES 100, C-FCCE  
LA RONGE, SASKATCHEWAN  
04 FEBRUARY 2009**

Report Number A09C0017

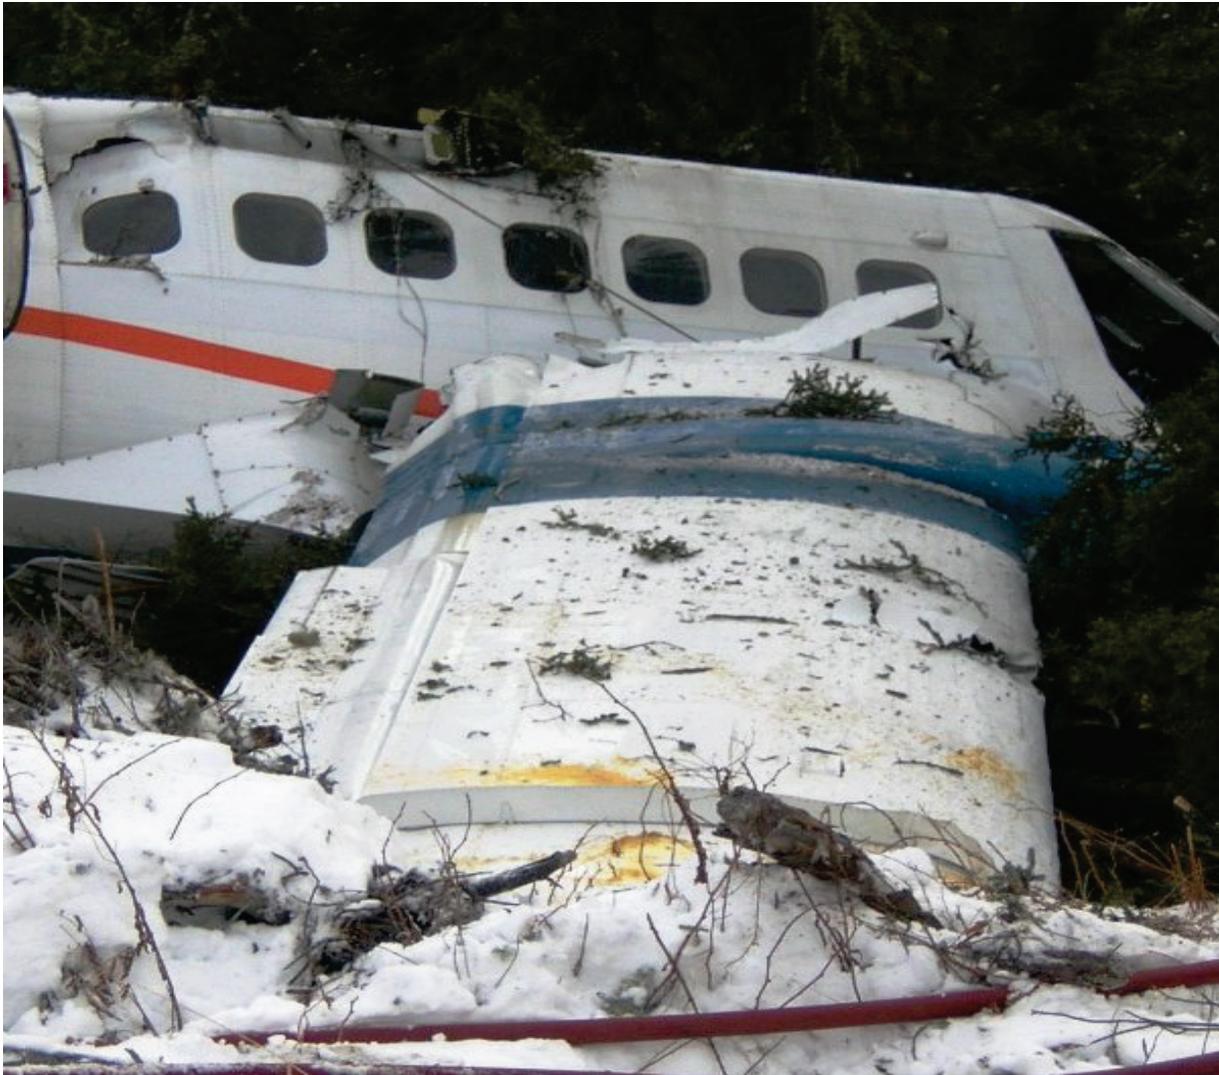
Several photographs of the aircraft were taken immediately after the accident. The upper surface of the right wing was visible in the photographs, but the left wing was not. Contamination was visible on the flaps near the right wing root and appeared to extend outwards in the form of a line along the flaperons. Contamination was also visible on the blue painted area surrounding the engine nacelle (see Photo 1.) Patches of oil deposited on the right wing when the right engine tore from its mounts were also visible. These patches of oil were compared to the patches visible in photographs taken the day following the accident when the temperature had increased above zero. Recognizable differences in the size of patches were noted (see Photo 2). This difference was likely caused by the melting of the contamination that had initially trapped the oil and restricted its spread. Wing contamination increases aerodynamic drag and reduces lift.

**Photo 1.** Right wing immediately after the accident

The weather data for La Ronge indicated that there had been two periods of snow after the aircraft had been parked on 29 January 2009 and that, in the afternoon of January 31, temperatures at or above zero had been experienced. Consequently, it was likely that the snow on surfaces of the aircraft melted, and then froze and adhered to the surfaces. Subsequent snowfall covered this contamination. While the snow may have been brushed off by the first officer, removal of all the contamination could not have been confirmed without a tactile test, which was not performed. Consequently, contamination of critical surfaces as revealed by post-accident photography was likely.

No mechanical failure was found that would account for the right yaw and bank after the nose ski and left main ski lifted-off. However, the contamination revealed by photographs on the right wing could have produced degradation in lift and increased drag on the right wing, and kept the wing in a stall condition at the low airspeed of a STOL type take-off. While the condition of the left wing was not documented in the photographs, lift-off of the left wing occurred within the range predicted by the ski supplement to the flight manual. Consequently, the left wing was likely uncontaminated or less contaminated. It is likely, however, that asymmetric contamination of the wings created a lift differential, producing a roll and yaw to the right. The captain's reaction in attempting to lift the wing with aileron would have increased the angle of attack over the right wing and exacerbated the condition. Eventually, the aircraft accelerated to a speed that generated sufficient lift over the right wing, and lift-off of the right ski occurred. The proximity of the trees, however, precluded a safe departure. When the flaps were raised, the lift over the right wing was again reduced and the right wing tip entered the snow.

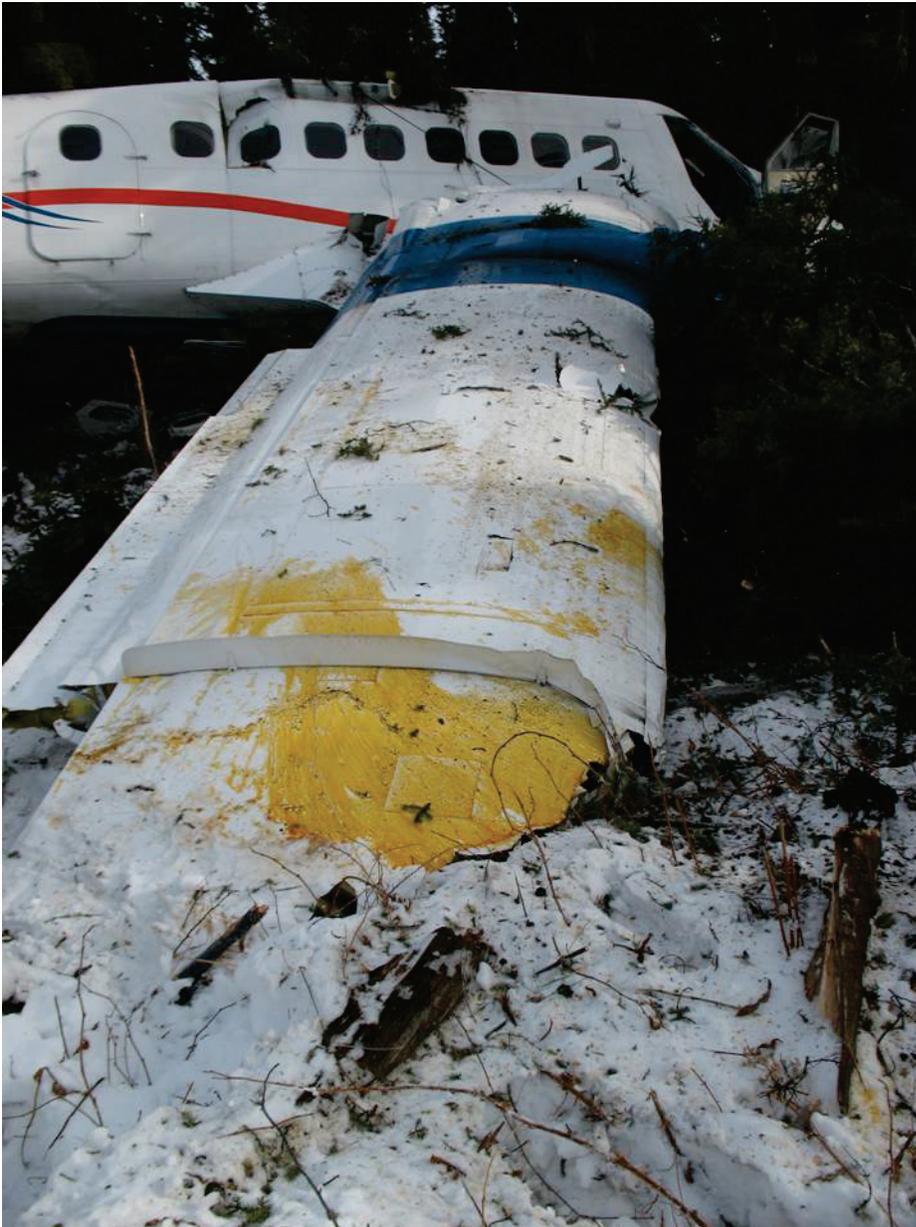
**Photo 2.** Right wing two days after the accident.
