**AVIATION INVESTIGATION REPORT
A13P0165**

LOSS OF CONTROL AND COLLISION WITH TERRAIN

**TYLAIR AVIATION LTD.
CESSNA 172L, C-FQTR
KAMLOOPS, BRITISH COLUMBIA, 30 NM WEST
06 AUGUST 2013**

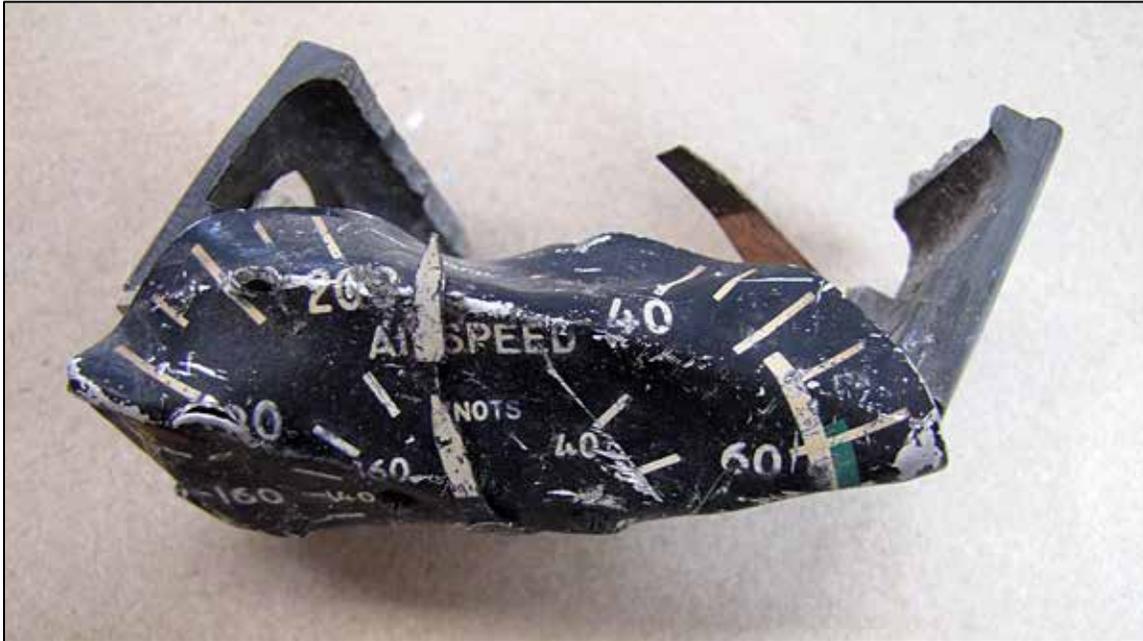
Flight instruments were destroyed; however, remnants of the airspeed indicator, altimeter, engine tachometer and Hobbs meter,⁴ turn coordinator, and flap position indicator were recovered and evaluated by the TSB Laboratory. The examination of the airspeed indicator dial face and pointer did not reveal any witness marks; however, it was noted that the pointer, due to the bends in the dial face, was trapped in the region past the 200 mph indication (Photo 1).

The normal operating speed range is 59 to 140 mph (manoeuvring speed). The caution range is 140 to 174 mph (the never exceed speed and red line). The highest graduation speed mark on the gauge is 210 mph. The dial face of the engine tachometer revealed witness marks indicating approximately 2550 rpm. The maximum operating speed for the engine at 5000 feet asl is 2600 rpm. The position of the throttle at the time of the accident could not be determined.

Photo 1. Occurrence airspeed indicator showing trapped pointer position

It is not known what manoeuvres the pilot may have been conducting, but a nose-drop during a steep turn or an improper stall recovery can lead to a spiral dive if not corrected in time. The primary reason why an aircraft would achieve speeds near or greater than the never exceed speed of 174 mph is a spiral dive. Both steep turns and stalls were planned as part of the training flight, and recovery skills had previously been demonstrated by the student pilot with the instructor on board.
