Air Transportation Safety Investigation Report A18W0113

COLLISION WITH TERRAIN

Kasper Kootenay Wings MS Special (basic ultralight), C-ITMF
Grande Prairie, Alberta
31 July 2018

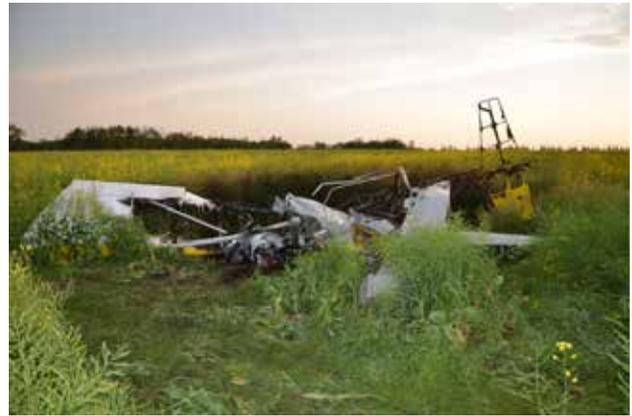
Figure 1. Accident site, looking west

When the aircraft was approximately 1 nm from the airfield, on the runway heading, it was seen at an altitude of 300 to 500 feet above ground level (AGL). The engine rpm was heard slowly increasing and decreasing but was not running rough. Moments later, the left wing dropped, and the aircraft entered a steep nose-down attitude. During the descent, the engine rpm increased rapidly, and the rpm remained high until the aircraft struck the ground (Figure 1).

The pilot was fatally injured and the aircraft was destroyed in an intense post-impact fire. The aircraft was not equipped with an emergency locator transmitter nor was one required by regulation; however, a portable SPOT Satellite GPS [global positioning system] Messenger was on board.

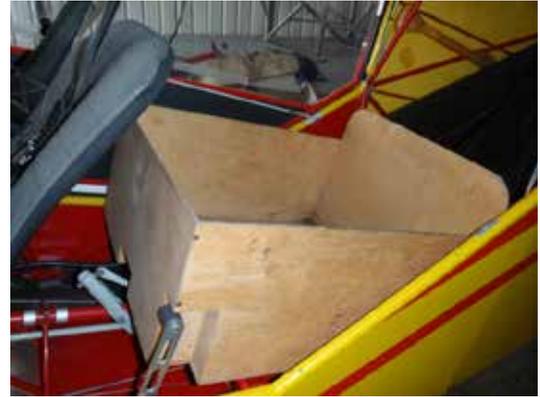
Figure 2. Wooden storage box (Source: Previous owner of the aircraft)

During preparations for the return flight, the rear seat of the aircraft was removed and a wooden storage box, which had been used many times by the previous owner, was installed (Figure 2). The box was secured to the aircraft floor structure at 4 attachment points matching those of the removed seat. All of the aircraft's historical records were placed in a backpack and secured in the box, along with the pilot's personal travel items.

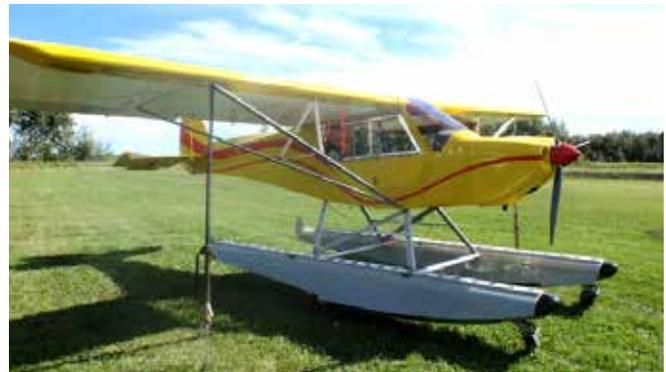
Figure 3. Kasper Kootenay Wings MS Special (Source: Previous owner of the aircraft)

The Kasper Kootenay Wings MS Special is a high-wing, 2-seat aircraft of steel tubing and fabric (Figure 3). The occurrence aircraft was built from plans and raw materials in 2001. All of the aircraft's records were destroyed in the post-impact fire.

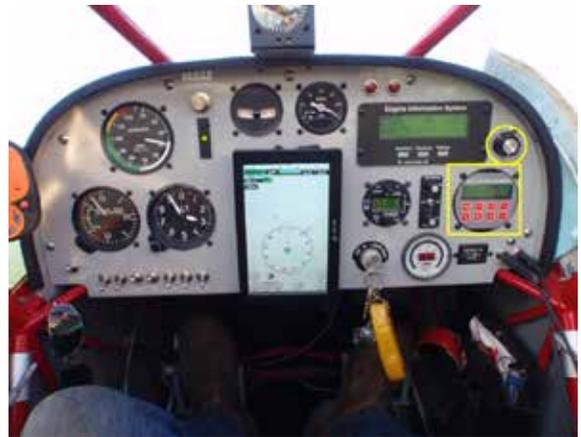
Figure 4. The occurrence aircraft's instrument panel showing the Simple Digital System programmer (yellow square outline) and mixture control knob (yellow circle outline) on the right of the panel (Source: Previous owner of the aircraft)

The SDS EFI system has a mixture control knob, which is located on the aircraft's instrument panel (Figure 4).

Mixture control allows the fuel injection system to be pre-programmed and also to be manually adjusted within a range of 50% more or less than the pre-programmed setting, giving the pilot independent control in the event of certain sensor failures. There can, however, be a loss of engine power at the leanest and richest settings of the adjustment range. Some pilots prefer to manually make the fuel mixture leaner using the knob once cruise power is set. The investigation was unable to determine whether the mixture control was manipulated during the flight, and, due to the intense post-impact fire, the final mixture setting could not be determined.
