AIR TRANSPORTATION SAFETY INVESTIGATION REPORT A21C0038

COLLISION WITH TERRAIN

Great Slave Helicopters 2018 Ltd.
Airbus Helicopters AS350 B2 (helicopter), C-FYDA
Griffith Island, Nunavut
25 April 2021

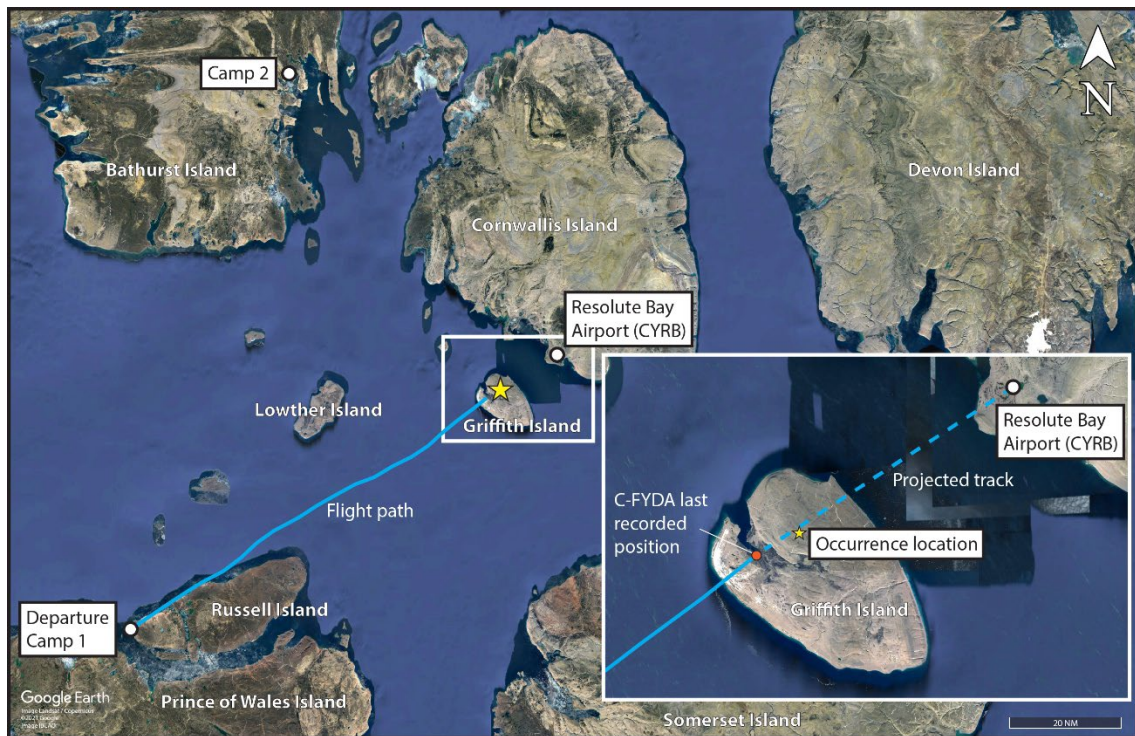
Figure 2. Occurrence flight track, with inset magnification of occurrence location and projected track (Source of both images: Google Earth, with TSB annotations based on the aircraft's satellite flight-tracking system position data)

At 1548, the occurrence helicopter departed Camp 1 on a visual flight rules (VFR) flight to CYRB (Figure 2).⁴ The occurrence flight track to CYRB took the helicopter above a mix of solid ice and ice chunks (i.e., ice pans) between Russell Island and Griffith Island, Nunavut.⁵ On board were the pilot, an aircraft maintenance engineer, and the lead biologist. Approximately 3 minutes after takeoff, a message originating from the pilot's satellite messenger was sent to GSH's dispatch and PCSP staff, reporting that the helicopter had departed and estimated arriving at CYRB at 1645.

For the first 25 minutes of the flight, the helicopter was generally flown at 110 knots, from 250 feet to 1000 feet above sea level (ASL). From the camp until the eastern edge of Russell Island, the helicopter's track was consistent with a direct track from the camp to CYRB. During the first half of the portion of the flight between Russell Island and Griffith Island, the helicopter's track diverged 1.0 to 1.5 NM left of the direct track. Approximately halfway between Russell Island and Griffith Island, the helicopter's track altered to the right, until the helicopter was approximately 1 NM right of the direct track, 15 NM west of Griffith

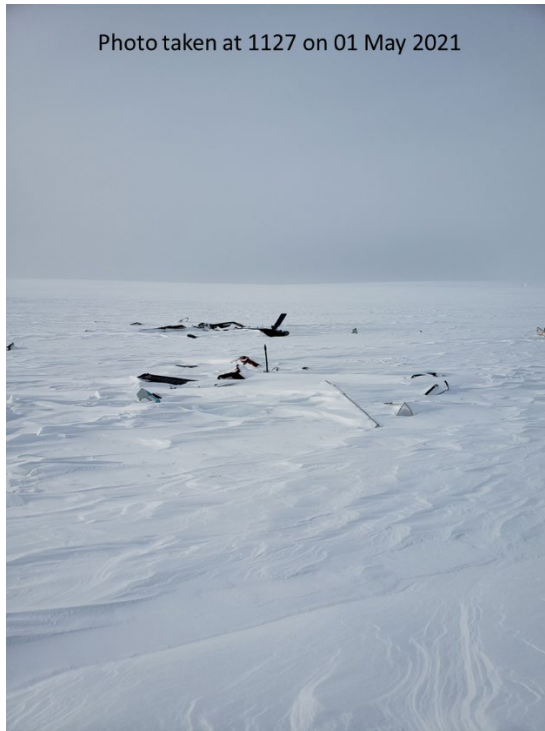
Figure 4. Photo of the crash site taken the day the TSB investigators reached the site (Source: TSB)

At the time of the occurrence, the ground was covered in more than 2 feet of snow. When ground SAR personnel reached the accident site, there was a coating of snow on most of the debris, from snow that had fallen since the accident. The fan-shaped crash site measured approximately 175 feet in length, and consisted of 4 main sections. The debris field was oriented on a track almost 180° to the occurrence flight's track towards CYRB. All debris was found beyond the initial impact crater in the snow.

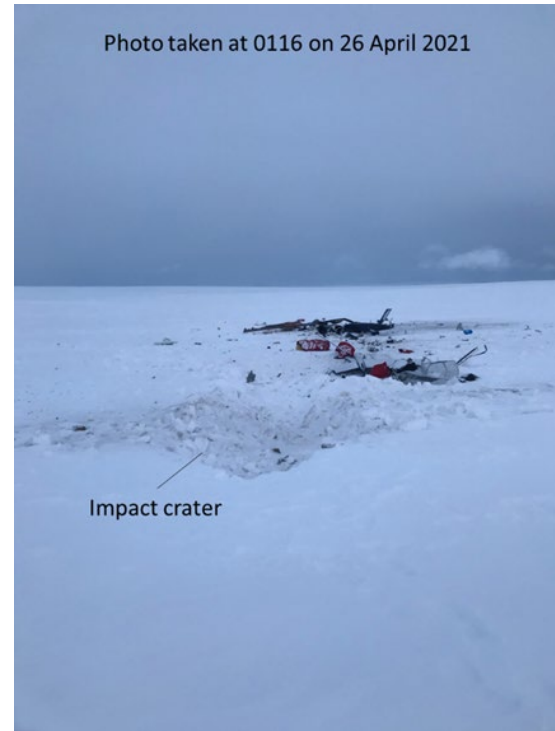
Figure 5. Photo of the crash site taken the day of the occurrence (Source: RCMP)

Ground SAR personnel who responded observed undisturbed snow to the sides of, and leading up to, the initial impact mark. The TSB laboratory used the available data and determined that the helicopter's pitch attitude and bank angle would have had to have been less than 35° and 22° respectively not to have left blade marks in the snow, assuming that the main-rotor blades were straight and not coning²⁰ (Figure 6). The extent of the damage and the length of the debris field were consistent with the helicopter impacting terrain with a relatively high horizontal and vertical speed. These impact characteristics are most commonly associated with a controlled-flight-into-terrain (CFIT) accident rather than a

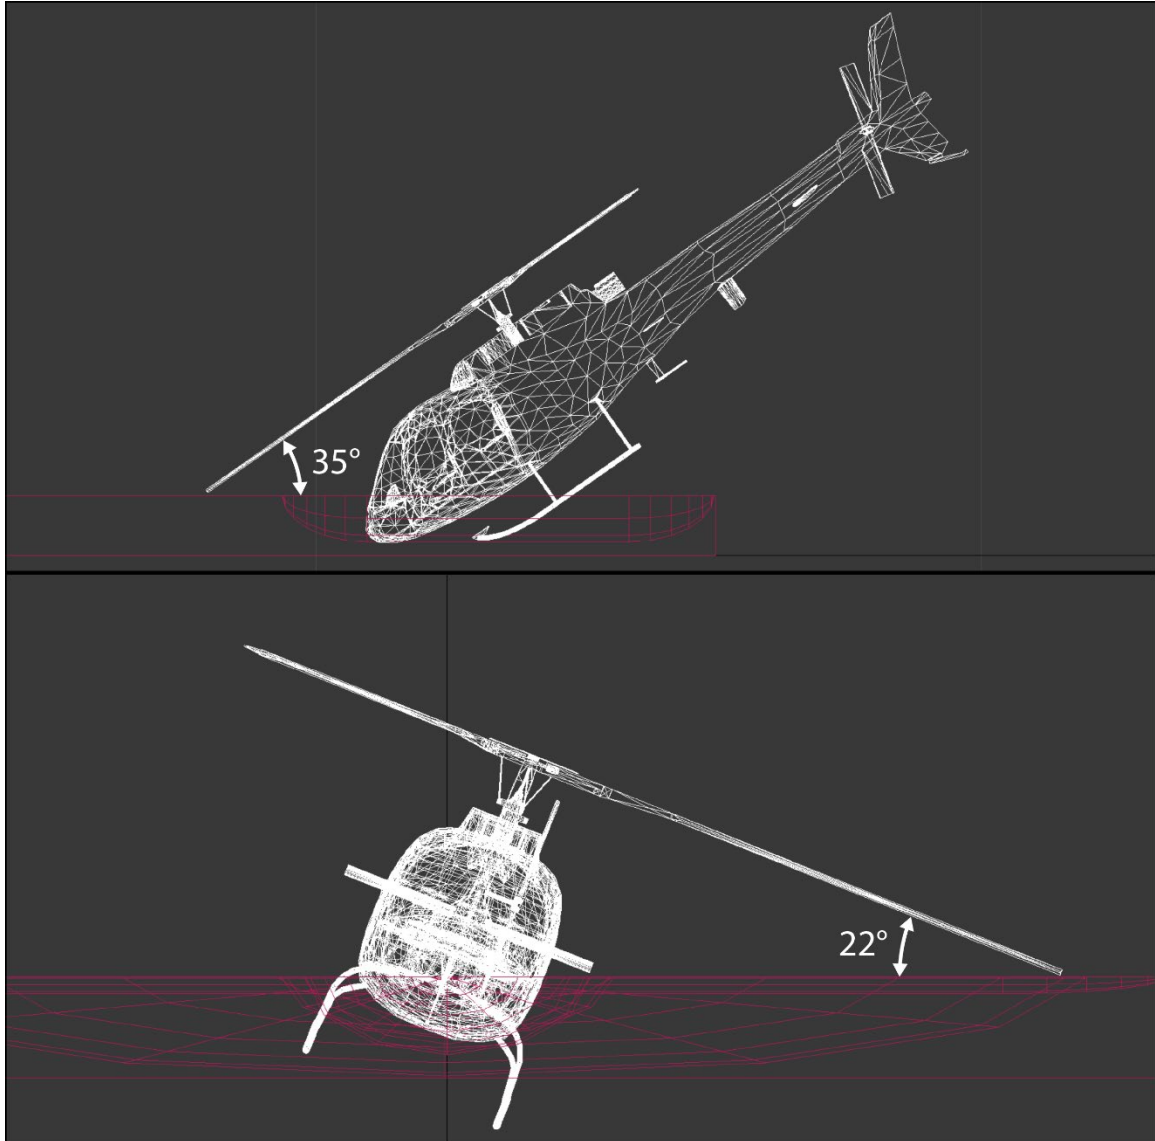
Figure 6. Illustration of the maximum possible pitch and bank angles of the occurrence helicopter at impact (Source: TSB)

loss-of-control accident (which is generally associated with a lower horizontal speed due to a steeper vertical descent).²¹

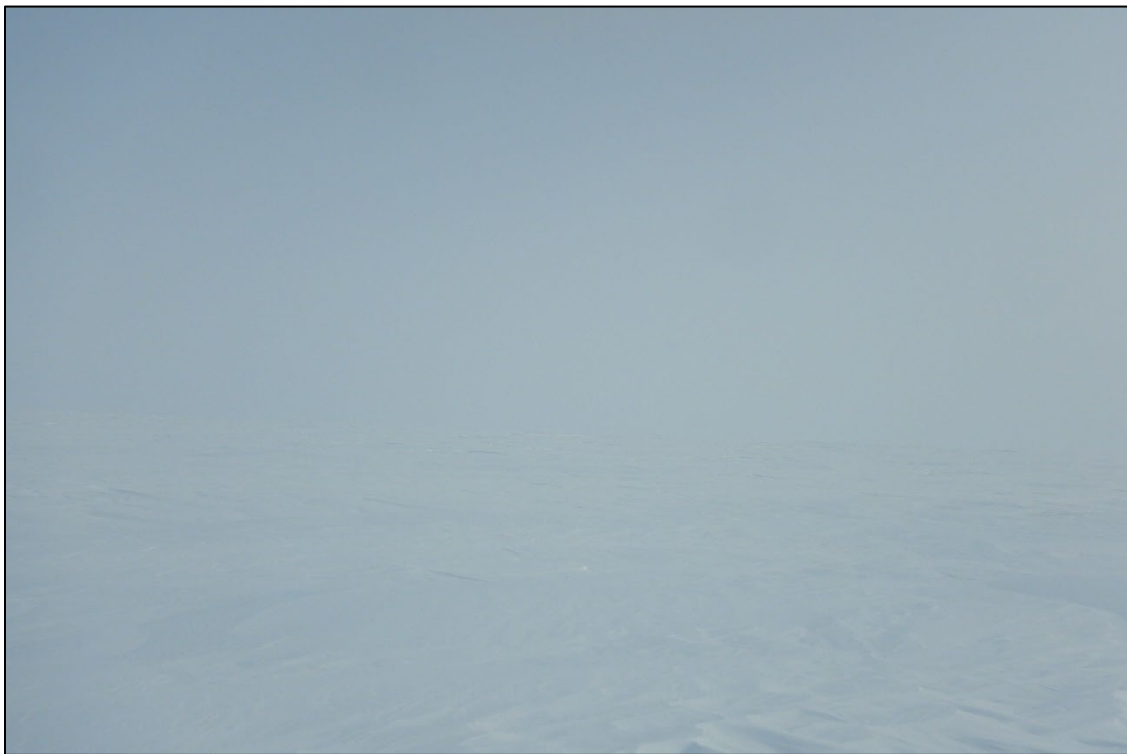
Figure 8. Photo taken at crash site on 01 May 2021, looking towards Resolute Bay. Perpendicular ridgeline approximately 1 statute mile away. (Source: TSB)

The photo below (Figure 8) was taken at the accident site, looking in the direction of Resolute Bay. When the photo was taken, the weather at CYRB was reported to be a visibility of 7 SM in light snow with a scattered cloud layer based at 3700 feet AGL.
