MARINE INVESTIGATION REPORT

M98M0003

ACCIDENT ABOARD SHIP

FISHING VESSEL "CAPE CHIDLEY"

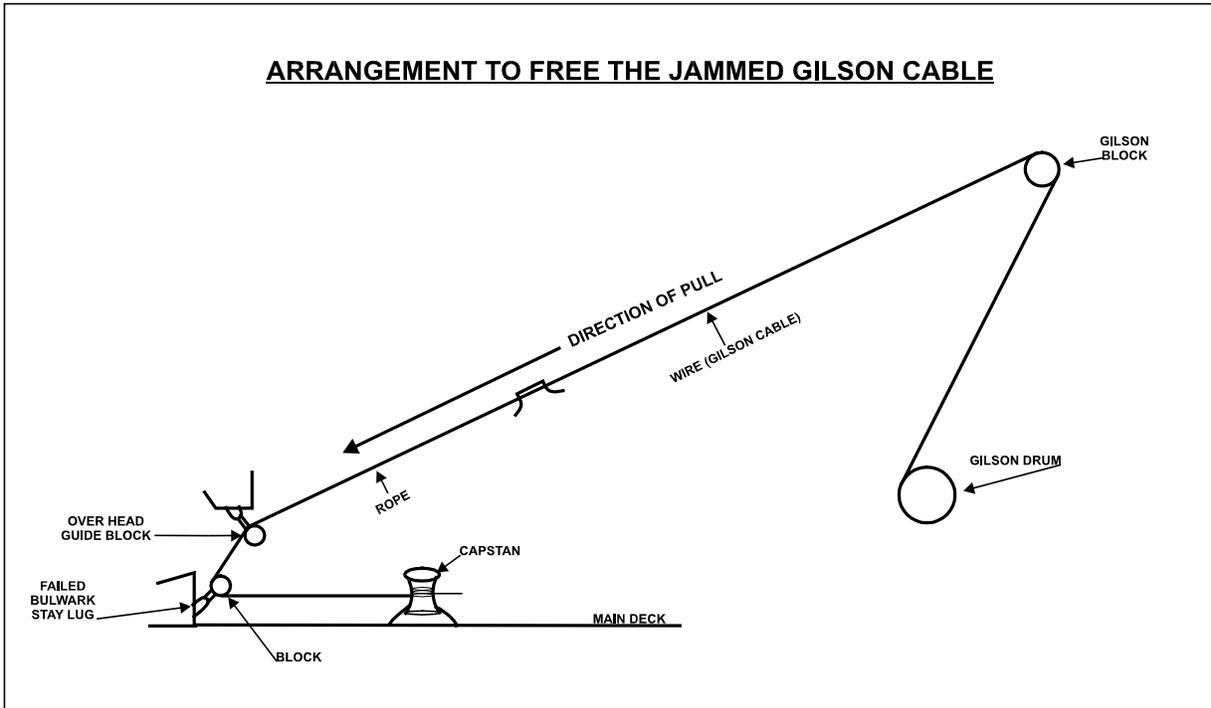
*Appendix A - Arrangement of Cable, Rope, and Blocks*

Using the gilson winch and cable over the gilson block at the head of the forward gantry, the crew attempted to lead the cable aft to the port trawl door. When slackening-off the gilson cable by rotating the winch drum, a riding turn of wire on the gilson drum jammed the cable and prevented it from being hauled out by hand. The capstan winch was then used to forcibly clear the riding turn of cable on the gilson drum (see Appendix A - Arrangement of Cable, Rope and Blocks).

In order to free the jammed cable, a rope was harnessed to the end of the gilson cable. It was then led through an overhead guide block at the top of the port gallows frame, down through a yo-yo block with a working limit of five tons, attached at the aft bulwark, and led to a capstan winch located on the port side of the afterdeck. The master warned all hands to stand clear as the cables and rope under strain ran the full length of the working deck.

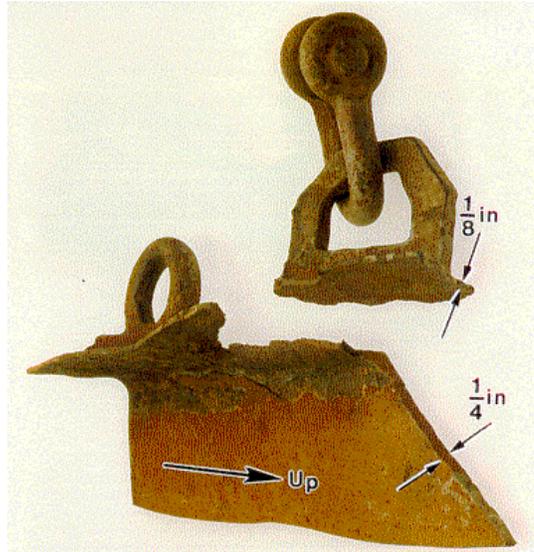
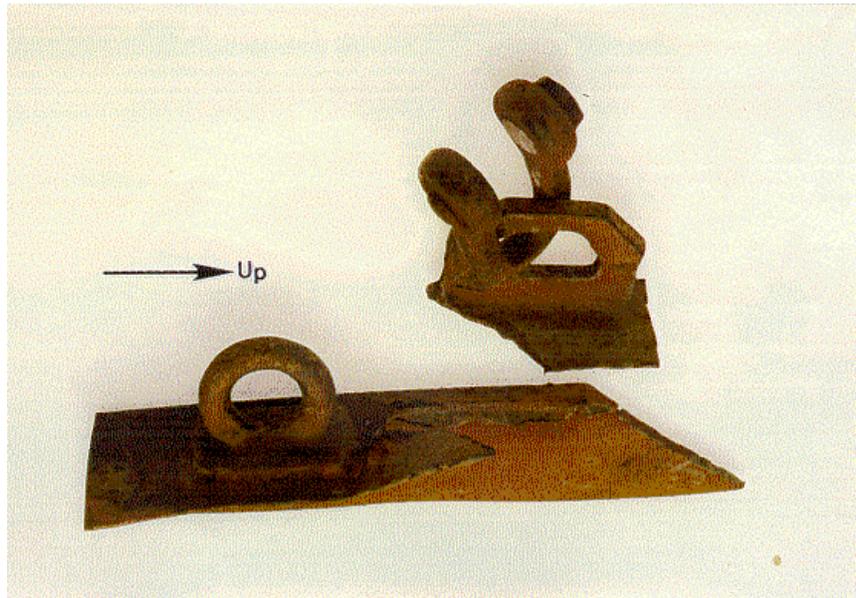
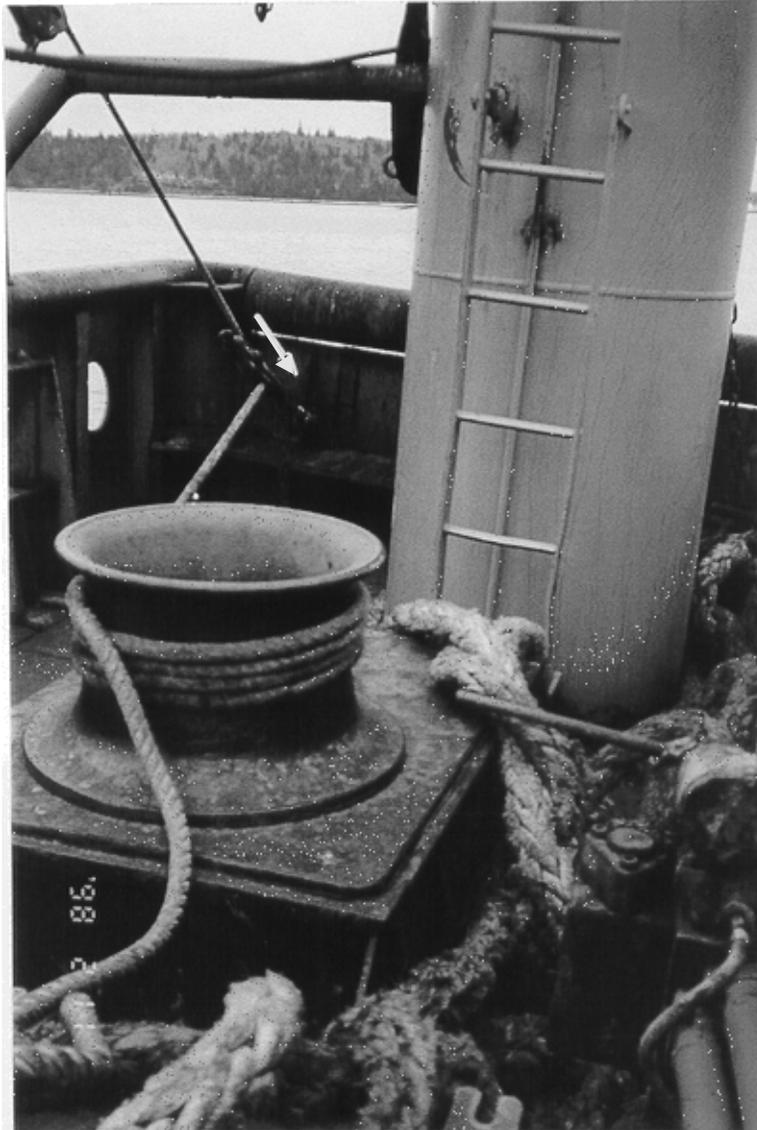
*Appendix B -*

The bulwark was stiffened by bulwark stays which comprised 12.7 cm x 7.62 cm x 0.95 cm inverted ordinary angle irons (see Appendix B - Photographs). The long flange of the angle iron (the standing flange) was at right angles and welded onto the bulwark. The face flange was parallel to the bulwark and had a pad-eye and a lug welded to it, which were used for securing blocks during fishing operations. Of the two rigging attachments, the one near the upper end was a lug and the other, approximately 12.5 cm below it, was a pad-eye. The general practice was to shackle the yo-yo block to the lower pad-eye and secure the safety chain to the upper lug. In this instance, both the yo-yo block and the safety chain were shackled to the upper lug.

- The face flange of the bulwark stay in way of the upper lug to which the yo-yo block was secured was severely corroded, wasted, and bent beyond the original 90-degree angle; this was particularly noticeable in the area of the upper rigging attachment.
- Other bulwark stays on the after deck, which were used for similar purposes, were in like condition and some had holes cut in the standing flange to take the block safety chain.
- The open link safety chain for the yo-yo block in use had one partially wasted link.

3. The section of the bulwark stay and the upper lug ripped away from the after ship's structure and struck the trawlerman, killing him.
4. The upper section of the bulwark stay in way of the lug was severely corroded and the face flange, which was bent beyond the original 90 degrees, was readily visible.

Following the occurrence, Nova Scotia's Department of Environment and Labour carried out an investigation into the occurrence. Under an order issued by the department, a comprehensive examination of all standing and running rigging for fishing operations including safety chains, anchor points for rigging and wire sizes of lifting purchases and rigging gear onboard was carried out for all vessels of the fleet, including the "CAPE CHIDLEY". Changes, repairs and/or replacements effected to "CAPE CHIDLEY" included, among others, the fitting of a new header to the bulwark stay and returning the bulwark stay to its original scantlings.
