MARINE INVESTIGATION REPORT
M01L0112

MAJOR WATER INGRESS

SCALLOP DRAGGER *ALEX B. 1*

OFF HAVRE-SAINT-PIERRE, QUEBEC
29 SEPTEMBER 2001

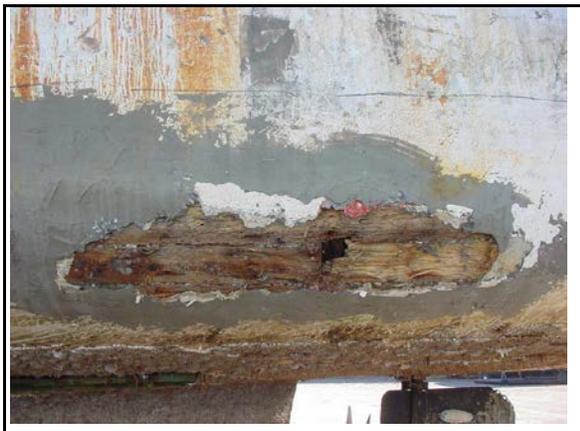
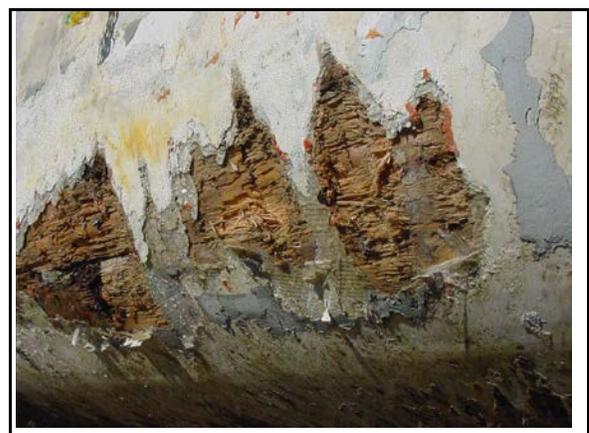
On both sides of the hull below the waterline in way of the lazarette, the fibreglass coating on the wood hull was severely damaged. Gaps in the fibreglass coating on each side were about 125 cm long and 50 cm wide, exposing the underlying wood. The wood planking showed deep scrape marks, indicating wear likely caused by repeated contact with the drag and steel cables on the hull. There was a hole, measuring approximately 10 cm in diameter, in the wood planking on the port side.

Examination of the vessel revealed substantial wear on the hull in way of the lazarette. These patches of excessive wear are in way of the drag hoist pulleys that were mounted on the stern A-frame. The fibreglass coating was worn through and there were deep gouges in the wood planking. The scallop drag on the *Alex B. 1* is a conventional fishing rig, quite heavy and cumbersome to handle. The drag was hoisted aboard and redeployed twice every hour. Consequently, every time the rig was hoisted aboard or deployed, it came in contact with the hull. To protect against the resultant abrasion, protection is applied to the hulls of fishing vessels where the fishing gear touches the hull. Various types of protection are used: on steel hulls, steel or rubber half-rounds are installed; wooden hulls are protected by a second layer of planking, a thick coating of fibreglass, or pads made of teflon or rubber. All of these protective devices have proved effective for shielding the hull against repeated contact with the fishing gear. Apart from a thin coating of fibreglass that completely covered the hull, the *Alex B. 1* had no additional protection in way of the lazarette. In five months of fishing activity, the hull had been compromised to the extent that the integrity of the vessel and the safety of the crew were greatly diminished.

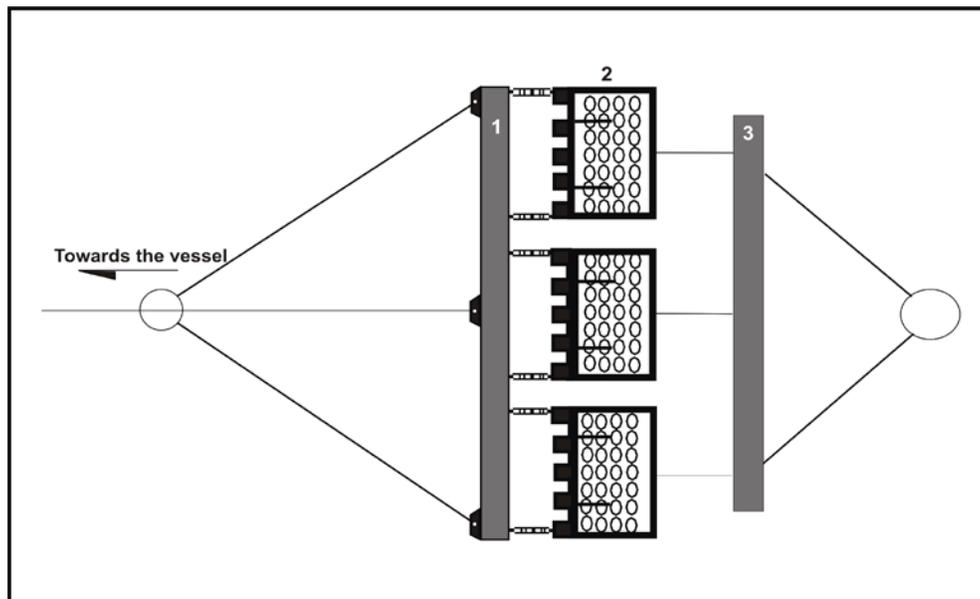
Figure 5 - The scallop drag

The scallop drag used by the *Alex B. I* is made up of three steel scallop rakes (see Figure 2). The three rakes (2) are rigged side-by-side and fastened to a steel beam (1), which is in turn fastened to a bridle and drag line. A wooden beam is fastened aft of the three rakes (3) to stabilize the drag on the seabed.
