MARINE INVESTIGATION REPORT
M02C0011

STRIKING

OF CRIB LIGHT 82

BY THE TUG-BARGE UNIT *PROGRESS/PITTS CARILLON*

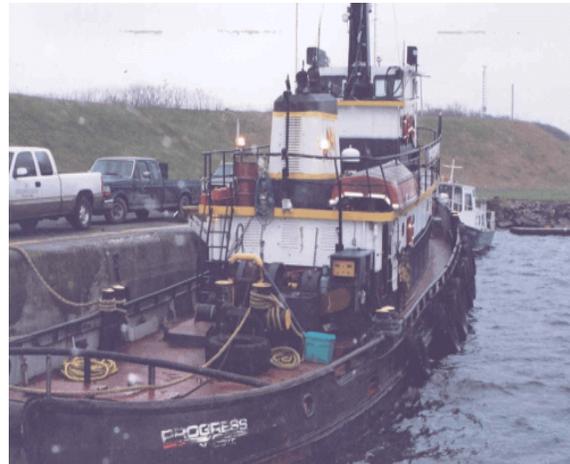
Photo 1. Harbour tug *Progress*

On the main deck, just aft of the superstructure, is a towing winch and a set of towing bollards for the purpose of pulling on a towline over the tug's stern (see Photo 1). The tug was not designed for push-towing operations and was not fitted with a push-towing arrangement.

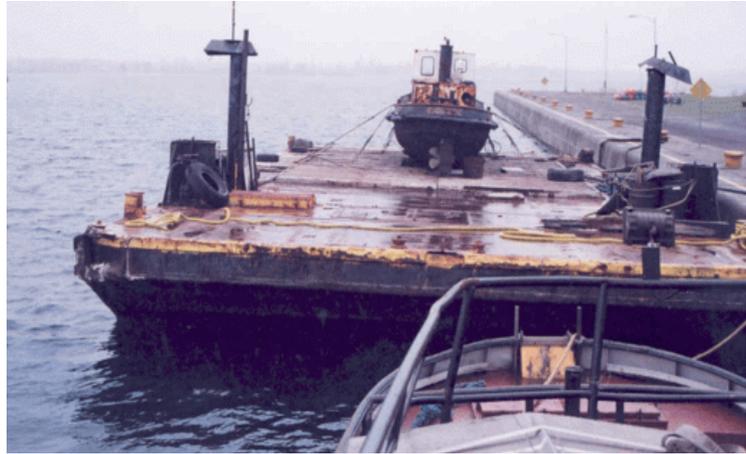
Photo 2. Barge *Pitts Carillon* with deck cargo (work boat) aft

The *Pitts Carillon* is a flat-topped steel barge designed to carry deck cargo. It is fitted with two anchoring spuds, which were in the raised position for transiting the Seaway. A 10 m long work boat was secured aft on the deck at centre. The spuds and work boat projected approximately 3.5 m above the barge's deck (about 5.5 m above the waterline). (See Photo 2.)

Five minutes prior to the occurrence, the lookout was sent below deck, thus depriving the watch of his services. At this juncture, the first officer was required to steer steady on course 220 (T) while planning a course alteration off crib light 82. The difficulty of the task was compounded by the fact that he was also required to use visual cues both forward and aft, i.e. the leading lights, the Doran Shoal range lights located abaft on the north shore, and crib light 82 ahead. In order to use the chart or radar to carry out course adjustments, the first officer was required to leave the helm, quickly find the information he needed and return to steer the vessel. However, his view of crib light 82 may have been intermittently obstructed by the work boat and spuds on the barge, as well as by the shore background lighting.

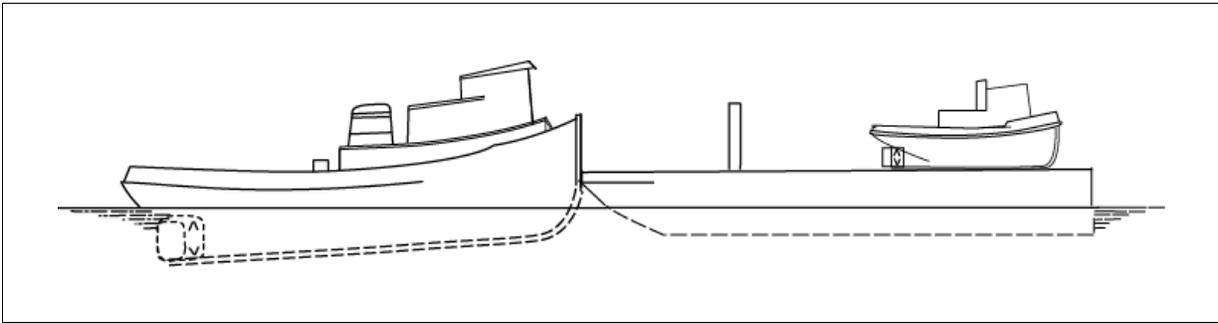
Figure 1. Push-towing configuration of the tug *Progress* and barge *Pitts Carillon* when leaving Montréal

At 2105,² on 20 April 2002, the tug *Progress*, pushing the barge *Pitts Carillon*, departed Montréal bound for Hamilton, Ontario. The tug's bow had been made fast to the bow (raked end) of the barge, thereby making the square-ended stern of the barge the leading edge of the tow (see Figure 1). En route, the master observed that the tug-barge unit proceeded at an unusually slow speed of only 4 knots at full ahead power.

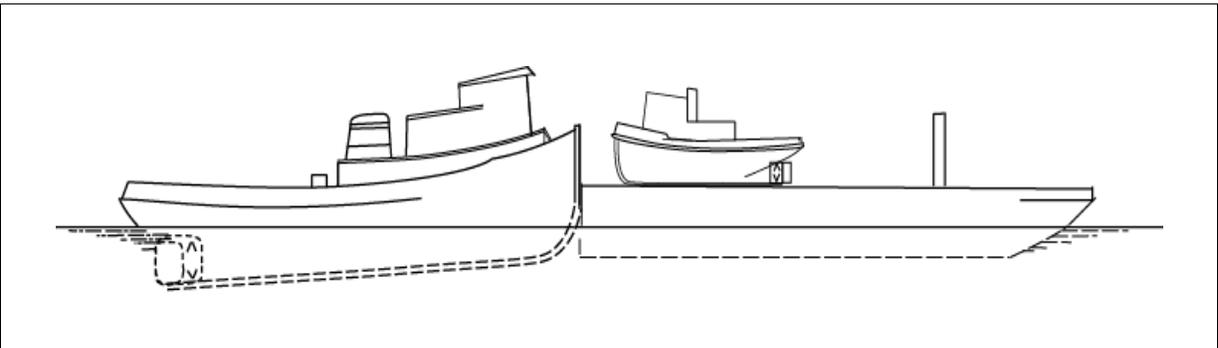
Figure 2. Push-towing configuration after disconnecting and repositioning vessels

At 0130 on 21 April 2002, the tug-barge unit tied-up at the Côte-Sainte-Catherine approach wall. The crew rested until about 0500, and at 0530, they undertook to disconnect the tow and reposition the tug to make its bow fast to the stern of the barge (see Figure 2). Upon completion of the tug-barge connecting rigging, concern was expressed that the rig was inadequately secured and that additional spring lines were necessary to safely operate the tow. The master did not deem it necessary to rig additional spring lines. However, when the unit stopped later, during the Seaway transit, extra spring lines were utilized.

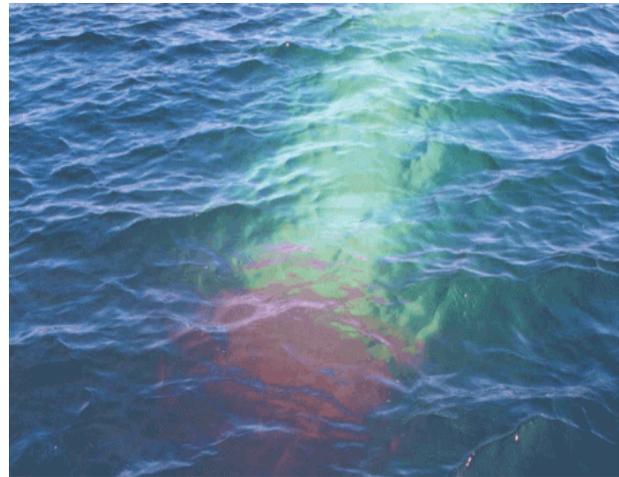
Photo 4. Collapsed crib light 82 under water.

Crib light 82 was knocked from its concrete base and remained submerged (see Photo 4).

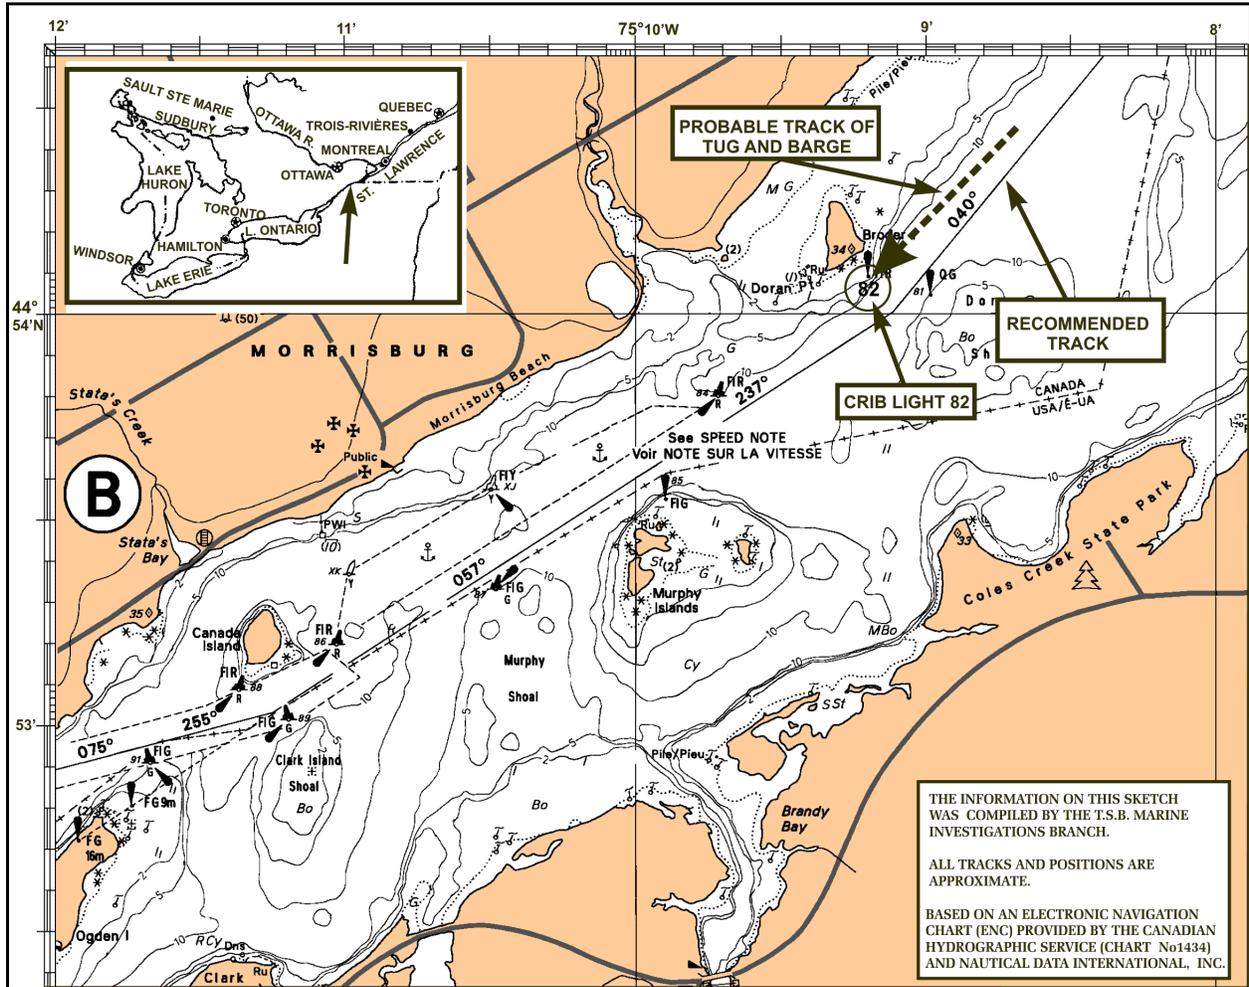
Appendix A – Sketch of the Occurrence Area

At approximately 2230, the captain was in his cabin and the tow was approaching Broder Island when two successive crashing sounds were heard as the tug jolted abruptly to port. The tug-barge unit had knocked down crib light 82 and continued to sail over the submerged navigation aid. (See Appendix A – Sketch of the Occurrence Area.)
