MARINE INVESTIGATION REPORT
M04L0105

STRIKING OF WHARF

HIGH-SPEED PASSENGER CATAMARAN
FAMILLE DUFOUR II
PUBLIC WHARF, ÎLE AUX COUDRES, QUEBEC
24 AUGUST 2004

Report Number M04L0105

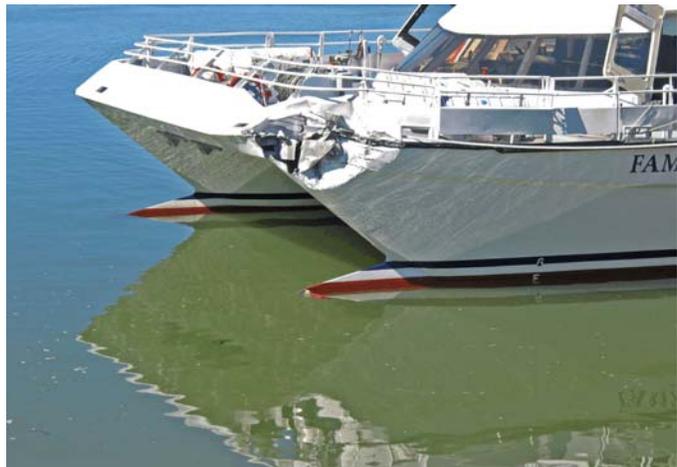
At approximately 0930, the vessel struck the southwest face of the public wharf at a speed of 8.7 knots and at an approach angle of about 37 degrees. The port corner of the bow and the port hull at the waterline sustained damage (see Photo 2).

Photo 2. Damage to the port bow

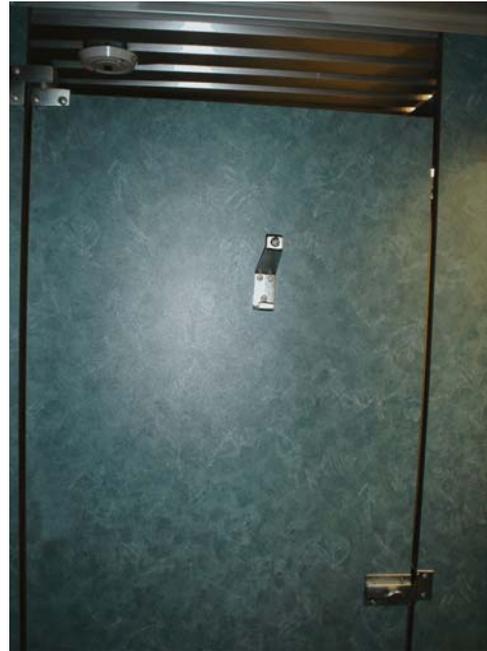
On board the *Famille Dufour II* there were a number of objects that had the potential to cause injury to passengers and crew in an accident because they were unsecured or inadequately secured. These included large metal garbage cans, electric fans, cash registers, a passenger service cart, several service tables, sound equipment, and various food and cleaning stores. Furnishings and finishings in passenger areas were also observed to be potentially injurious: these included, for example, protruding metal coat hooks (see Photo 3), flat-screen monitors, sharp edges on passenger tables (folded position), and non-tempered glass panels used in the gift-shop display case.

Photo 3. Aft-facing steel coat hook on the inside of the washroom door

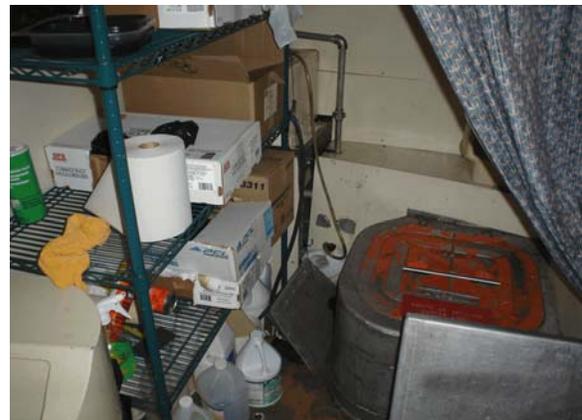
- unsecured stores stowed near the starboard engine room emergency escape hatch (see Photo 4);

Photo 4. Unsecured stores near the starboard engine room escape hatch

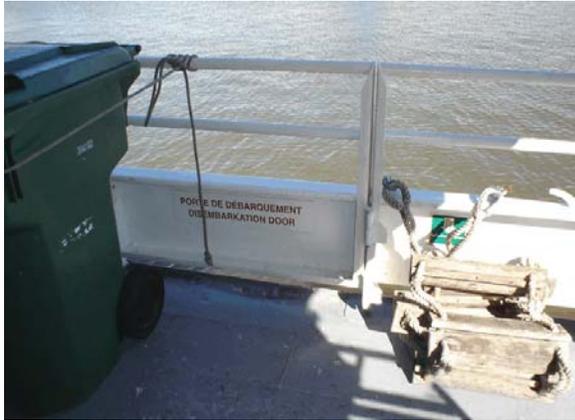
- trash bins lashed to embarkation gates (see Photo 5); and
- two Jacob's ladders for embarkation into the liferafts located at the forward end of the main deck, which were not rigged for immediate use but were stowed forward of the point of embarkation and secured to a deck pad eye by a shackle (see Photo 6).

Photo 5. Trash bin lashed to the aft starboard embarkation gate

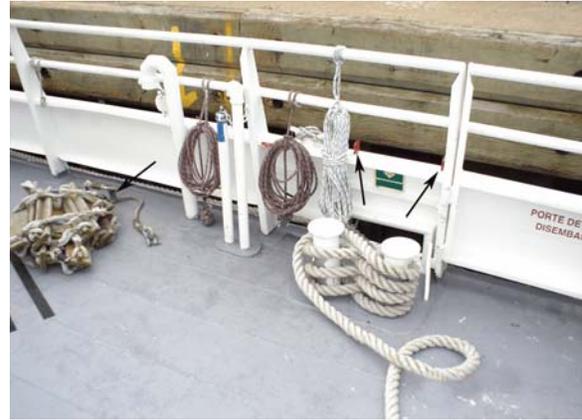
Photo 6. Port side Jacob's ladder secured to the main deck (left-hand arrow) and points for attachment when deployed (right-hand arrows)

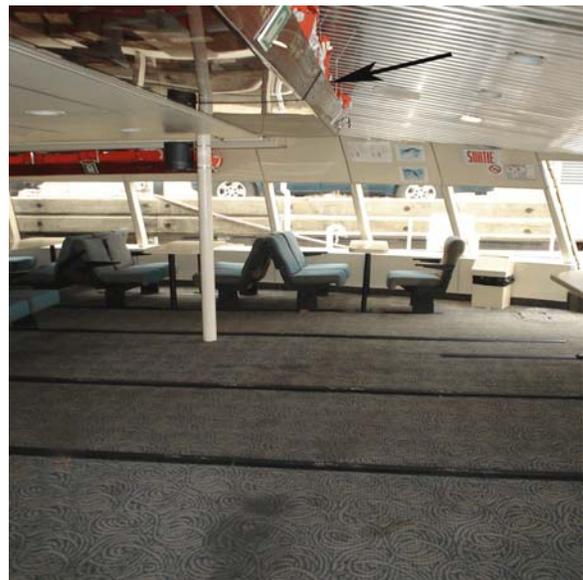
The lifejackets were tightly stacked within the rack and were difficult to retrieve because of the height of the front panel and the vertical metal strapping used to secure the rack in place. The height from the top of the front panel of the overhead rack to the deck was 2.18 m (86 inches). Although the row of seats under the overhead rack was in place at the time of the occurrence, its removal for seating reconfiguration happens from time to time on this vessel (see Photo 8).

Photo 8. View of children's lifejackets (arrow) stowed in an overhead athwartships rack and rows of seats removed from the deck

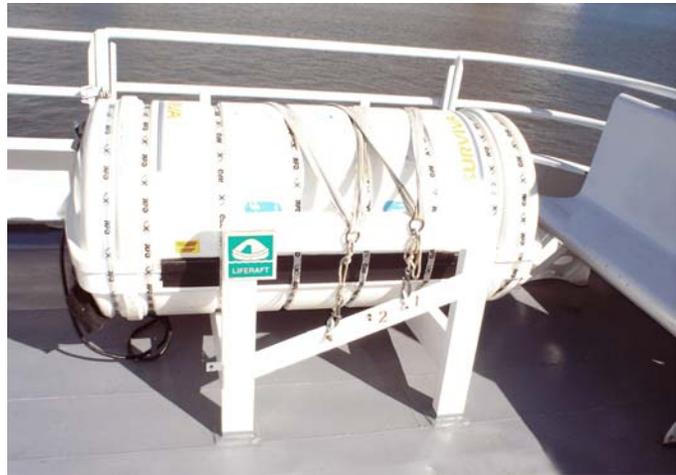
The vessel was equipped with ten 25-person and two 50-person RFD Surviva inflatable liferafts secured in their cradles by lashings fitted with senhouse slips (see Photo 9). Such a securing arrangement requires human intervention for the launching.

Photo 9. Liferaft secured by lashings fitted with senhouse slips

Although not a factor in this occurrence, the lashings that secured the vessel's 12 inflatable liferafts were fitted with senhouse slips that required manual operation to deploy the liferafts. The lashings did not incorporate a hydrostatic release unit or other system to allow the liferafts to float free in the event the vessel should sink.

In response, TC agreed that the liferafts of all passenger vessels should float free in the event of sinking. An amendment to the *Life Saving Equipment Regulations* will be sought to bring this into effect when the regulations are revised as part of Phase II of the *Canada Shipping Act* regulatory reform process. This work is expected to begin by the end of 2006. Meanwhile, TC issued Ship Safety Bulletin 03/2001, recommending that all vessels, irrespective of their size, stow their liferafts (other than davit-launched rafts) and inflatable rescue platforms so they float free in the event of sinking.
