MARINE INVESTIGATION REPORT
M05C0063

GROUNDING

BULK CARRIER *MICHIPICOTEN*
BRUSH POINT LIGHTED BUOY G17
ST. MARY'S RIVER, ONTARIO
28 OCTOBER 2005

Report Number M05C0063

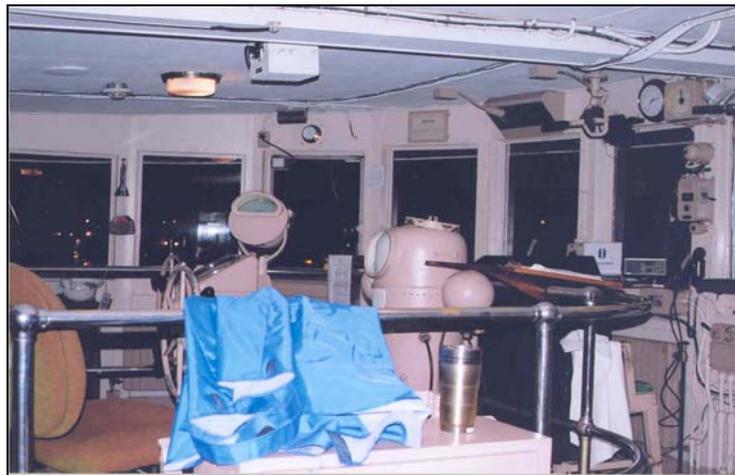
The steering station is located on a raised platform in the middle of the wheelhouse providing the wheelsman with a good view ahead while in close proximity to the course and rudder angle indicators.

Photo 2. View of the raised platform in the middle of the wheelhouse, looking to port.

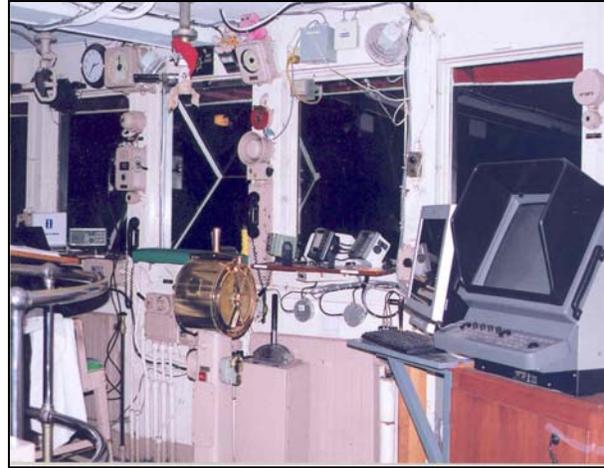
The master was conning the vessel mainly from the pilot's chair, which is forward and starboard of centre. From this position, he had to lean back and look over his right shoulder to see the ECS unit. The light level of the unit's screen was set to monochrome night display, which coloured the entire screen in red. The screen had also been covered with a red transparency to further lower the brightness of the screen. This reduced the clarity of information displayed, including the vessel's position icon.

Photo 3. The pilot's seat is located between the controls on the left and the ECS on the right.

At the time of the occurrence, the display was set to the default night mode with the red monochrome option. Additionally, a red transparency had been placed over the screen to further reduce brightness. Although navigation details were thus harder to discern, this did not prevent the wheelsman from using the chart display as a cue to warn the master that the vessel had left the intended track.

1. The use of the monochrome option for the ECS in conjunction with the night display presentation and the red transparency placed over the screen resulted in a reduction of chart, course, and vessel-position details.
2. The master's schedule may have predisposed him to fatigue-related performance issues.

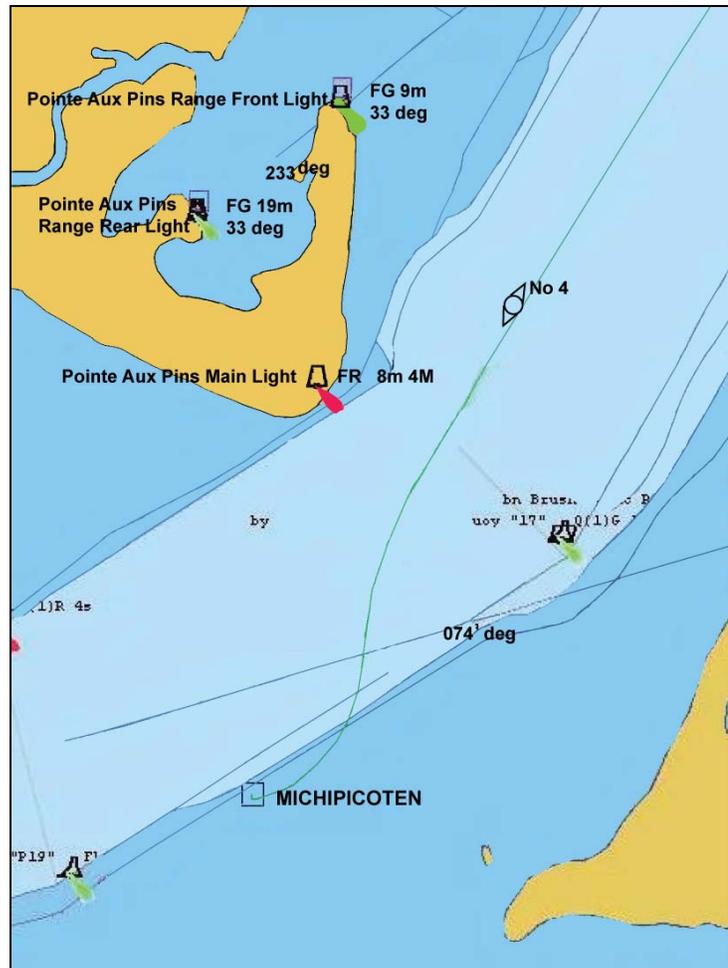
At this time, he reportedly gave the wheelsman the order "20 degrees starboard" with the intention of settling on the new course of 238° T. The wheelsman, however, heard the order as "20 degrees port." As a result, he turned the wheel until the rudder angle indicated 20 degrees to port. He then repeated the order, although the master has no recollection of the order being repeated.

As the *Michipicoten* began turning to port, the master did not observe the movement of the rudder angle indicator from his forward seated position. At approximately 0725, the master saw the image of what appeared to be the ranges at Brush Point reflected in one of the wheelhouse windows. He interpreted this image to mean that the vessel was turning to starboard.

At 0727, the *Michipicoten* was continuing to turn to port. Meanwhile, the wheelsman was able to see the electronic chart display from the steering position. Although untrained in its use, he deduced that the *Michipicoten* was southbound, out of the channel, and informed the master that the last manoeuvring instruction to port may have been a mistake.

The master immediately ordered “hard to starboard.” The *Michipicoten* reduced its turning rate to port and started turning to starboard. However, the vessel was too close to the channel’s southeasterly side and at 0733 the vessel grounded in soft mud, just inside the Canadian border between Brush Point buoys G17 and P19 in position 46°27'34" N, 084°28'23" W (see Figure 2). Following the grounding, all tanks were sounded, and no ingress of water or apparent damage was found. In its grounded position, the vessel did not obstruct either upbound or downbound traffic. The vessel remained grounded until tug assistance was provided several hours later.

Figure 2. Vessel track before the grounding

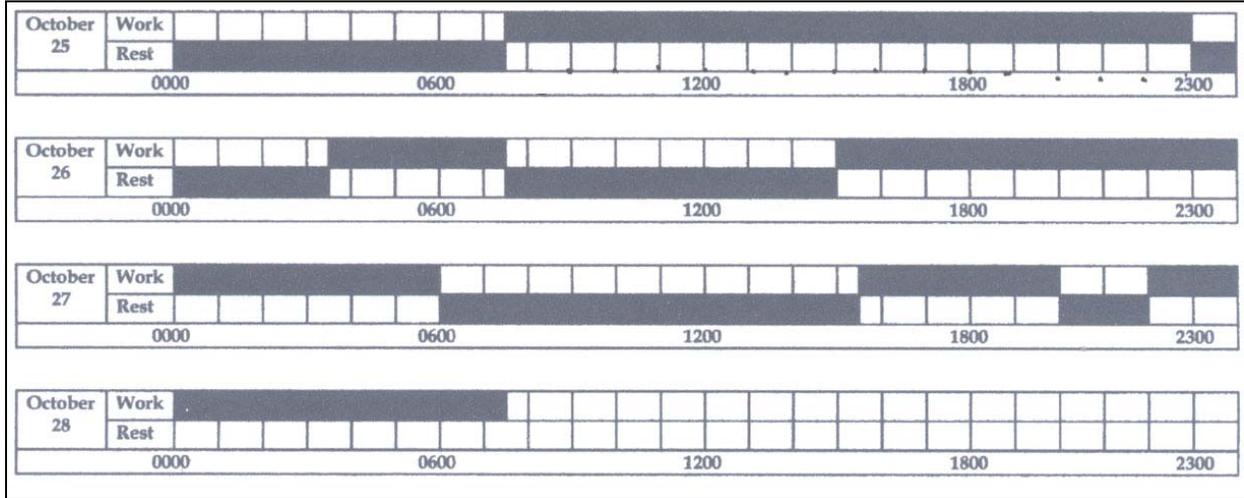
The master piloted the bulk carrier *Saginaw* for 15.5 consecutive hours from 0730 until 2300 on October 25. Commencing at 1500 the following day, he piloted the vessel single-handedly for another 15 consecutive hours until 0600 on October 27. Finally, commencing at 2200, he piloted the *Saginaw* for seven and a half hours until it arrived at the Algoma Steel docks, Sault Ste. Marie, at 0520 on October 28. Minutes later, he boarded the *Michipicoten* at about 0545 and piloted it until it grounded less than two hours later at 0730.⁵

The master rested for a total of four and a half continuous hours during the 24-hour period beginning at 0730 on October 25. Later on October 26, he rested for seven and a half continuous hours and, on October 27, he rested for nine and a half continuous hours.⁶

He obtained a total of 13.5 hours of rest during the 48-hour period commencing at 0730, October 25, and the same time on October 27. During a second 48-hour period between 0730, October 26, and 0730, October 28, he obtained a total of 19 hours.⁷

Figure 3. Master's work/rest history

In this occurrence, some features of the master's work/rest schedule fall short of the minimum acceptable levels identified in the requirements. For example, a minimum of six consecutive hours of rest in a 24-hour period¹² is considered necessary, whereas the master had only four and a half hours of rest between 2300 on October 25 and 0330 the next morning. In addition, a total of at least 16 hours of rest during any 48-hour period is a minimum requirement and the master had rested for a total of 13.5 hours in one of the two 48-hour periods under review.¹³

On 25 October 2005, the master was on duty for 15.5 consecutive hours and overnight between 26 and 27 October, he worked another 15 consecutive hours. At the time of the accident, he had been on duty for nine consecutive hours. Although he had 19 hours of rest in the 48 hours immediately before the occurrence, it is unclear how many of those hours were spent in sleep.

Taking into account the master's 15.5-, 15-, and 9-hour periods over three days and one instance of having rested for fewer hours than the minimum set out in the established guidelines, this schedule may have predisposed him to fatigue-related performance issues.
