**MARINE INVESTIGATION REPORT
M06N0014**

FIRE IN CARGO OIL TANK

**SHUTTLE TANKER *KOMETIK*
CONCEPTION BAY SOUTH
NEWFOUNDLAND AND LABRADOR
08 APRIL 2006**

Report Number M06N0014

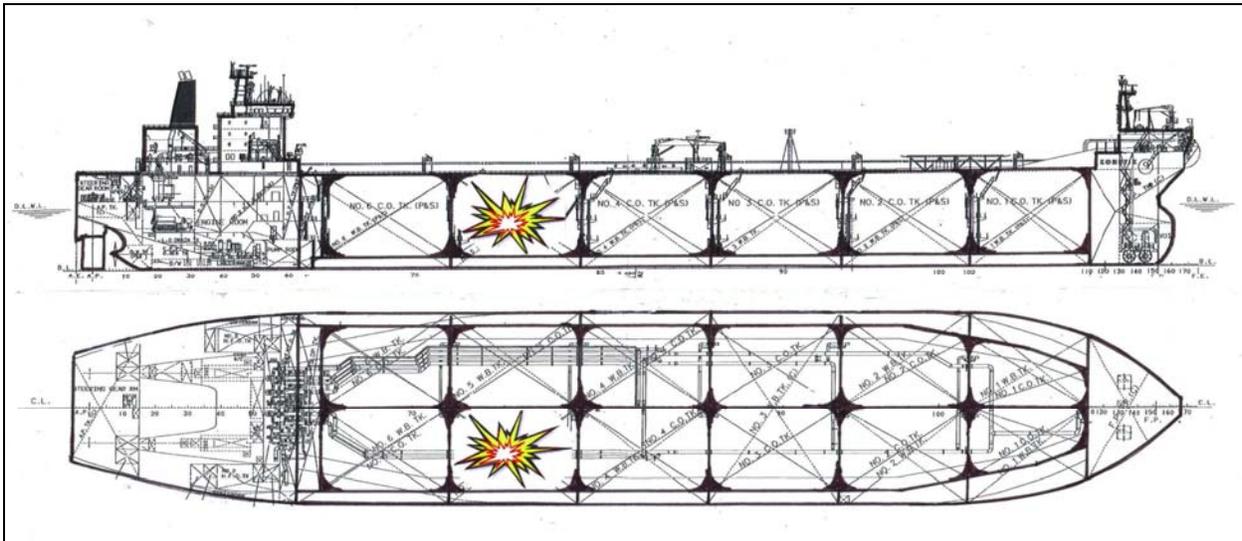
Figure 2. Cargo tank arrangement

A post-occurrence tank inspection revealed the presence of oil residue that was not present during a visual inspection the day before the occurrence. The residue's presence can be explained by the cycling of the stripping valve for COT No. 5 starboard which is located in the adjoining tank (No. 6 starboard) on the morning of the occurrence. This was demonstrated from April 21 to April 22 when the operating company performed a post-occurrence test by cycling the stripping valve for cargo tank No. 5 starboard – at which point approximately 1.7 cubic metres of water and cargo oil flowed back into the tank's suction well.

The fire therefore likely occurred when combustible vapours from the back-flowing oil/water mixture that had entered that workspace were ignited by the welder's arc.

3. When conflicting work items were not identified during pre-planning, the cycling of the tank stripping valves on two occasions allowed a flammable air/hydrocarbon fuel mixture to form in the tank where hot work was to be performed.

4. The atmosphere in cargo tank No. 5 starboard was not tested immediately before or during the work, thereby allowing an explosive atmosphere to go undetected.
