MARINE INVESTIGATION REPORT
M09W0147

BOTTOM CONTACT AND SUBSEQUENT SINKING

PASSENGER VESSEL *EXPLORATHOR*
GULF ISLANDS, BRITISH COLUMBIA
23 JULY 2009

Report Number M09W0147

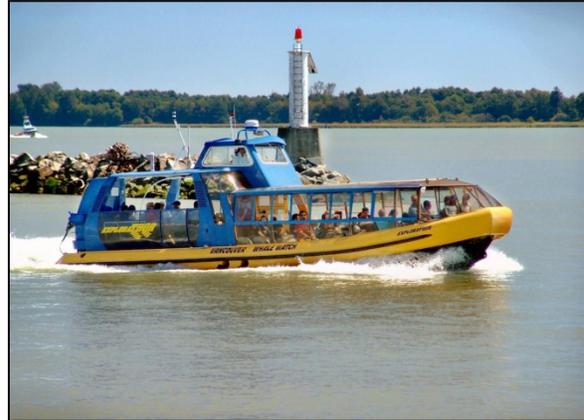
Photo 1. The *Explorathor*

The *Explorathor* was a rigid-collar³ passenger vessel capable of high speeds. Passengers were accommodated in enclosed seating forward and on a covered deck aft. The raised conning station was centrally located, and the propulsion machinery was located aft.

The aluminum hull was subdivided into four watertight compartments and a single compartment watertight collar. The vessel's intact stability report indicated that it could remain afloat with any one of these compartments flooded.

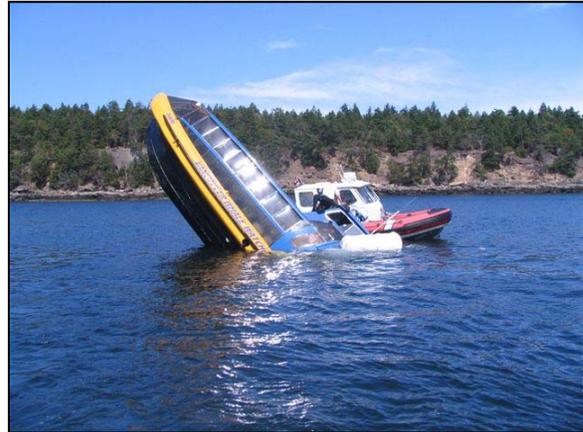
At approximately 1330, the *Explorathor* experienced a power failure and lost propulsion. The crew member donned a lifejacket and was transferred to a nearby private vessel, the *Vertigo*, followed by the master of the *Explorathor*. At 1344, the *Explorathor* sank in Campbell Bay in position 48°51'15" N, 123°15'08" W, after having floated for at least 5 minutes in a vertical position. The vessel's 50-person inflatable liferaft floated free from the vessel and inflated.

Photo 2. The *Explorathor* as it sank. *Vertigo* visible. (Photo credit: S. Riddell)

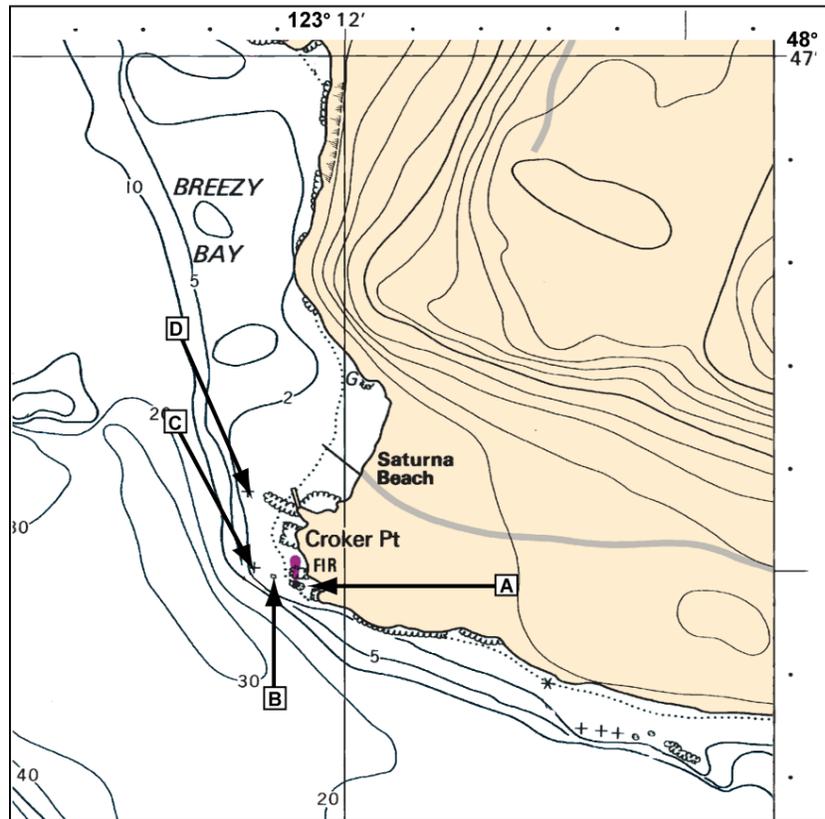
Figure 1. Canadian Hydrographic Service Published Navigation Chart 3477. Chartlet: Croker Point, Saturna Island, British Columbia.

Canadian Hydrographic Service (CHS) Chart No. 3477 depicts several rocks off Croker Point (see Figure 1):

- A: an above-water rock with Croker Point light and daymark
- B: a drying rock, which would have been awash at low tide
- C, D: two underwater rocks with less than 2 m of depth⁹

According to the *Canadian Tide and Current Tables*, rock B was approximately 0.14 m underwater at the time of occurrence.

Rocks B, C, and D are approximately 40 m and 55 m west, and 185 m northwest, respectively, of Croker Point light and daymark as measured from the chart.

The damage to the vessel—deep scrapes and indentations along the hull, and the separation of the welded keel plates— is consistent with striking a hard, solid object (such as a rock) at high speed. Given the presence of the drying rock and the two underwater rocks off Croker Point, as well as the height of the tide at the time of the occurrence, it is likely that the vessel struck one of these rocks.
