RAILWAY INVESTIGATION REPORT

R02Q0021

MAIN TRACK DERAILMENT

QUEBEC NORTH SHORE AND LABRADOR RAILWAY

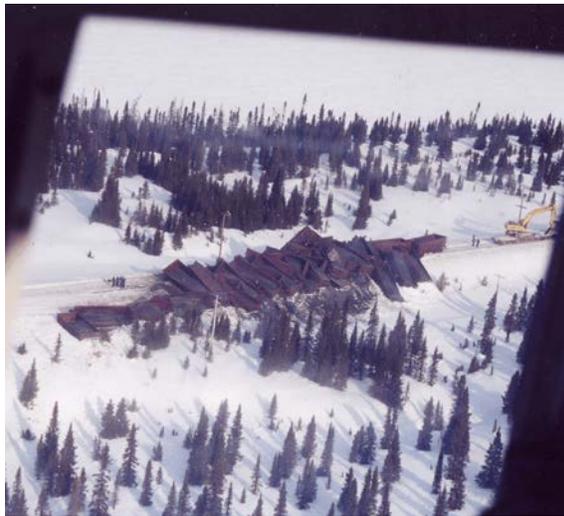
The derailed cars were lying accordion style and piled up on top of each other, forming a heap of scrap and iron ore on the right-of-way (see Figure 1). Thirty-three cars were destroyed and seven cars were seriously damaged. About 300 metres of track was damaged. The weather was clear and the temperature was -12°C.

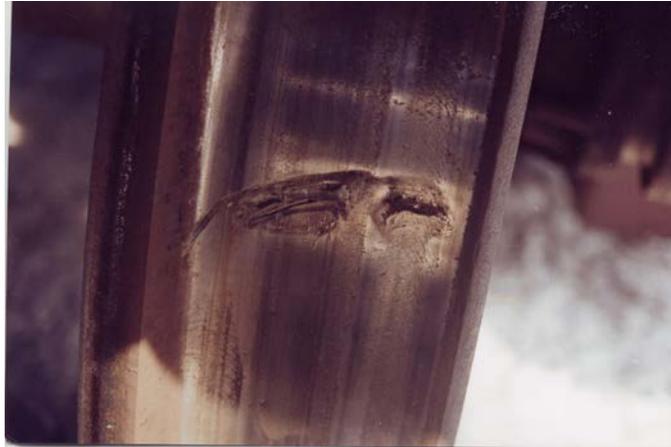
An examination of the cars revealed that the wheels on the east side of the cars preceding the 25<sup>th</sup> car (17<sup>th</sup> to 24<sup>th</sup> cars) had a mark across the wheel tread (see Figure 2). No other mechanical defects were observed on the cars.

The wheel flange marks visible on the ties at the point where the destruction of the track started continued up to the first derailed car. In addition, the mark on the wheels on the east side of the cars preceding the derailed cars confirmed that the east rail broke under the 17<sup>th</sup> car as train PH 187 passed.

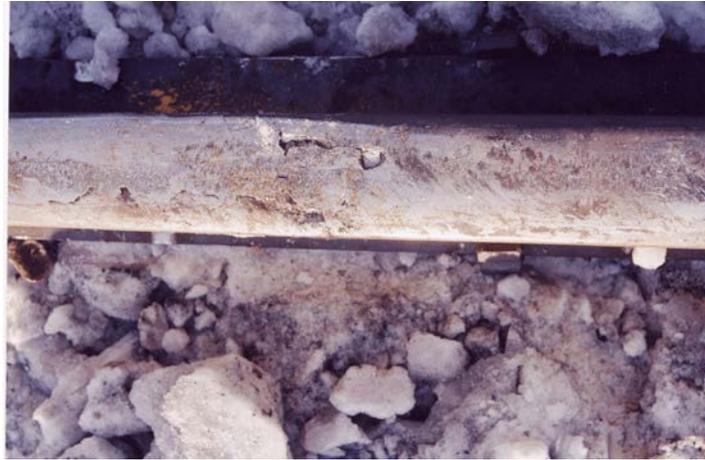
At approximately Mile 139.33, where the destruction of the track started, the rail had a crushed head (see Figure 3). This surface defect was noted in the inspection of 05 February 2002 and was categorized as "priority 1." A few feet south of this defect, the rail was broken under the last derailed car. Four pieces of broken rail, two pieces of rail head and two pieces of rail base were recovered and sent to the TSB Engineering Laboratory for analysis. There were no wheel flange marks or marks from dragging parts to the north of where the rail was broken. Wheel flange marks were visible east of the track, leading to the first derailed car.

Examination of the rail by the TSB Engineering Laboratory (report No. LP 030/02) indicated that wear of the rail was minimal. The rail head surface showed signs of light shelling on the interior side of the head. Tests on rail specimens showed that the rail had a maximum tensile strength of 171 ksi.<sup>1</sup> The hardness of the rail head surface approached a Rockwell C hardness of 42 (or Brinell 393) in the first 0.7 mm; a surface hardness of this magnitude is normal and is due to strain hardening of the surface layer of the metal.

The laboratory tests revealed that there were no pre-existing cracks in the rail specimens and that the break occurred quickly, and everything indicates that the rail broke suddenly as the train passed. The fracture pattern observed on the rail specimens indicates that a fracture started at the rail head surface and coincided with the edge of the creep on the rail that acted like a stress raiser. The high tensile strength and relatively high hardness measured on the rail specimens are properties indicating a material that is sensitive to the initiation and development of internal flaws; thus, the rail was sensitive to impacts from the wheels, especially in cold weather.

In addition, special visual inspections had been conducted to identify rail defects. The defects had been assessed according to their severity and repair work had been planned accordingly. However, the relatively high number of crushed heads—an average of about two defects per mile of track between Mile 130 and Mile 150—did not allow the repair teams to complete the repair work as planned.

QNS&L implemented a system to follow up on the priorities and to control risks in order to correct the most priority defects. Criteria acceptable for rail defects were tightened; for example, the acceptable limit for crushed heads went from 13 mm to 7 mm.

The company will develop an action plan and a preventive maintenance program to correct surface defects by controlling the wheel-to-rail interface dynamics. Under this initiative, 45 new rail lubricators will be installed and put in service, a wheel reshaping plan will be put in place, a wheel-shaping tower will be purchased and the number of grinded rail will be doubled (from 800 to 1600 runs per mile each year).
