**RAILWAY INVESTIGATION REPORT
R04T0013**

MAIN-TRACK DERAILMENT

**CANADIAN PACIFIC RAILWAY
FREIGHT TRAIN NO. 104-18
MILE 24.83, MACTIER SUBDIVISION
BOLTON, ONTARIO
22 JANUARY 2004**

Report Number R04T0013

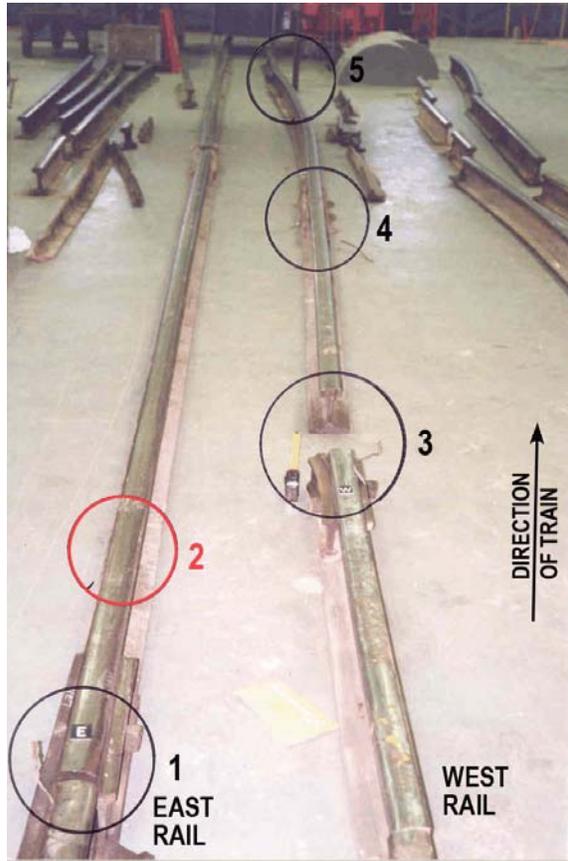
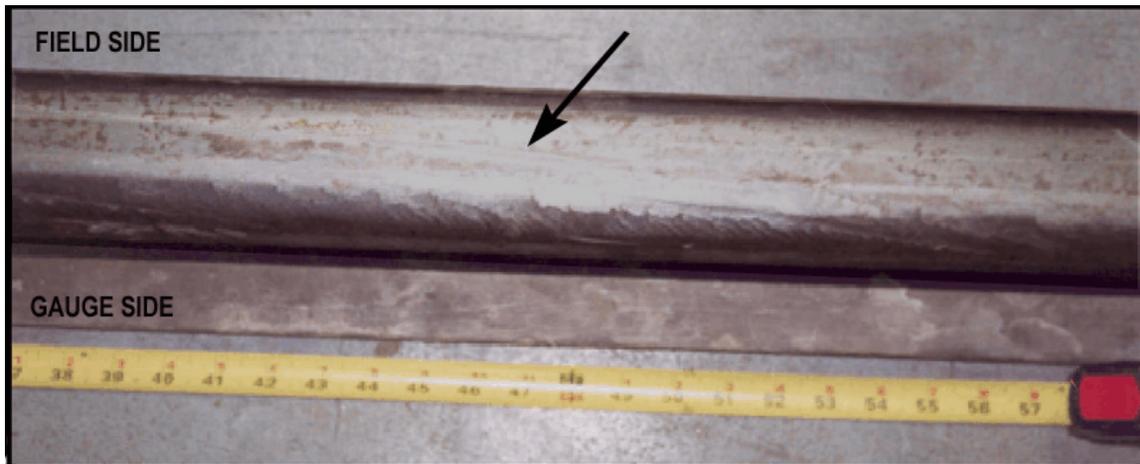
The recovered rail sections and associated track components (including broken joint bars) were arranged into their approximate field position at CP Rail's Test Department (see Photo 1). As observed by TSB investigators, the examination revealed marks on the gauge side of both rails, on the gauge side of the joint bars, and on the head of the rail. These marks indicated that the wheels had dropped between the rails (see Photo 2). Wheel flange marks were present on the web of the west rail (gauge side), indicating that this rail had turned over to the high side of the curve. Impact damage was present on the fasteners.

There was no evidence of polishing or of batter marks on the rail fracture surfaces, or on the fracture surfaces of the broken joint bars. However, one joint bar on the west rail and a second joint bar on the east rail exhibited some pre-existing fatigue cracks.

Based on marks on the rail, the POD was approximately 45 to 50 feet south of the Castlederg Sideroad crossing. The derailment likely occurred when the west (high) rail started to roll over under the lead locomotive. The wheel rim marks on the head of the east (low) rail, approximately 50 feet south of the crossing, likely occurred when the trailing truck of the second locomotive (CP 6010) dropped between the rails. Similar marks on the west rail, approximately 80 feet south of the crossing, likely occurred when the wheels of the third locomotive dropped in as that rail rolled over. The joint bars, weakened by pre-existing fatigue cracks, broke as the rail twisted and rolled.
