**RAILWAY INVESTIGATION REPORT**  
**R05V0141**

**DERAILMENT**

**CANADIAN NATIONAL**  
**FREIGHT TRAIN A47151-05**  
**MILE 56.6, SQUAMISH SUBDIVISION**  
**GARIBALDI, BRITISH COLUMBIA**  
**05 AUGUST 2005**

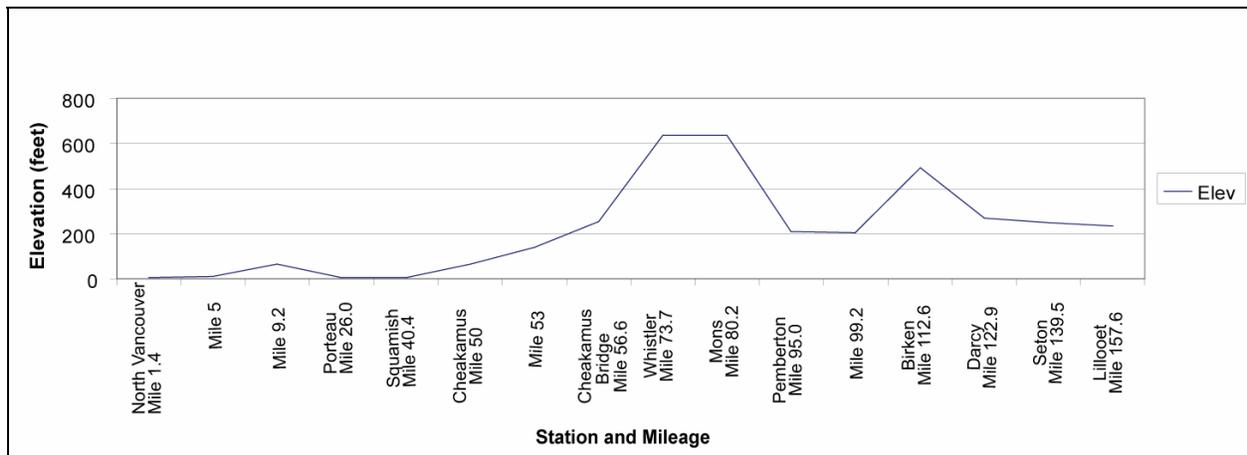
Figure 2. Squamish Subdivision elevation profile (train proceeding from left to right)

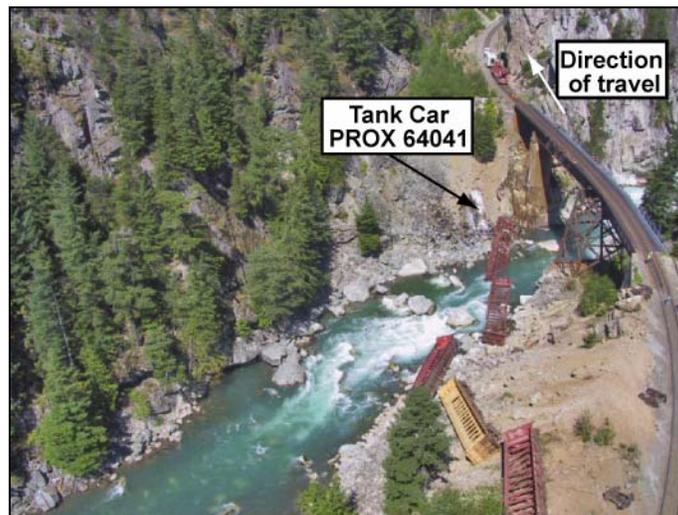
After making the necessary emergency broadcast and notifying the RTC, the conductor initiated an inspection of the train, discovering that nine cars (the 4th to the 12th) had derailed to the west (inside) of the 12-degree 20-minute left-hand curve at the Cheakamus River Bridge. A total of four cars had fallen off the bridge; tank car PROX 64041, a load of 73 per cent concentration sodium hydroxide (4th car), and three empty centre beam flat cars. The tank car struck the concrete bridge pier and landed on the north bank of the river (see Photo 1) and the three empty centre beam flat cars behind it landed on their sides on the river bed. The four derailed cars following, three empty centre beam flat cars and an empty wood chip gondola car, were on their sides. The 12th car, an empty wood chip gondola, was upright, with only the B-end<sup>4</sup> (north) end derailed.

**Photo 1.** Tank car position after the derailment

Tank car PROX 64041 was a non-pressure tank car, type 111A100W3, built in November 1984. The derailed tank car fell off the west side of the Cheakamus River Bridge, onto the north bank, and came to rest on its right side with the manway facing downstream at an angle of about 30 to 35 degrees. The jacket was severely damaged and damage to the tank itself was most severe at the AL location, which at this point, was the top corner of the lower (downhill) end of the tank. All valves and the manway cover had been sheared off the car. The manway had also been dented at the A-end. The trucks separated from the car and most of the rigging and safety appliances were gone. Spilled product had coated the entire top of the car as well as most of the surrounding area to about 20 m upstream and 25 m downstream.
