**RAILWAY INVESTIGATION REPORT  
R07V0213**

**NON-MAIN-TRACK COLLISION**

**CANADIAN NATIONAL RAILWAY  
BELTPACK ASSIGNMENT YPSS01-04  
MILE 464.33, CHETWYND SUBDIVISION  
PRINCE GEORGE, BRITISH COLUMBIA  
04 AUGUST 2007**

Report Number R07V0213

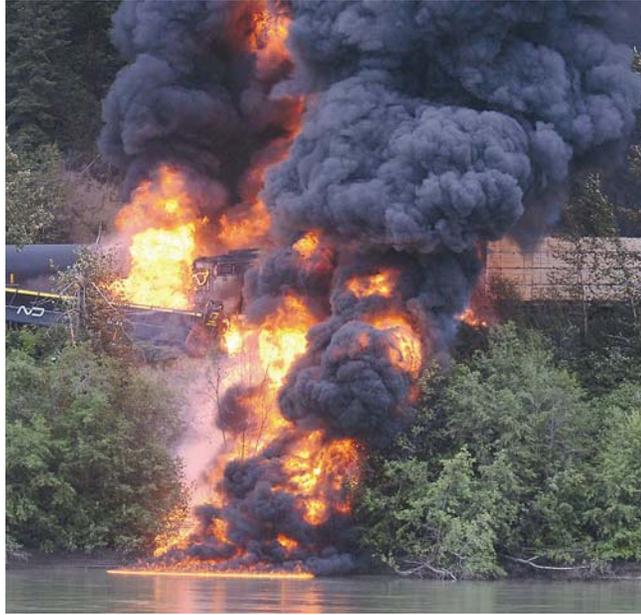
The yard movement had contacted tank car AGCX 10203, a load of gasoline (UN 1203) on train M357, tearing a hole in the side of the car and igniting a fire (see Photo 1). A second carload of gasoline from train M357 also derailed and burned.

**Photo 1.** Post-collision fire

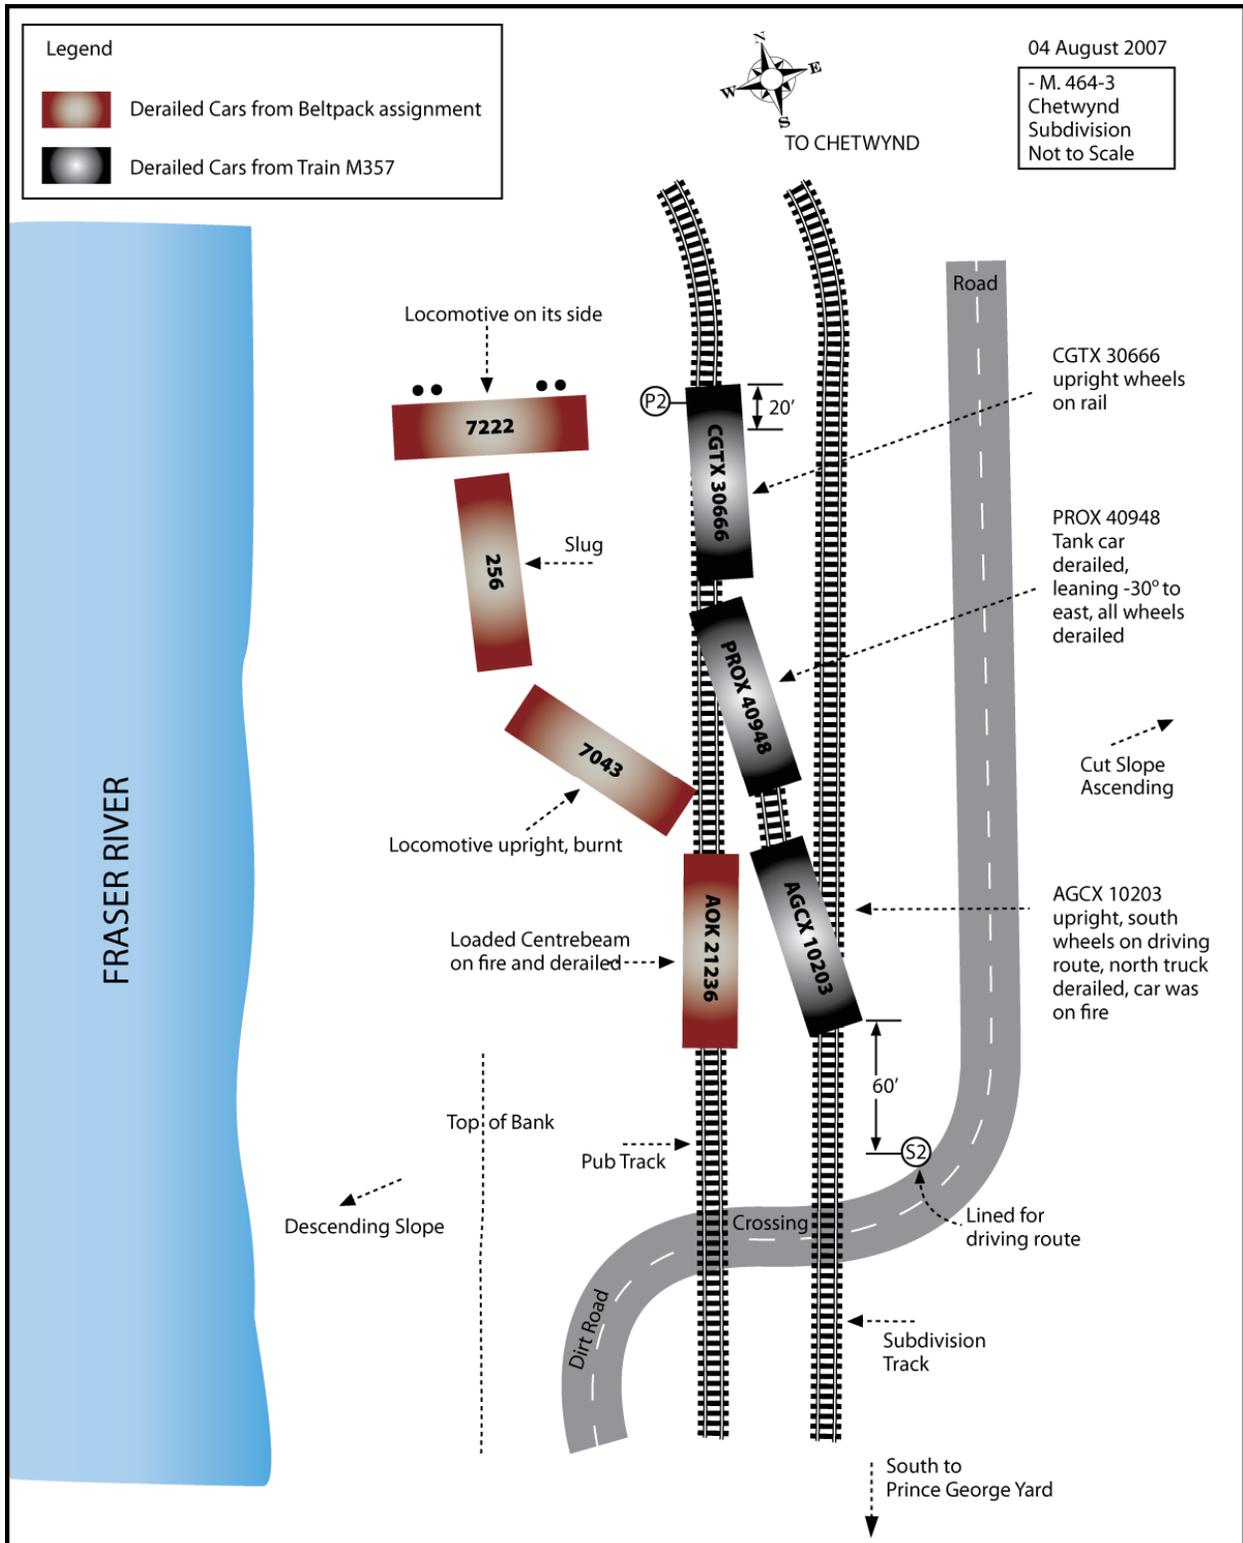
Figure 2. Derailed schematic

The yard movement derailed to the west side of the track, with locomotive CN 7222 ending on its side down the embankment by the Fraser River. CN 256, the yard slug, was derailed on its side to the west partially down the embankment, with locomotive CN 7043 derailed upright closer to the track. The carload of lumber was derailed and upright near the track.

The tank car of gasoline had one set of trucks on the subdivision track and the other derailed on the crossover. Of the other two tank cars, PROX 40948, a load of gasoline, was derailed and leaning approximately 30 degrees to the east and CGTX 30666, a load of diesel (UN 1202), was upright and on the rails.
