RAILWAY INVESTIGATION REPORT

R08Q0028

MAIN-TRACK TRAIN DERAILMENT

**CANADIAN NATIONAL
FREIGHT TRAIN M-308-31-31
MILE 46.46, DRUMMONDVILLE SUBDIVISION
VILLEROY, QUEBEC
31 DECEMBER 2008**

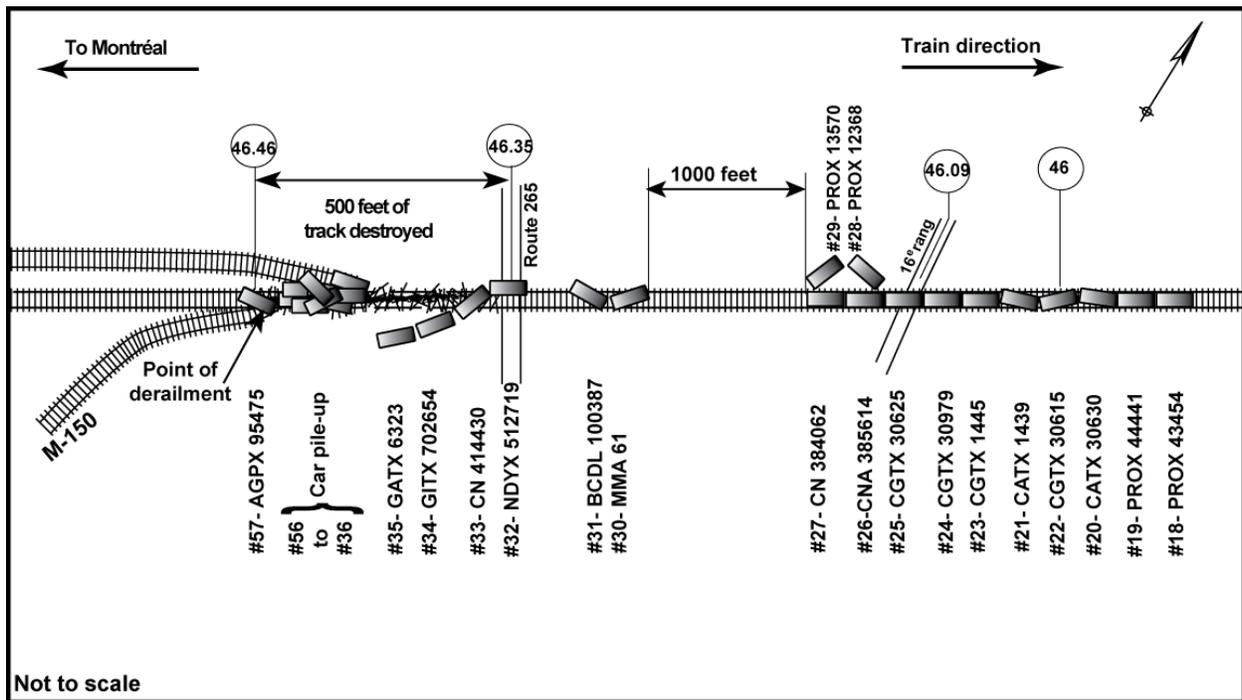
Figure 2. Diagram of the derailment area

The derailment area covers a distance of approximately 2500 feet, from turnout M150 at Mile 46.46 to Mile 46.00 (see Figure 2). The section includes two public grade crossings: the Route 265 crossing at Mile 46.35 and the 16^e Rang crossing at Mile 46.09. The derailed equipment consisted of seven empty tank cars, six empty box cars and twenty loaded covered hopper cars.

The first derailed cars, the 20th to 22nd cars, remained upright on the roadbed, each with a derailed truck. The following cars, the 23rd to 27th cars, remained on the track. The 28th and 29th cars rolled off their trucks and derailed to the north side of the track. The following cars, the 30th to 35th cars, separated from the front of the train and derailed near the Route 265 crossing. The rest of the derailed cars piled up between the crossing and turnout M150.

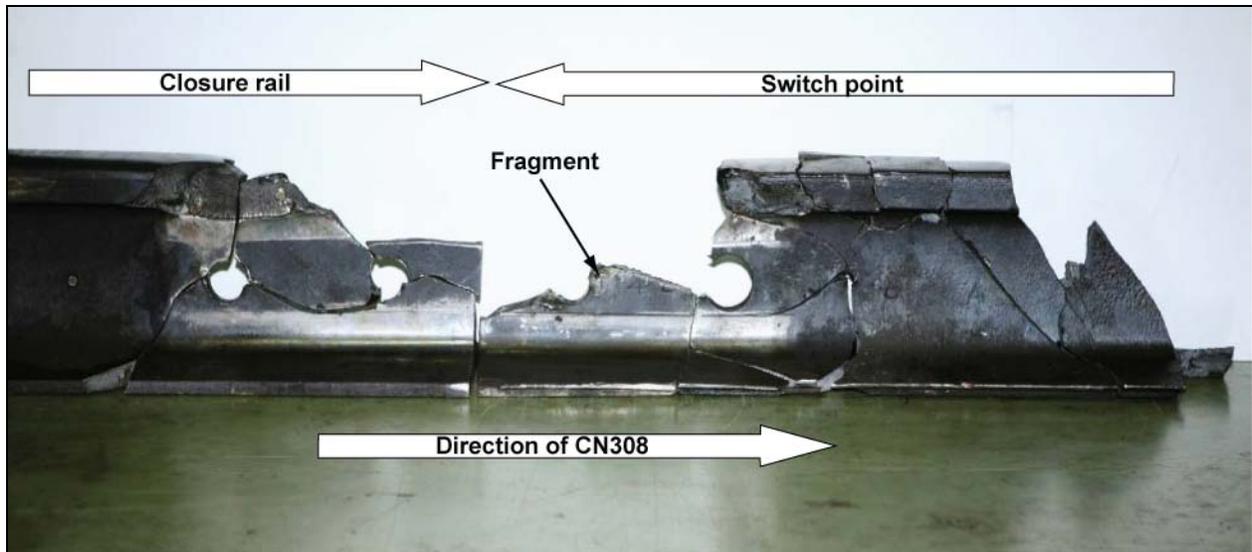
Photo 1. Reconstruction of the southern switch point and the straight closure rail

Track damage started at turnout M150 and continued eastward for approximately 500 feet. Around the switch heel block, the eastern end of the closure rail was broken, and the switch point was broken into several pieces. Several broken components were recovered; however, the rail head and the upper part of the web were missing (see Photo 1).

TSB laboratory examination (report LP 005/2009) of the rail fragments showed that horizontal cracks had developed between the joint bolt holes. Some fracture surfaces had flattened, worn surfaces caused by the friction of fragments created by the fracture. Most of the fractures were caused by overstress; no evidence of fatigue was noted. The crushed rail head on the ends of the rail fragments indicates that, due to the pounding of the wheels, the rail fragmented from the heel block to the switch point.

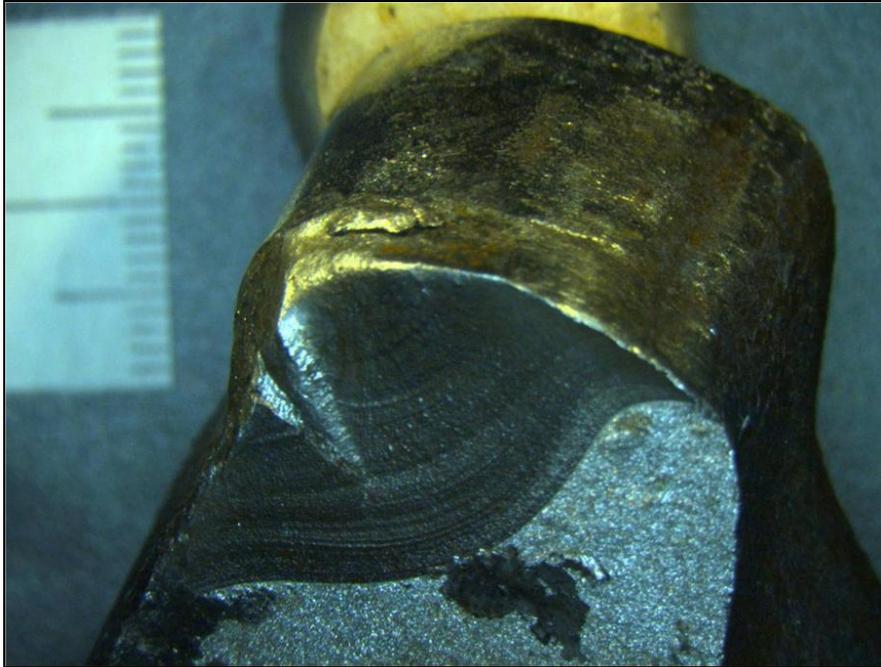
Photo 2. Upper part of the splice bar

The inside splice bar of the southern switch heel block joint was broken in two. A fatigue crack originated from a notch on the side in contact with the rail and spread to the upper part of the splice bar just below the rail head (see Photo 2).

The edges of the heel block that were in contact with the rails had a smooth, polished surface, indicating long-term wear from friction. The four switch heel block joint bolts showed wear. Three of them were sheared and had pre-existing cracks due to fatigue. The low temperature at the time of the accident may have contributed to reducing steel toughness, thus facilitating overstress fractures.

The fatigue crack in the splice bar started on the side in contact with the rail and propagated upwards. The crack was invisible because it was covered by the rail head. In addition, the continuous inspection of internal rail defects does not examine splice bars; as a result, the crack could not have been found during one of the many turnout inspections.

1. The use of an appropriate wrench, or some other effective means, would have enabled an inspector to check bolt tightness.
2. The crack in the splice bar was covered by the rail head and could therefore not be detected in the course of the many turnout inspections.

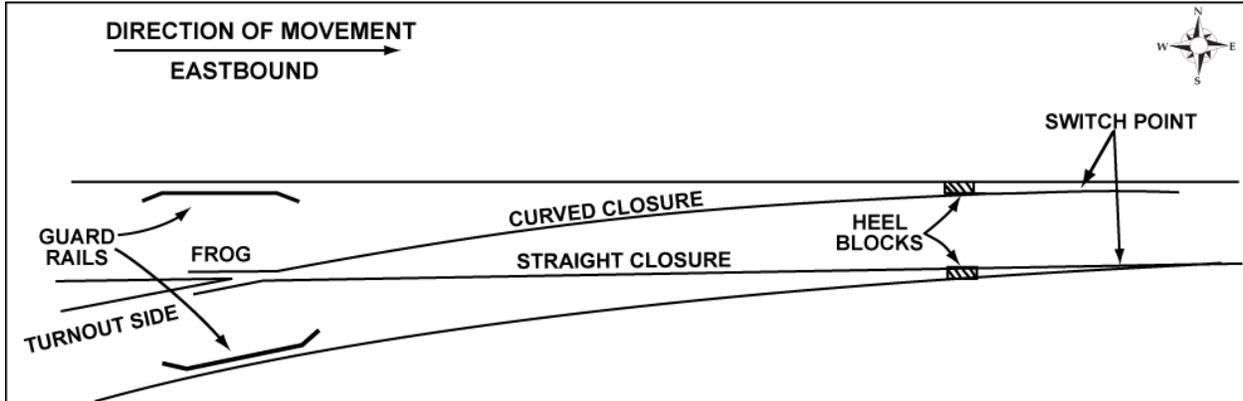
Appendix A - Turnout Diagram

Turnout M150 is a CN No. 12, 132-pound, hand-operated turnout (CN Standard Plan Drawing TS-012) with the switch points facing east (see Appendix A). The Samson switch point was manufactured in 1976 by Algoma Steel. The switch point and the straight closure rail had less than 2 mm of wear.
