RAILWAY INVESTIGATION REPORT
R09Q0047

MAIN-TRACK DERAILMENT

CANADIAN NATIONAL
FREIGHT TRAIN M-365-21-21
MILE 6.53, LAC-ST-JEAN SUBDIVISION
SAINT-TITE, QUEBEC
21 NOVEMBER 2009

Report Number R09Q0047

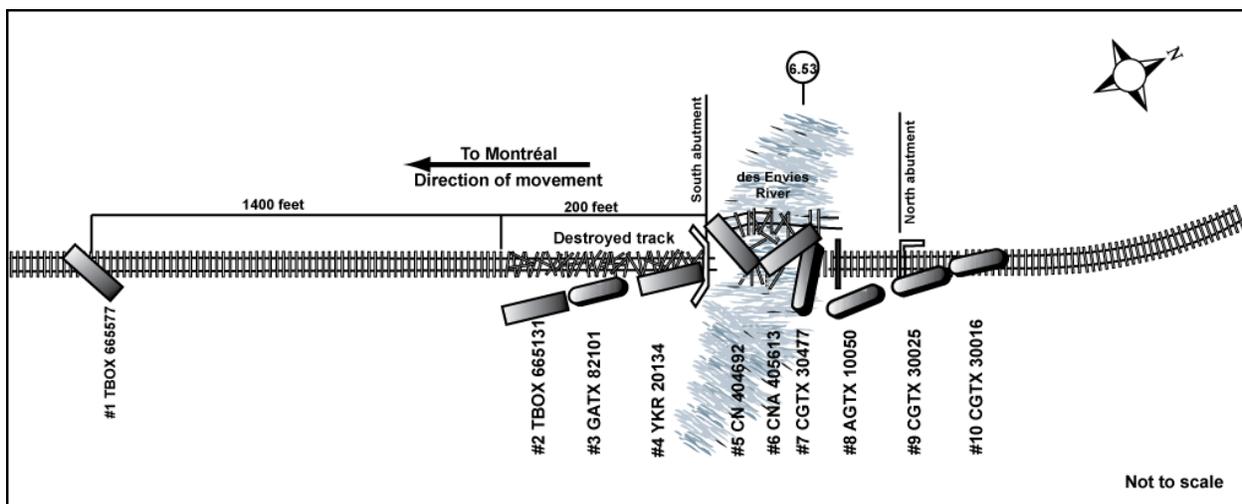
Figure 2. Schematic of accident site

The derailed rolling stock consisted of five loaded box cars and five empty tank cars (see Figure 2). No wheel marks or dragging equipment marks were observed to the north of the bridge. Near the south bridge abutment, wheel flange marks were observed on the tops of the ties and on the tie plates. These marks extended over a distance of 1600 feet southward and ended at the trailing truck of the first derailed car, box car TBOX665577. This car remained coupled to the forward part of the train with the trailing truck derailed on the east side of the track. The next three cars descended the embankment and came to rest in the ditch on the east side of the track near the south bridge abutment. The 5th, 6th and 7th cars came to rest on the trusses of the south span that had collapsed into the river bed (see Photo 1). The other derailed cars were on the north side of the river.

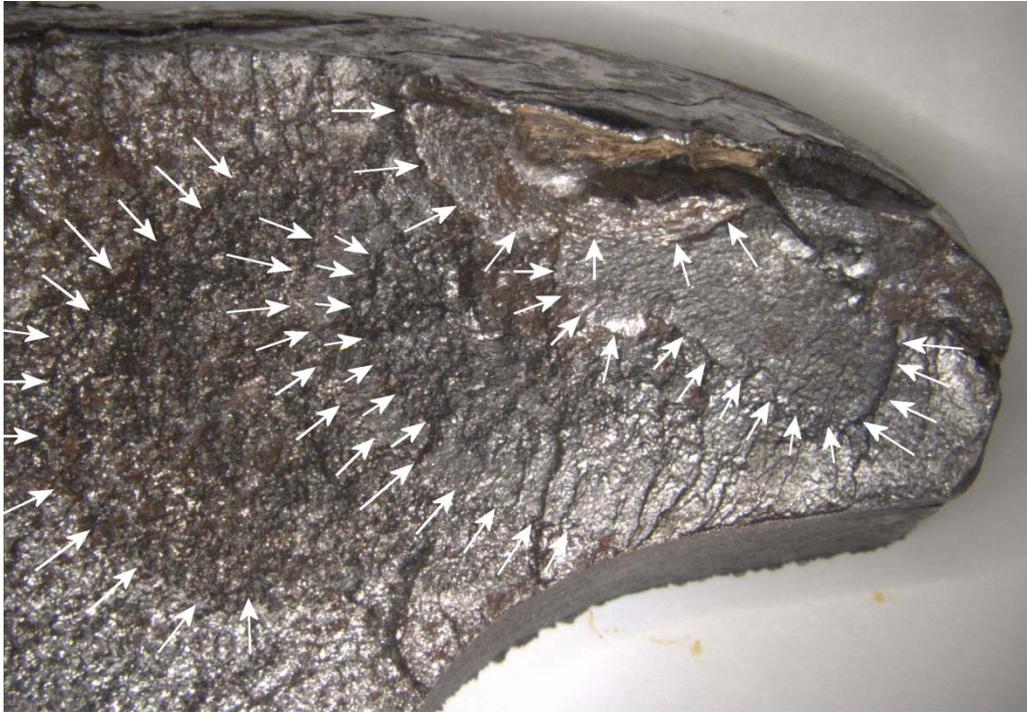
However, the pieces identified as A1² and B1 showed different indicators. Both fracture surfaces had regions near their gauge corners that had a thumbnail-shaped contour suggestive of pre-existing fatigue cracking. The pre-existing cracking on fracture surface A1 was only 4.5 mm long, while that on fracture surface B1 extended across approximately 40 per cent of the total head area. Fracture B1 exhibited multiple crack arrest lines, with progressively less corrosion and a rougher surface topography further away from the gauge corner. Examination with a scanning electron microscope (SEM) at different points in the progressive fracture region revealed transgranular cleavage, which indicates rapid crack growth, together with smooth areas indicating slow crack growth. This indicates a varying rate of crack growth (see Photo 2). The fracture surface in the last region of progressive growth, which immediately preceded the final failure in overload, shows transgranular cleavage indicating that the last phase of progressive growth was relatively rapid.

Photo 2. Arrows show crack arrest lines. Progressively less corrosion and a rougher surface topography was visible further away from the gauge corner.

Examination revealed that surface B1 had a large pre-existing transverse defect extending from the gauge corner approximately halfway through the head. This transverse defect initiated at a sub-surface crack and propagated by fatigue downwards in the head. The defect grew at different rates since its initiation. It was not possible to measure these rates of growth, but the combination of characteristics indicating rapid and slow rates suggests that the growth rate of the defect was not stable. Since the characteristics of the last region of progressive growth indicate rapid growth, it is possible that this defect grew rapidly after the last inspection for internal rail defects, and that it was much smaller at the time of the last inspection.

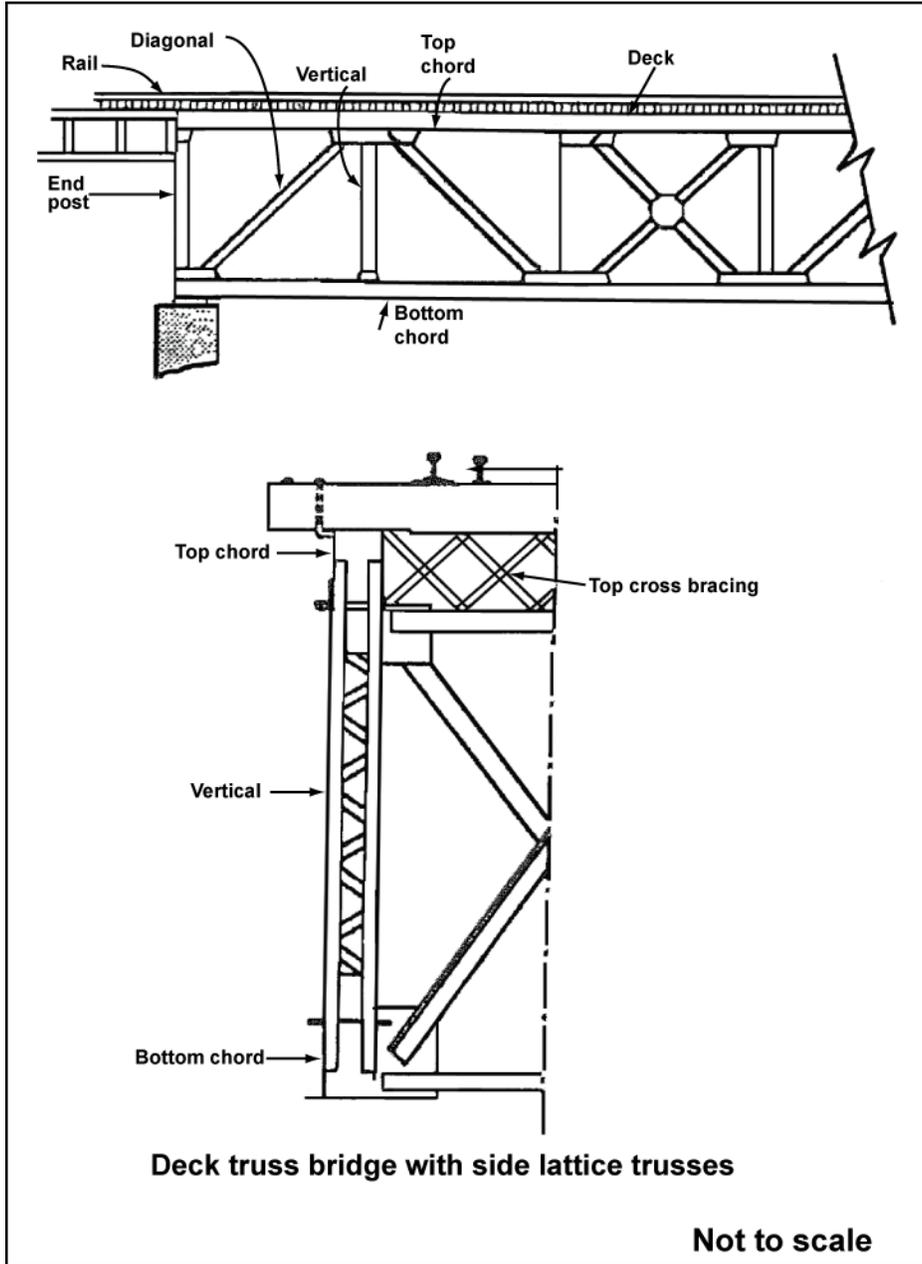
Appendix A – Railway Bridge Sketch

The primary and secondary steel members of the south span were twisted, wheel flange marks and scrapes were visible on the top of the top chord, and several rivet heads were sheared off (see Appendix A). The deck ties were broken up; however, the wood fibres in the tie fragments showed no signs of deterioration or rot. The south abutment backwall was struck by the right front and the coupler of the 5th car and broke into several pieces.

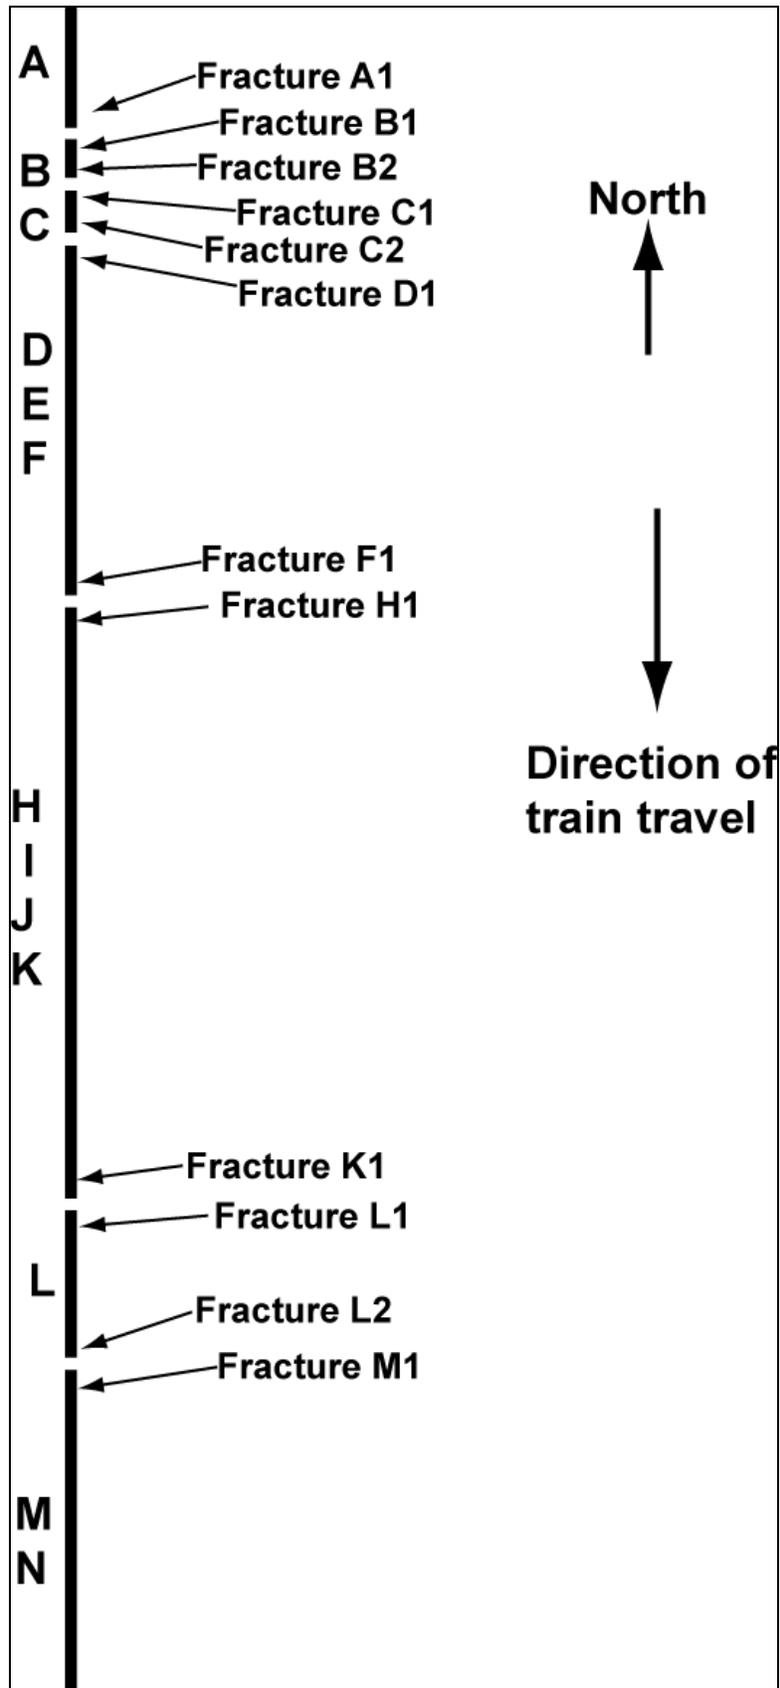
Appendix B – Nomenclature of Rail Pieces Recovered

All derailed rolling stock and the steel members of the south span were examined; no pre-derailment defects were found. Over 30 pieces of broken rail were recovered and sent to the TSB Laboratory, where a section of about 130 linear feet of rail was reconstructed (see Appendices B and C). Piece A, from the east rail, had remained fastened to the ties. Its end, which was projecting 18 inches beyond the end of the north span above the central bridge pier, was fractured and pounded downwards. Piece B, 3 feet 10 inches in length, was found near the central pier, buried under the bottom chord of the collapsed span.
