**RAILWAY INVESTIGATION REPORT  
R14W0041**

**MAIN-TRACK TRAIN DERAILMENT**

**CANADIAN PACIFIC RAILWAY  
FREIGHT TRAIN 490-15  
MILE 43.10, MINNEDOSA SUBDIVISION  
KEYES, MANITOBA  
15 FEBRUARY 2014**

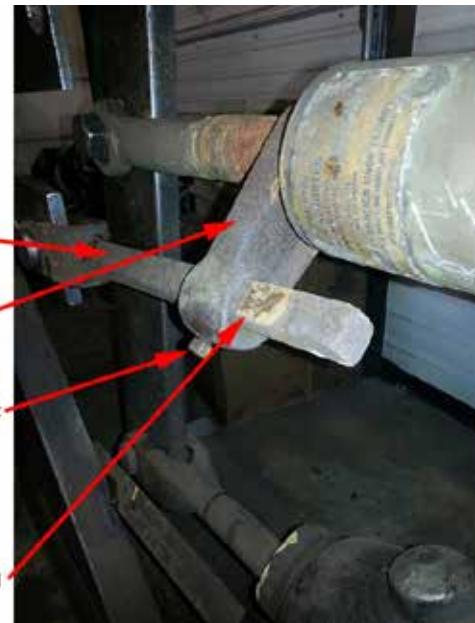
**Photo 1. Slack adjuster on test rack**

At Red River Air Brake, the slack adjuster for car MOCX 482212 was tested on an SA-01 test rack (Photo 1). The slack adjuster passed the “take up” portion of the test, but failed the “let out” portion.

During teardown of the slack adjuster, it was determined that the cut-out cock, 4 reservoir gaskets and the branch tee gaskets were leaking due to normal wear. A slack adjuster failure can result in the brake rigging becoming too tight. Such a condition can lock the wheels in place, causing wheel tread slid flats and ultimately high wheel impacts on the rail.

It was also noted that the control rod on the slack adjuster was not tack welded to the control rod head as required, potentially allowing it to move from its initial setup position, which can affect its performance.

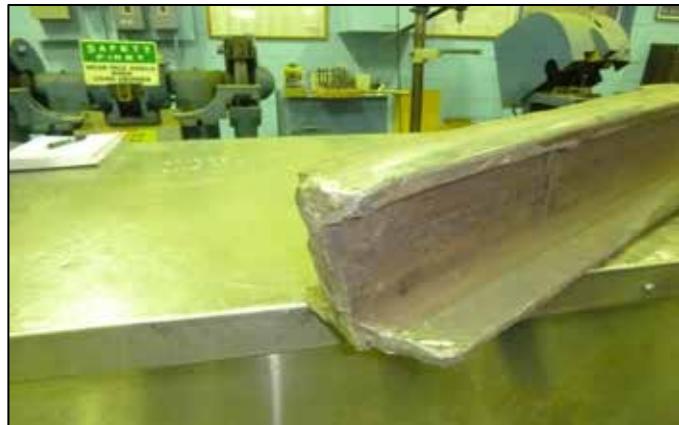
**Photo 2. Fracture surface with rail end batter showing tie position**

The west end of the rail displayed a fracture surface with characteristics typical of brittle failure. The fracture surface exhibited heavy batter, which is consistent with a rail that had broken, but remained in place for some time and was damaged by multiple wheel impacts (Photo 2).

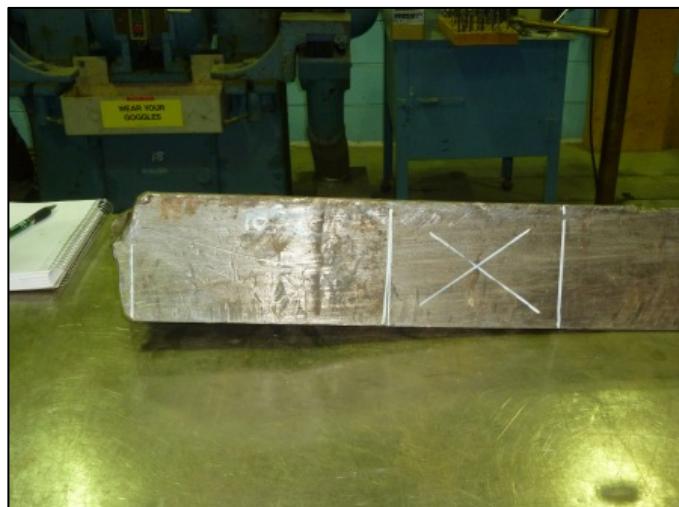
**Photo 3. Base of rail**

Examination of the bottom of the rail base identified tie locations (Photo 3). It appeared that a single crosstie narrowly supported the broken rail before the derailment. There was no evidence of any deleterious material, metallurgical or manufacturing defects in the rail.

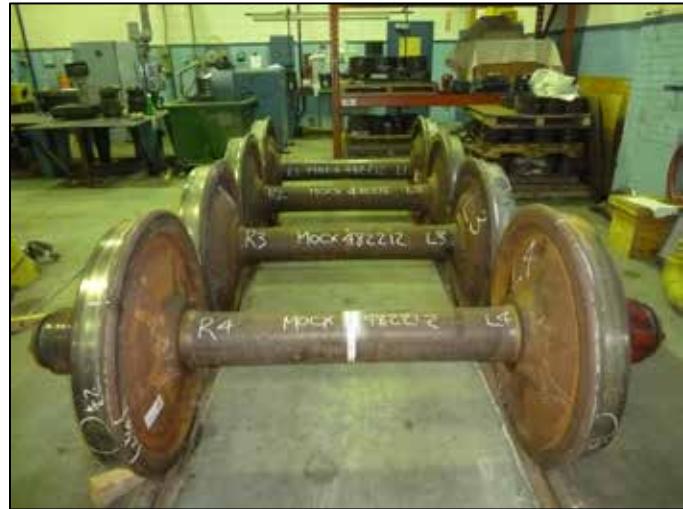
**Photo 4. MOCX 482212 wheel sets**

All wheels displayed numerous non-condemnable intermittent shells, spalls and minor tread build-up. The wheel treads displayed numerous slid flats ranging from 1 inch to 3.5 inches in length throughout the tread circumference (Photo 4).

- The L1 wheel tread had one 2.25-inch-long condemnable slid flat. The mate R1 wheel had 5 condemnable slid flats ranging from 2.0 inches to 2.25 inches in length;
- The L2 wheel tread had 2 adjoining condemnable slid flats (2.5 and 3.5 inches long) that combined to form a 6-inch-long flat spot on the tread surface (Photo 5). The mate R2 wheel tread had one 2-inch-long and one 3.5-inch-long condemnable slid flats;
- The L3 and R3 wheel treads displayed a number of slid flats ranging from 1.25 inches to 1.75 inches in length throughout the tread circumference. None of these slid flats were condemnable; and
- The L4 wheel tread had one 2.75-inch-long condemnable slid flat. The mate R4 wheel tread had two 2.75-inch-long condemnable slid flats.

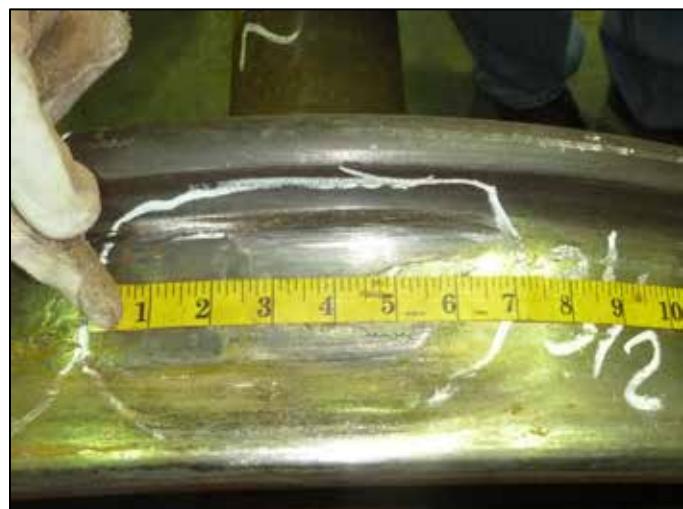
**Photo 5. L2 wheel tread**

Examination of the wheel sets from MOCX 482212 determined that all wheel treads had numerous slid flats ranging from 1 inch to 3.5 inches in length that extended circumferentially throughout the treads. The most significant wheel condition was the L2 wheel tread, which had 2 adjoining condemnable slid flats (2.5 inches and 3.5 inches long) that combined to form a 6-inch-long flat spot on the tread surface. This tread defect corresponded to the car's highest measured wheel impact of 189.60 kips at a speed of 34.59 mph. This equates to a calculated WILD impact of 255.04 kips at 50 mph. The rail failed catastrophically in brittle mode likely as a result of a high wheel impact imparted on the rail by a condemnable 6-inch-long slid flat wheel tread on the L2 wheel of car MOCX 482212 on train 298.
