RAILWAY INVESTIGATION REPORT

R17W0190

Hi-rail crane boom failure

Brandon, Manitoba

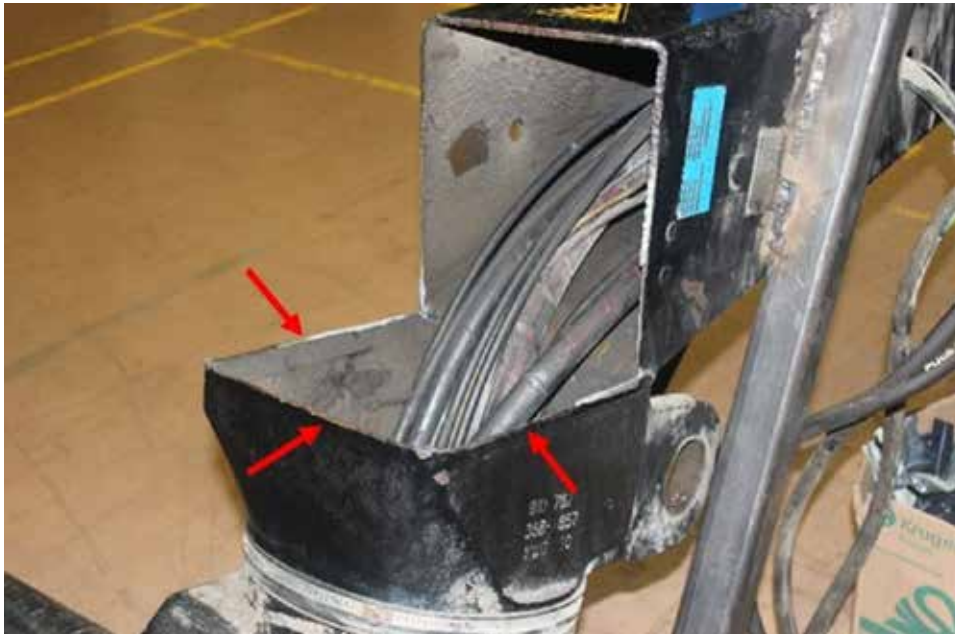
A post-accident visual examination conducted at CP's Weston Shops in Winnipeg revealed that the crane column failed as a result of the failure of a weld that joined the column to the crane base. The fracture appeared to originate at the toe of the weld, on the interior of the column (Figure 3).

Figure 3. Location of the failure of the crane column weld, indicated by the red arrows

1. While tie plates were being unloaded, the crane column failed in the welded region that joined the column to the crane base.
2. The extended crane boom dropped and the operator was thrown from the basket onto the track, about 12 feet below; the operator sustained serious injuries.

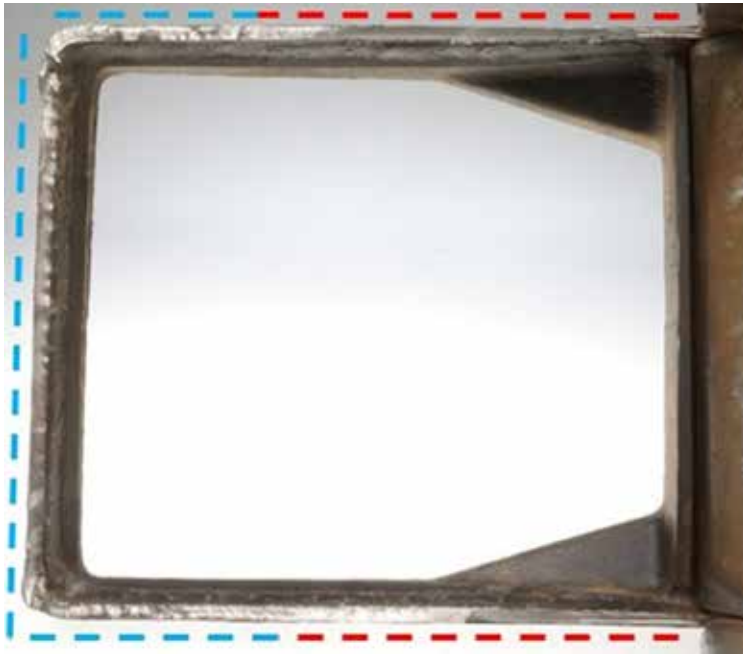
Visual examination of the failed crane column revealed that the failure occurred in the welded region that joined the column and the crane base. The fracture originated in the heat-affected zone at the toe of the weld, on the interior of the column. The fracture surface had two distinct regions with different appearances. One region was flat and perpendicular to the axis of the column, and the other region had a 45-degree slanted surface (Figure 5).

Figure 5. Fracture surface in the welded region joining the crane column and the crane base. Note the flat region (outlined by blue dashes) and the angled region (outlined by red dashes).

The 45-degree slanted region was relatively small and displayed features that are typically associated with final overstress rupture.

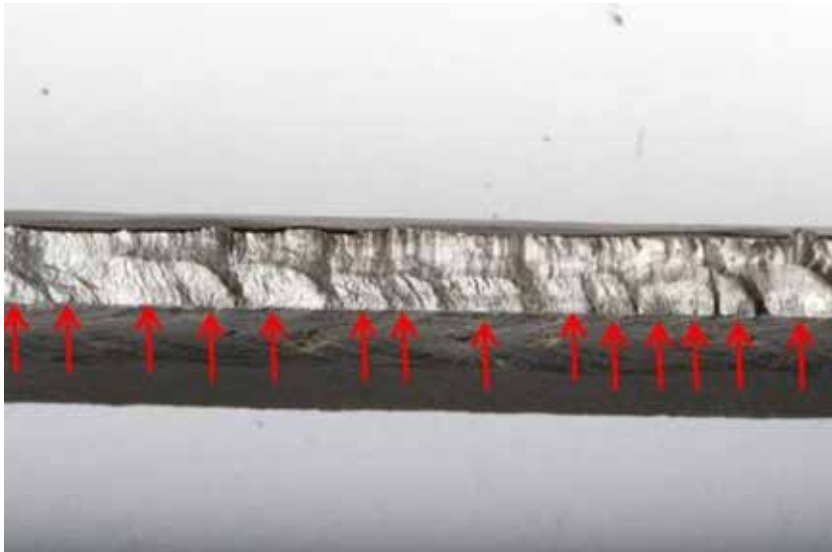
The flat region exhibited multiple small semi-elliptical features that originated on the inner surface of the fracture and had progressed toward the outer surface of the column's rear and side walls (Figure 6).

Figure 6. Fatigue fracture surface from the flat region. The semi-elliptical regions, marked by the red arrows, indicate multiple crack origins.

The semi-elliptical features are typically associated with multiple origins of fatigue cracks. A small number of the flat regions had an oxidized appearance, suggesting that they had been exposed to moisture for some time before the failure (Figure 7).

Multiple fatigue cracks had originated in the heat-affected zone at the toe of the weld, on the interior of the column, and propagated outward through the rear and side column walls. The final column failure occurred when the fatigue cracking reached a critical size and the column could no longer sustain the service load.

3. Multiple fatigue cracks had originated in the heat-affected zone at the toe of the weld, on the interior of the crane column, and propagated outward through the rear and side column walls.

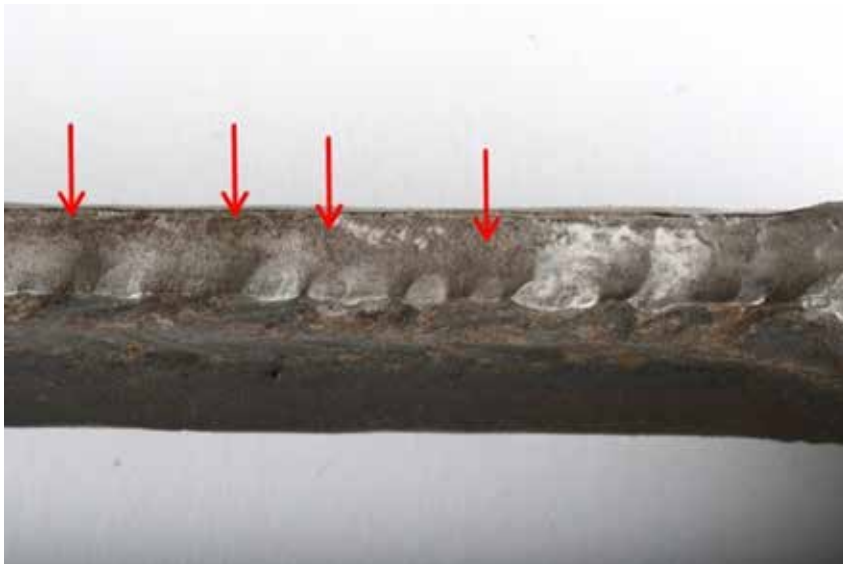
Figure 7. Oxidized fracture surface, indicated by the red arrows

On the crane, the paint measured about 0.0065 inches thick in the weld region. The paint was generally intact, with the exception of a number of small areas of corrosion (Figure 7). In the corroded areas, the paint was likely breached before the column failed. The breach in the coating exposed small localized areas of steel to the environment and resulted in oxidation.

A small number of the fatigue cracks open to the exterior column surface had an oxidized appearance, suggesting that they had been exposed to moisture for some time before the failure. The length of time that some of the small fractures were exposed to the exterior column surface could not be determined.

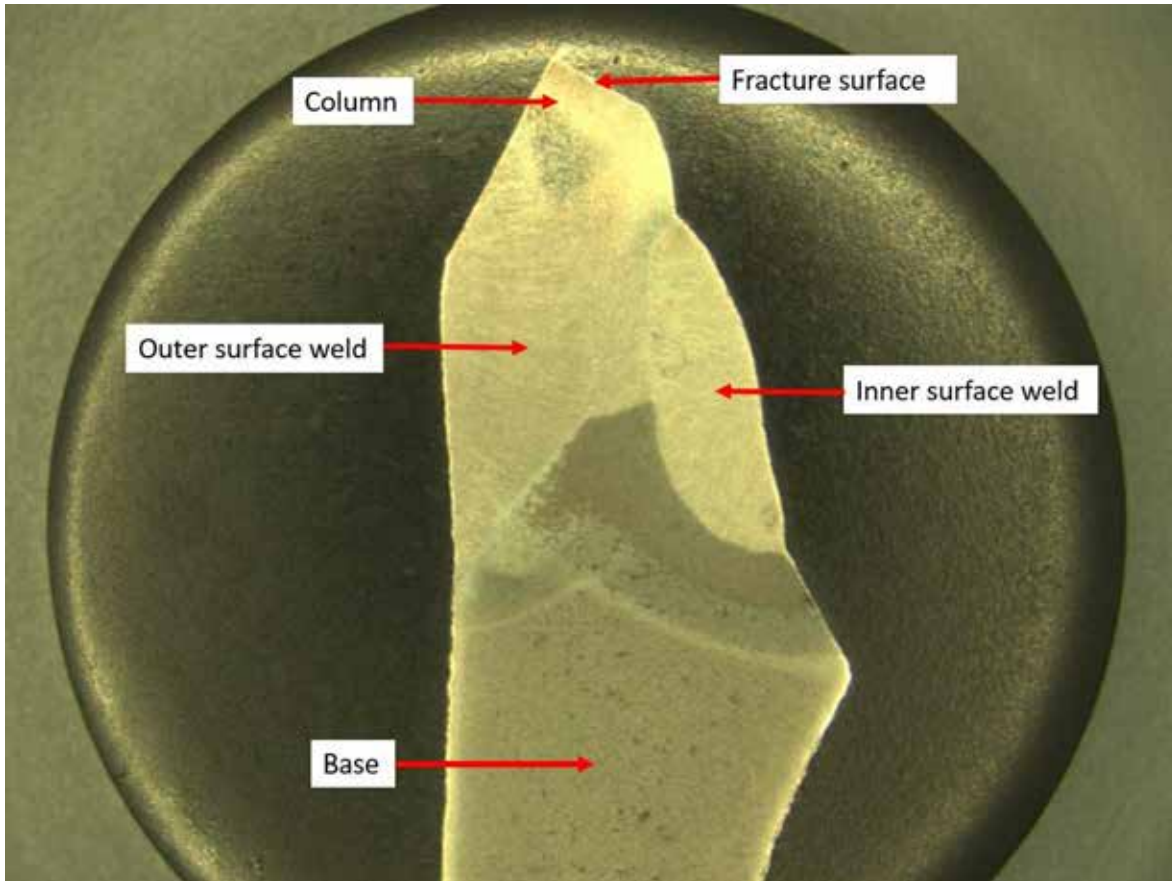
Metallurgical examination of the weld cross-section determined that there were 2 welds: 1 weld on the inner column surface and 1 weld on the outer surface (Figure 8). Both welds were homogeneous and had good penetration. The different microstructures of the column and base parent metals, the weld bead, and the heat-affected zones were typical for this type of welding.

Figure 8. Cross-section of the weld, showing the fracture surface

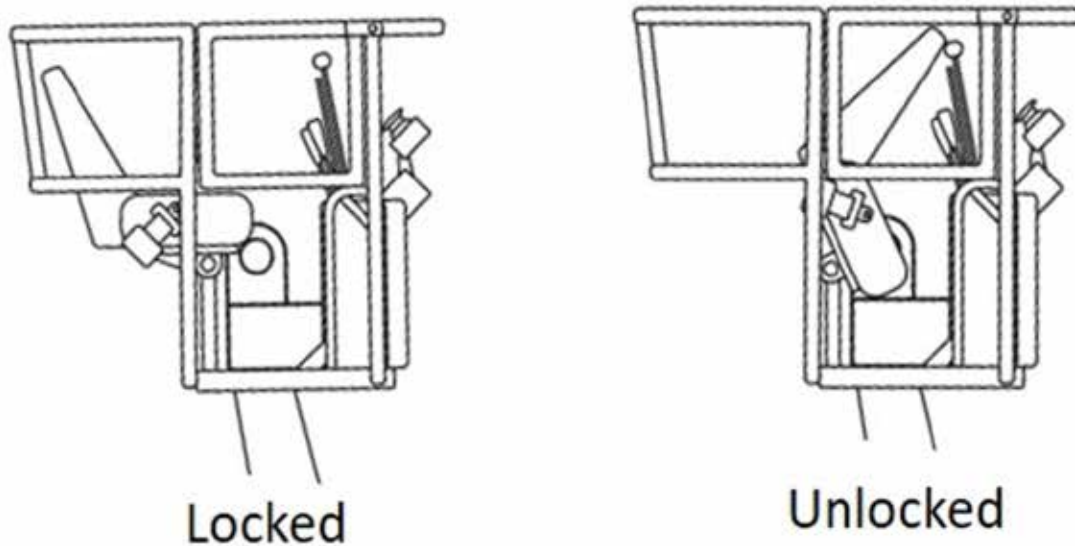
The operator's seat design includes a locking mechanism that is meant to prevent the seat from pivoting up and forward (Figure 9). However, at the time of the occurrence, the operator's seat was in the forward hinged position. The seat-locking mechanism had missing parts, was inoperative, and was covered in dirt, suggesting that the locking mechanism had been inoperative for some time.

Figure 9. Seat schematic showing controls and seat in the locked and in the unlocked and pivoted positions

- The buckle portion of the seatbelt system was missing, rendering the seatbelt system inoperative.
- The seat-locking mechanism was missing parts and inoperative. With the locking mechanism inoperative, the operator could not lock the seat in place to prevent it from moving up and forward in the event of a boom column failure.
- A support piece of the frame on the underside of the bottom of the operator's basket was broken and corroded.
- All of these components were covered in dirt, indicating that they had been in this condition for an extended period of time.

- **Daily inspections:** Inspect the operator's seat assembly for any looseness, wear or defects. Including but not limited to seat mounts, hardware, hinges and latch systems. Confirm that the seatbelt is operating properly.
- **Quarterly inspections:** Inspect the mounting bolts for tightness and torque, pins for any unusual wear, and all other hardware for cracks, defects or corrosion.
- **Annual inspections:** Perform non-destructive testing of the operator's seat assembly.

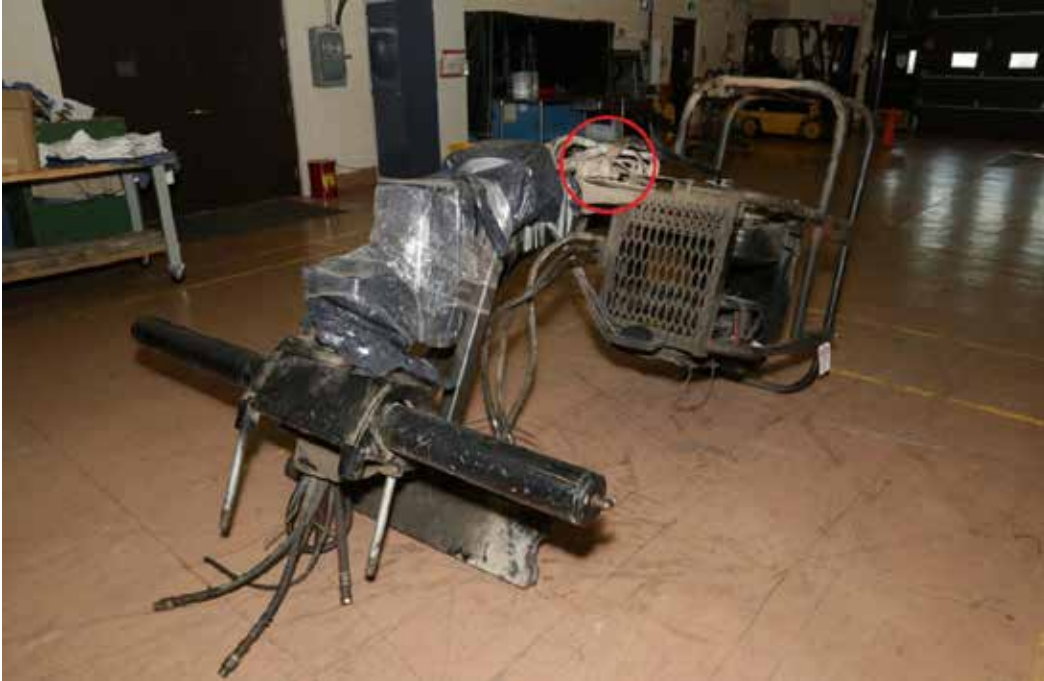
A support piece of the frame on the underside of the bottom of the operator's basket was broken, corroded, and covered in dirt (Figure 10 and Figure 11).

Figure 10. Crane assembly with circle identifying a broken piece of the basket frame

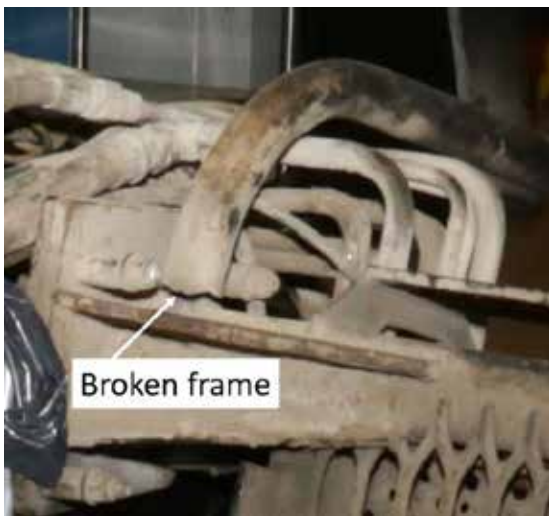
Figure 11. Close-up of broken basket frame

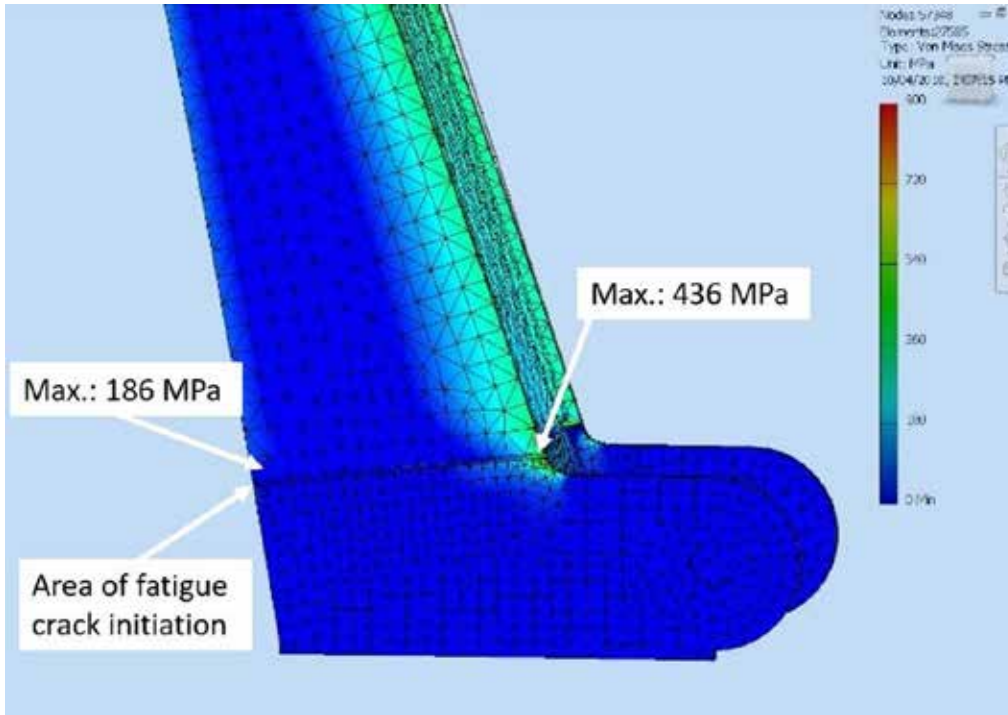
- With the existing fatigue crack, the crane's load capacity was reduced by about 60% before factoring in any safety margin.
- Without the existing fatigue crack, the maximum stress would have been within the stress limits for the entire weld with the boom at an angle below 60 degrees relative to the ground.
- Without the existing fatigue crack, with the boom raised at or above 60 degrees, the stress would have increased by about 64%. The highest stress recorded was 436 megapascals (MPa), which was located at the corner of the front and side walls of

the column. This area of highest stress is not in the area where the initial cracking was observed in the failed crane column (Figure 12).

Figure 12. Finite element analysis showing the stress level in the area of the weld joint in the column when raised to 60 degrees relative to the ground
