RAIL TRANSPORTATION SAFETY INVESTIGATION REPORT R21D0001

EMPLOYEE FATALITY

Canadian National Railway Company
Yard assignment YPC011-06
Mile 1.9, Montreal Subdivision
Montréal, Quebec
06 January 2021

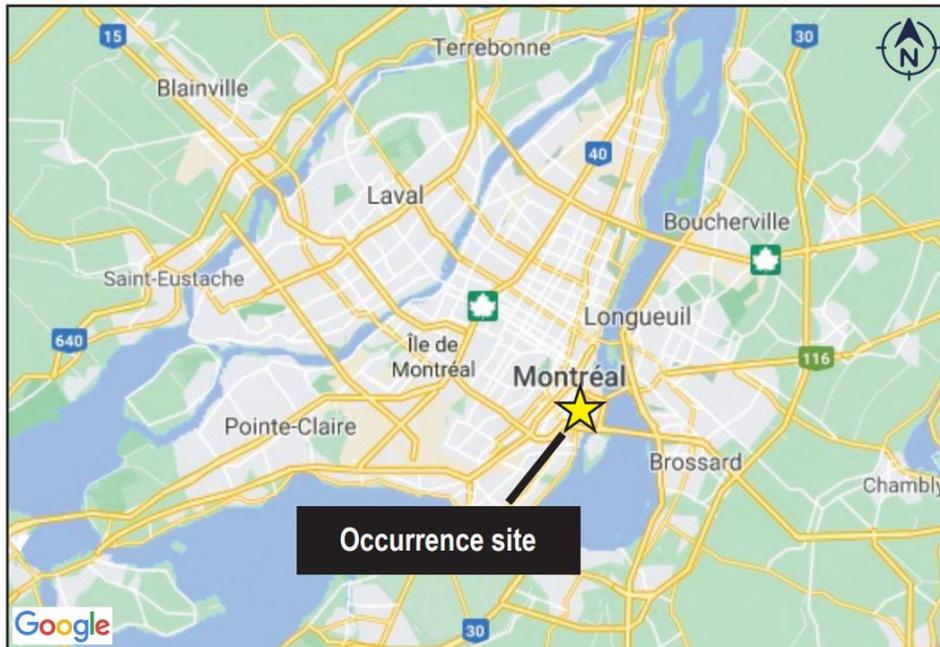
Figure 1. Occurrence site (Source: Google Maps, with TSB annotations)

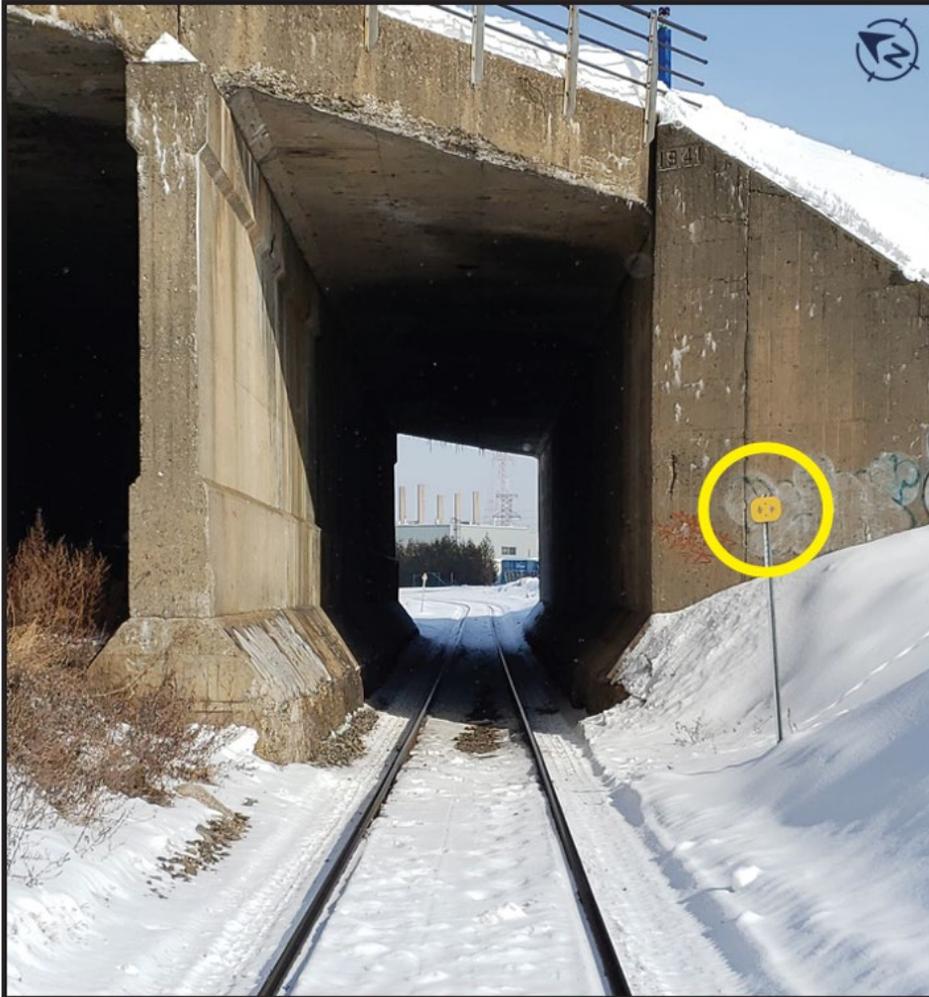
Track PD06 crosses Bridge Street at a public grade crossing.² Stop signs installed on both sides of the public grade crossing indicate to movements that they must come to a complete stop before entering the crossing in order to confirm that the warning devices have been activated.³ The track then passes through a tunnel about 175 feet long under the tracks linking the Victoria Bridge to Central Station. Restricted clearance signs are located at both ends of the tunnel⁴ (Figure 2).

These signs remind train crews that riding moving equipment within the marked area is prohibited⁵ to reduce the risk of injury.

Figure 2. Eastward view of the tunnel on track PD06, with restricted clearance sign circled (Source: TSB)

The train did not stop before entering the tunnel to allow the assistant conductor to get off the car and walk through the tunnel, even though this was required by regulations. To ride the car through the tunnel and avoid being in the space between the side ladder of the car and the concrete wall, the assistant conductor repositioned himself on the end ladder of the leading car.

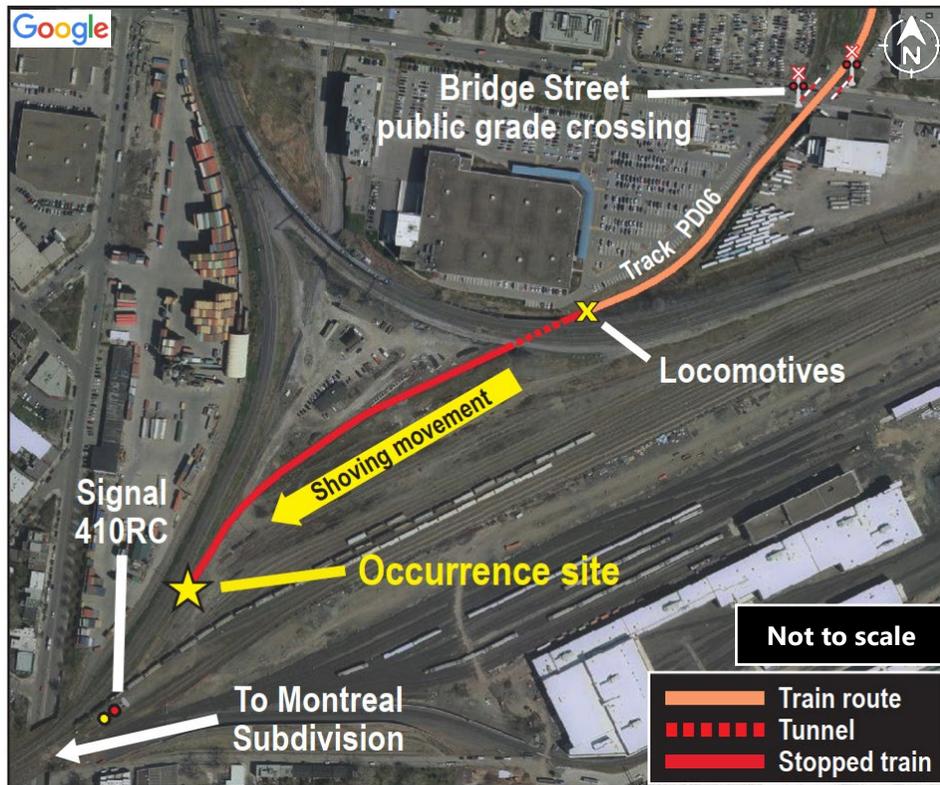
On the occurrence site, the locomotives were stopped east of the tunnel entrance on track PD06; the leading car was about 400 feet from signal 410RC (Figure 3).

Figure 3. Map of the occurrence site (Source: Google Maps, with TSB annotations)

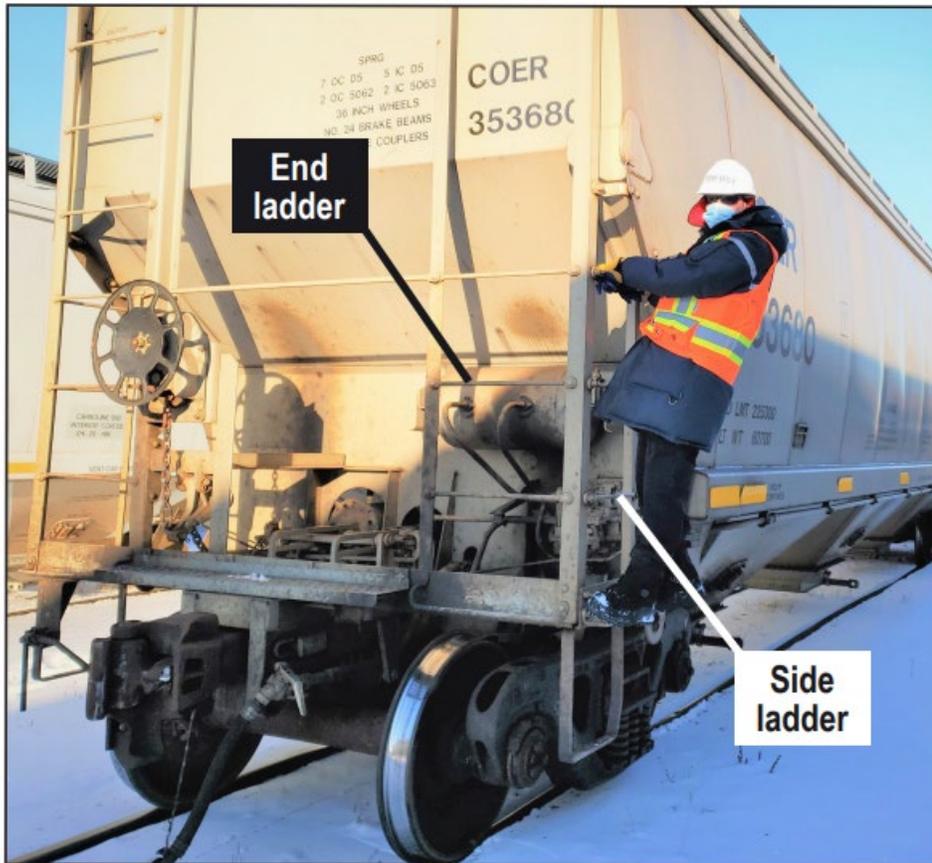
This repositioning on the end ladder was contrary to CN's instruction, which stipulates that personnel riding equipment must use the side ladder (Figure 4).⁹ Employees are therefore able to get off the car more easily in case of emergency. This positioning also reduces the risk of serious injury should an accidental fall occur. The occurrence crew commonly followed this practice, without the knowledge of yard supervisors, to reduce the number of stops needed to get on or off equipment¹⁰ and to decrease their total time occupying the Bridge Street public grade crossing.

Figure 4. Positioning on the side ladder of the moving equipment (Source: TSB)

Following the occurrence, CN issued a circular to warn its employees about sudden stretch on the couplers resulting from slack action following excessive use of the independent brake. The circular reiterated the safety rules for riding equipment, the rules for communication between peers, and the importance of remaining vigilant to protect oneself against sudden movements and shocks caused by slack action. CN also issued an operating bulletin requiring movements on the Port of Montreal spur to be led by a locomotive or, when shoving equipment, by caboose CN 79834.¹⁶
