# Air Transportation Safety Investigation Report A19Q0073

## LOSS OF CONTROL AND COLLISION WITH TERRAIN

ULM Québec Inc.  
DTA Voyageur II 912S (basic ultralight), C-IULM  
St-Cuthbert (ULM Québec) Aerodrome, Quebec  
24 May 2019

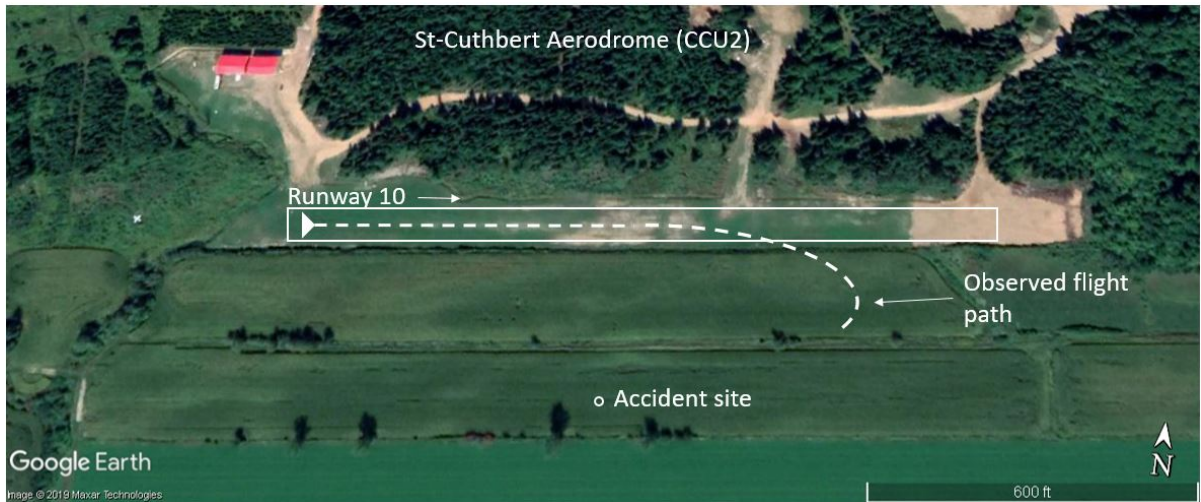
At approximately 2008, the aircraft commenced a takeoff on Runway 10. During the initial climb over the runway, several engine backfires<sup>2</sup> were heard. The aircraft then commenced a steep right turn and entered a dive before it disappeared behind a pile of hay bales. The aircraft struck the ground in an agricultural field south of the runway (Figure 1).

Figure 1. View of the aerodrome and the occurrence aircraft's observed flight path (Source: Google Earth, with TSB annotations)

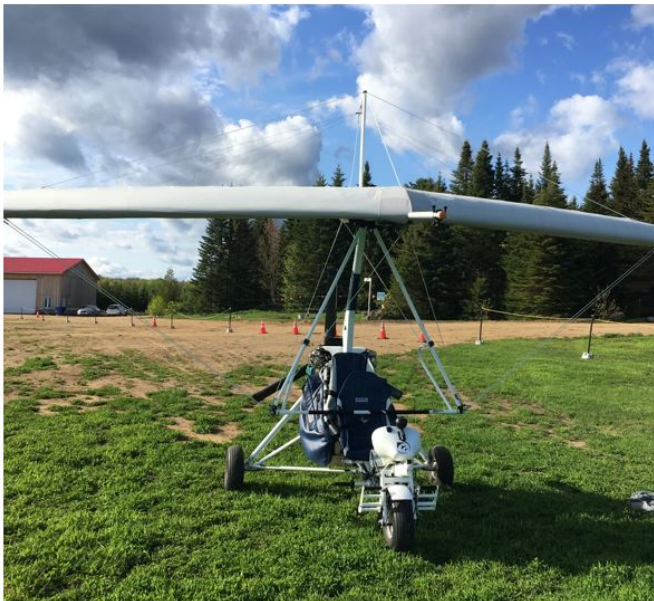
The DTA Voyageur II 912S is a single-engine, 2-seat ultralight trike which uses weight-shift as a means of flight control. It is powered by a 100-horsepower, 4-stroke Rotax 912 ULS engine and a fixed-pitch carbon fibre 3-blade propeller (Figure 2). The occurrence aircraft was equipped with optional dual controls and a DTA Diva wing allowing for a 472.5 kg maximum take-off weight. Dual controls are provided by extensions bolted to the rear of the flight control bar, which allow the pilot providing

Figure 2. Occurrence aircraft (Source: pilot)

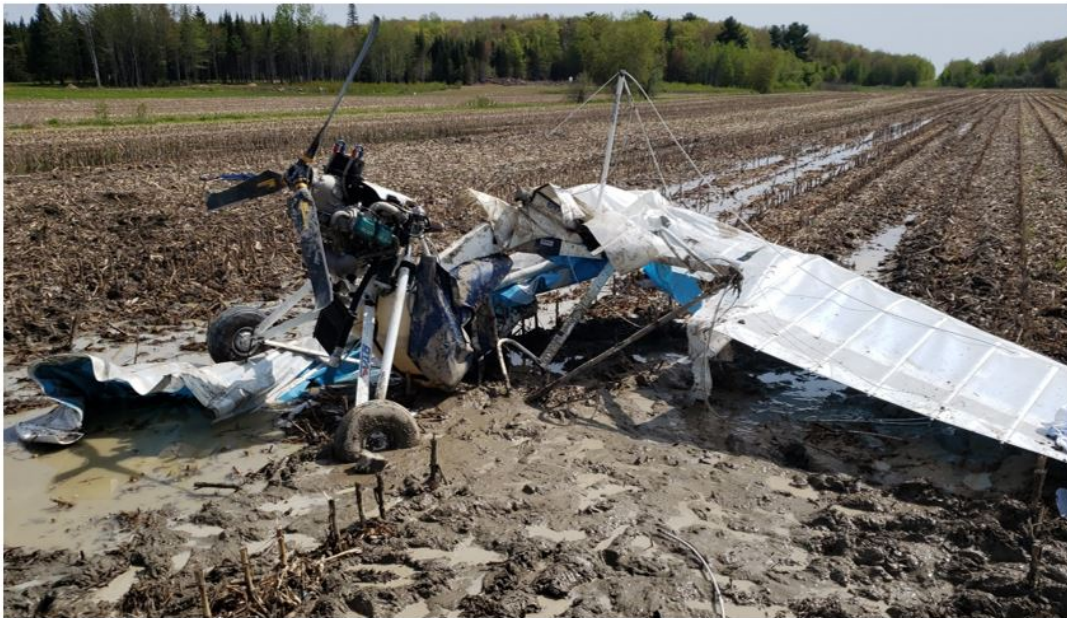
The collision with terrain occurred at CCU2, approximately 375 feet south of the Runway 10/28 centreline, in an agricultural field parallel to the runway. The recent snow thaw had left several inches of mud and water in certain areas (Figure 3).

Figure 3. Wreckage of the occurrence aircraft (Source: TSB)

The tricycle, wing, engine, and propeller were examined at the accident site. Damage to the tricycle indicated that it collided with the ground in a right-bank slip and steep nose-down attitude. The impact forces caused the front of the main frame member of the tricycle to bend left and upward several degrees. The nose wheel and steering mechanism was displaced aft and turned several degrees past its normal maximum deflection. On the occurrence aircraft, engine throttle could be controlled by the right pedal for the front seat or by a small lever located on the right footrest for the

The wing tubular structure was found to have several deformed and fractured components. On-site examination of the wing revealed that it impacted the ground on the nose and left leading edge. Tearing damage was present on the left-wing trailing edge as a result of contact with the rotating propeller. Damage to the control bar and the position at which it was found were consistent with the pilot attempting to recover from the dive with a left turn before impact with the ground. All damage to the wing, including that caused by the rotating propeller, was found to have been a consequence of the impact with the ground.
