# Air Transportation Safety Investigation Report A19Q0096

## COLLISION WITH TERRAIN

Rans S-6ES Coyote II (advanced ultralight), C-IIIJ  
Rougemont, Quebec  
01 July 2019

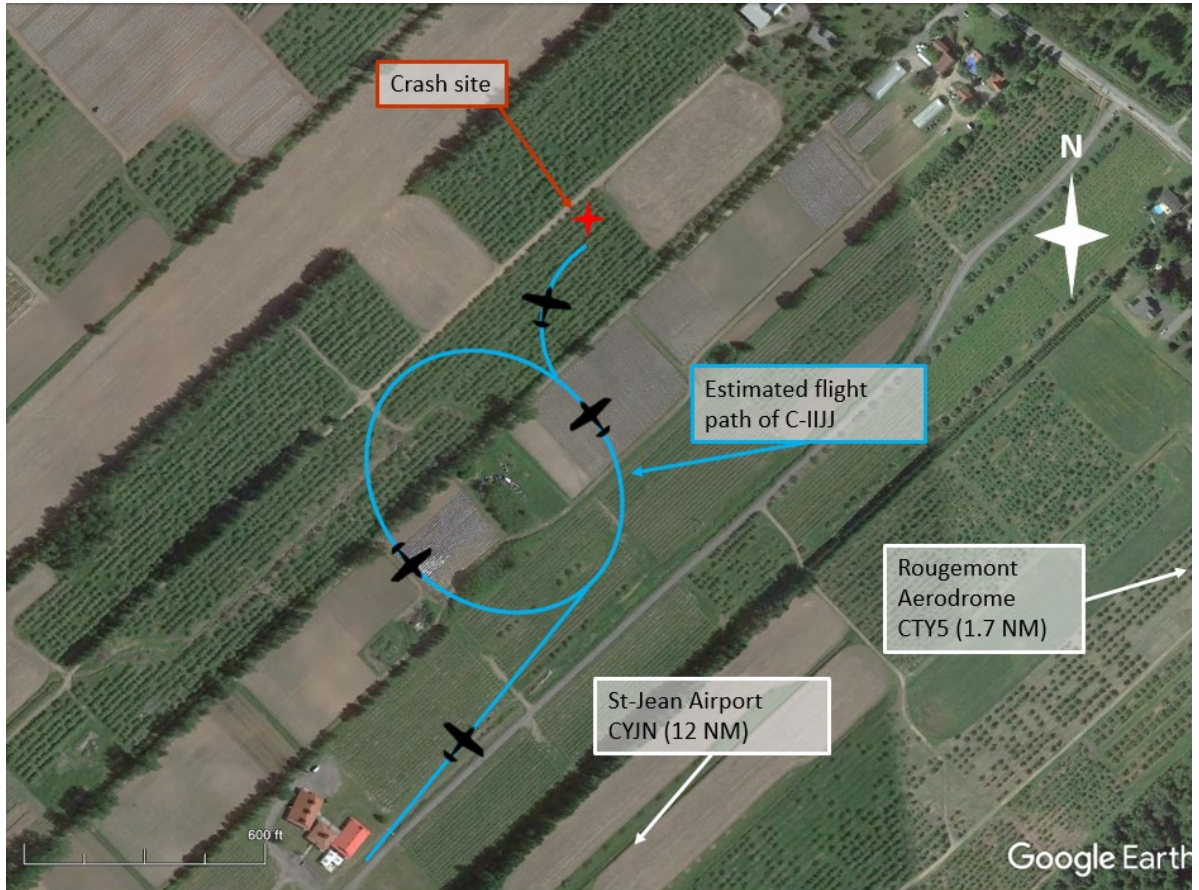
At approximately 1125, the pilot took off for a local VFR pleasure flight in the vicinity of Rougemont, with the owner as passenger. At approximately 1133, the aircraft reportedly passed over an orchard in Rougemont at low altitude (i.e. less than 200 feet above ground level) in a counter-clockwise turn. At approximately 1135, the aircraft changed direction and turned northeast. It lost altitude and crashed

into the orchard trees (Figure 1). The 2 occupants were fatally injured. No signal was detected from the emergency locator transmitter (ELT).

Figure 1. Estimated flight path of the occurrence aircraft (Source: Google Earth, with TSB annotations)
