Air Transportation Safety Investigation Report A20W0072

COLLISION WITH POWER LINE

Privately registered
Harmon Rocket II, C-FZXS
Hugget/Goodwood Field Aerodrome, Alberta
26 September 2020

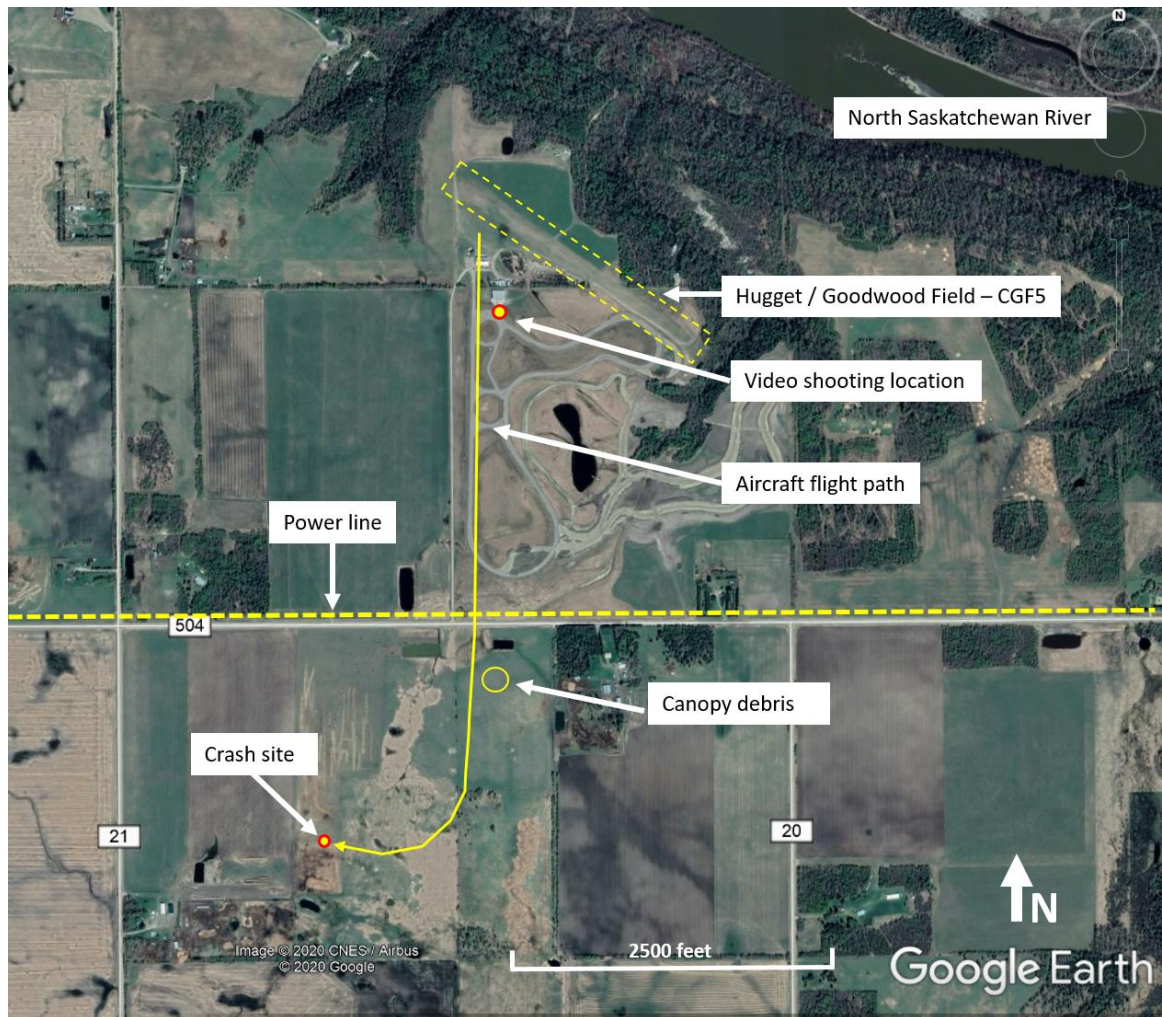
After the 2nd circuit, the aircraft turned left, descended to approximately 25 feet above ground level (AGL) and flew over the racetrack straightaway from north to south. Based on videos recorded by observers on the ground, at the south end of the straightaway the aircraft initiated a climb and struck the upper of 2 wires of an unmarked power line on the north side of Township Road 504 at between 32 and 35 feet AGL (Figure 1). The aircraft pitched up steeply, climbed to approximately 700 feet while rolling right to an almost inverted attitude and changing heading to the west. When the aircraft began to descend, it rolled left to a wings-level attitude, and continued to descend until it struck the ground, in a 40° nose-down attitude.

Figure 1. Map showing the occurrence aircraft's flight path, the power line and the accident site (Source: Google Earth, with TSB annotations)
