Air Transportation Safety Investigation Report A20O0053

MID-AIR COLLISION

Privately registered
Champion 7GCB, C-FPTR
and

Privately registered
Cessna 172M, C-GEDC
Arnprior/South Renfrew Municipal Aerodrome, Ontario, 12 NM ENE
14 June 2020

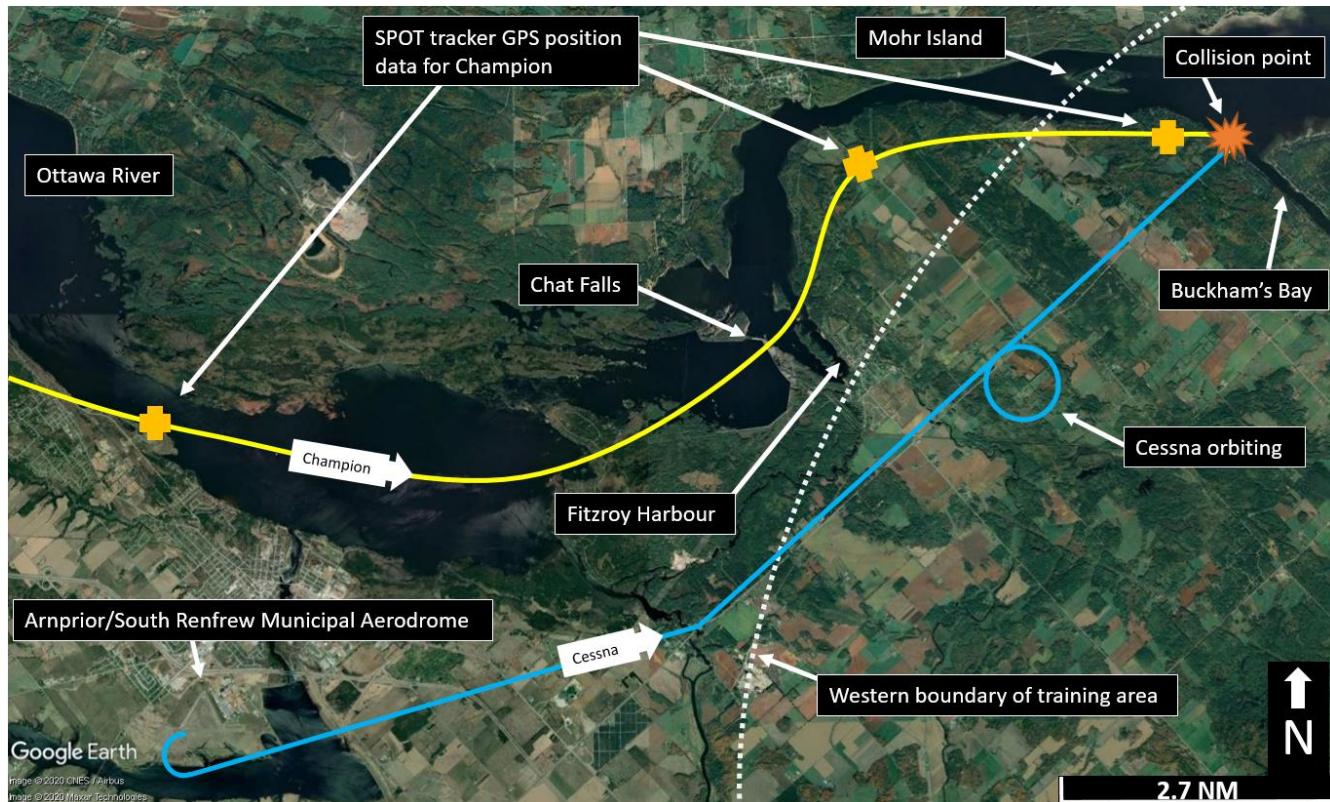
Figure 1. Estimated flight paths of the Champion and the Cessna (Source: Google Earth, with TSB annotations)

At approximately 1446, the 2 aircraft collided while flying over the Ottawa River near Buckham's Bay, approximately 12 NM east-northeast of CNP3 (Figure 1).

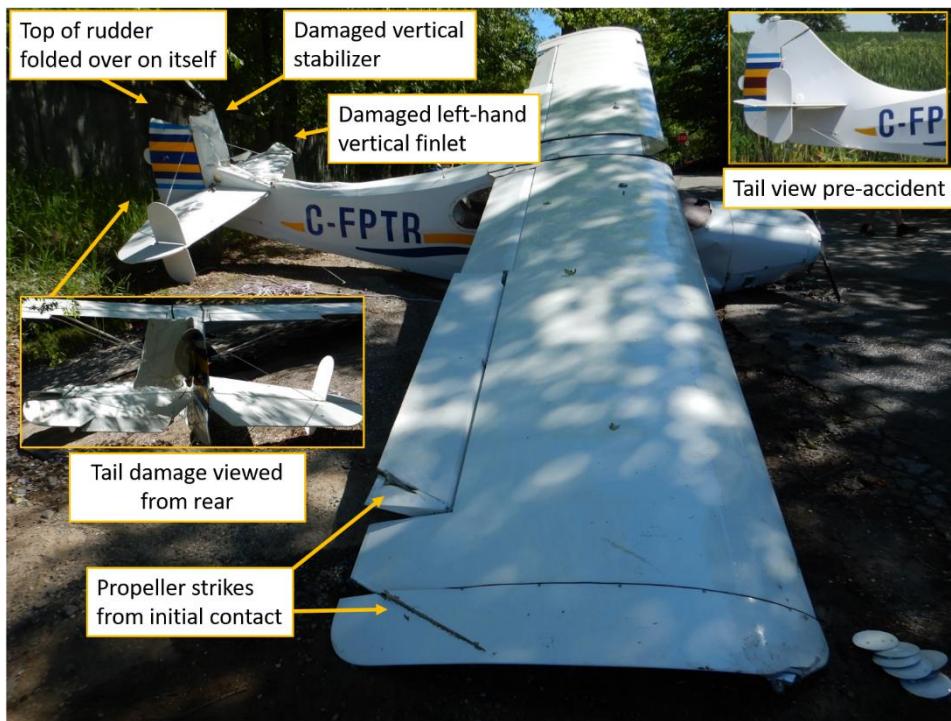
Figure 2. Damage to the Champion (Source of main image and tail damage inset image: TSB. Source of tail view pre-accident inset image: Third party, with permission)

The damage sustained by both aircraft is consistent with the angle of the collision and correlates well with the direction of flight and converging tracks.

During the collision sequence, the Champion sustained 2 propeller strikes on the top of the right wing: one close to the wing tip, along the trailing edge of the wing, and the other on the right aileron. The tail was extensively damaged in the collision (Figure 2). The damage caused the pilot to lose the ability to control the aircraft using the ailerons, horizontal stabilizer or the rudder. He was, however, able to control the pitch of the aircraft using engine power. Increasing the engine power would pitch the nose of the aircraft up, while decreasing it would pitch the nose down.

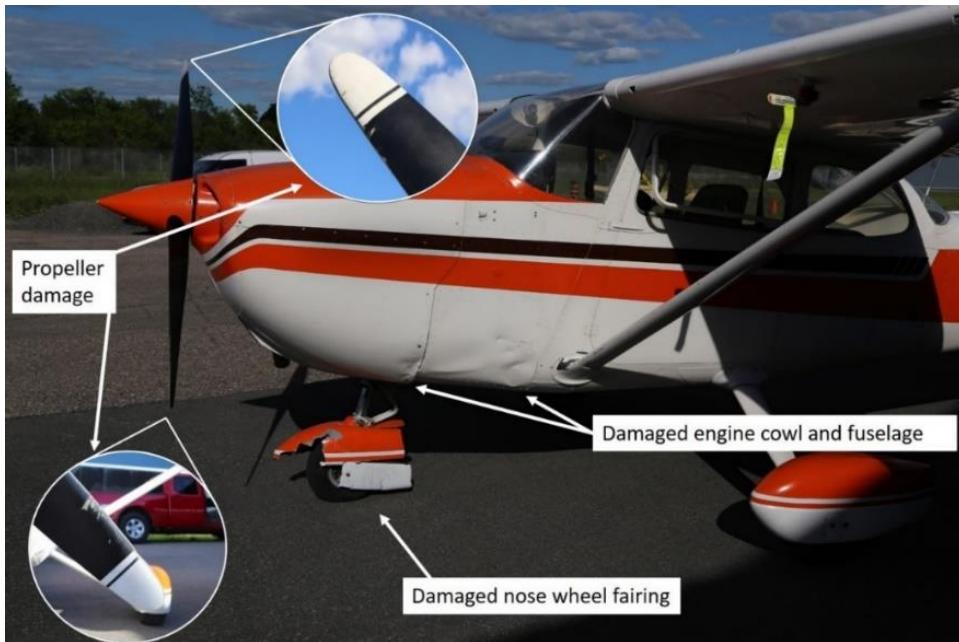
Figure 3. Damage to the Cessna (Source: Ottawa Police Service, with TSB annotations)

The damage to the Cessna consisted of some scraping and paint marks on both propeller blades, a damaged front wheel fairing, and some damage to the left-hand engine cowl and lower left-hand portion of the fuselage immediately aft of the firewall (Figure 3). The damage did not lead to any control issues for the pilot.
