Transportation
Safety Board
of Canada

Air Transportation Safety Investigation Report A20W0046

LOSS OF CONTROL AND COLLISION WITH TERRAIN

Privately registered
Murphy Aircraft Mfg Ltd. SR3500 (Moose), C-GATR
Rolly View, Alberta, 2 NM NE
03 July 2020

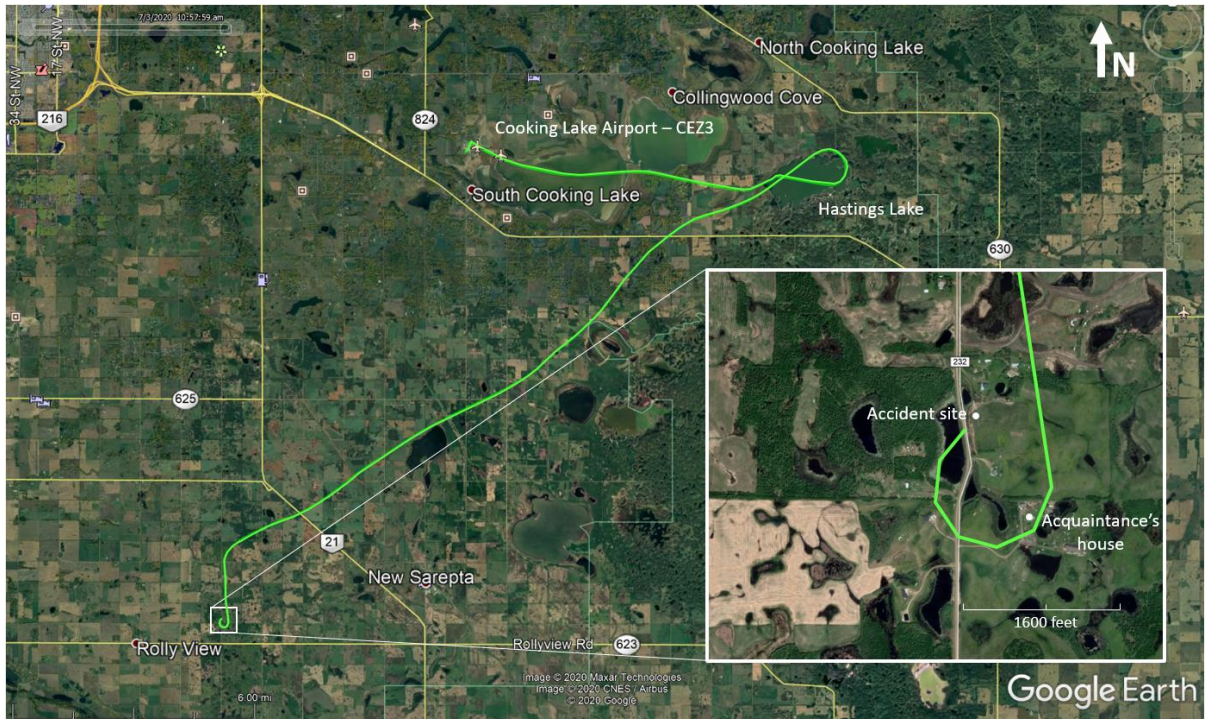
Figure 1. Occurrence flight track, with final turn in inset image (Source: Google Earth, with TSB annotations)

Details of the flight path (Figure 1, main image) were captured by a portable global positioning system (GPS) in the aircraft. After departing Runway 10 at CEZ3 on wheels, the aircraft flew 6 nautical miles (NM) east to Hastings Lake and conducted a water landing at 1045. After the landing, the aircraft departed the lake and conducted a left climbing turn before proceeding toward the town of Rolly View, Alberta.

During the southern arc of the turn, the aircraft's ground speed decreased from 117 mph to 93 mph, while the aircraft's altitude increased to 400 feet AGL. The radius of turn was approximately 600 feet (Figure 1, inset). While in the turn, the aircraft stalled and entered a spin with rotation to the left. At 1057, the aircraft struck terrain in a steep nose-down, left-wing low attitude, in farm pasture near Rolly View, approximately 12 NM east of the Edmonton International Airport (CYEG). The investigation was not able to determine which pilot was at the controls at the time of the accident.

The radius of the turn was determined to be 600 feet. To achieve this radius at a constant altitude, with no slip or skid, at an average TAS of 91 mph, the aircraft would need a 43° bank angle.
