# AIR TRANSPORTATION SAFETY INVESTIGATION REPORT A21P0018

## **LOSS OF CONTROL AND COLLISION WITH TERRAIN**

Airspan Helicopters Ltd.  
Bell 212, C-GNYI  
Bowen Island, British Columbia  
05 March 2021

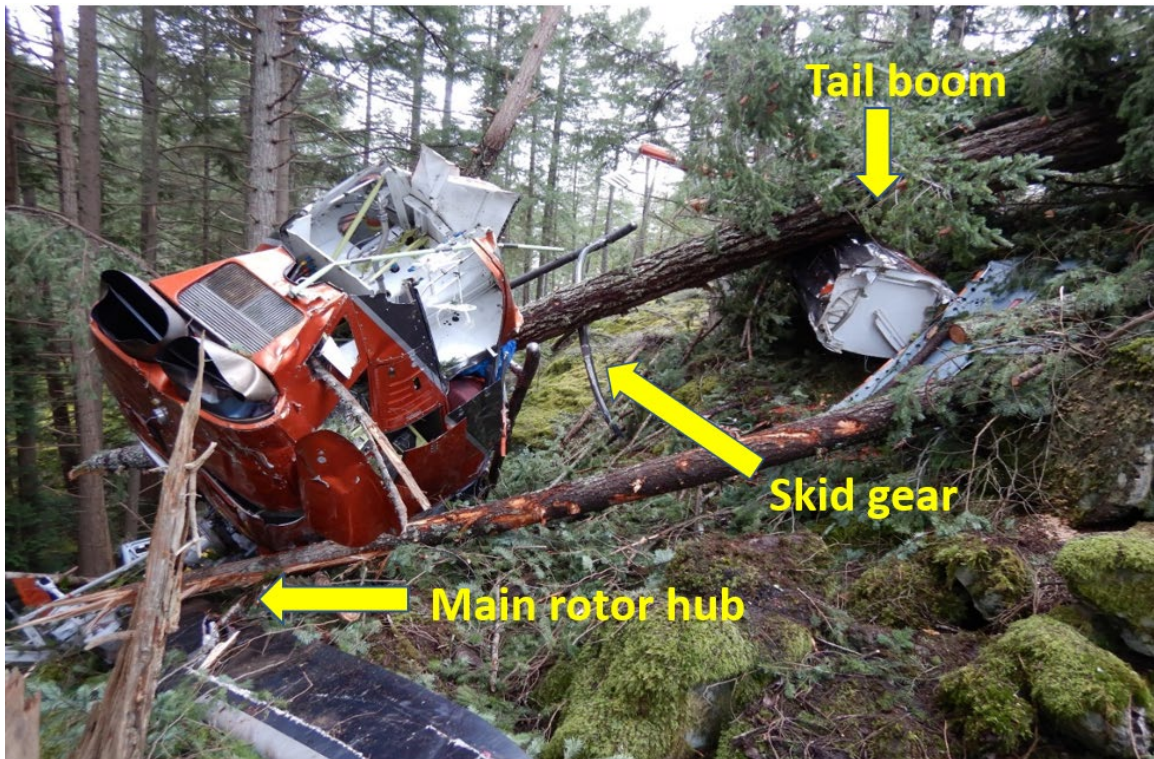
Figure 5. The occurrence helicopter at the accident site (Source: TSB)

The wreckage was located on a rocky outcropping surrounded by a forest of Douglas fir and red cedar trees. The trees adjacent to the site showed some minor damage related to the helicopter's descent and impact. Two trees had been topped and one large fir tree had been uprooted completely, coming to rest on top of the tail boom and the underside of the fuselage (Figure 5).

All of the helicopter debris was located within an 80-foot radius of the fuselage. The fuselage came to rest on its upper left side,  $\frac{3}{4}$  inverted on the roof and with a nose-down attitude. The tail boom was severed at the mounts and sitting uphill from the fuselage, facing the opposite direction. The nose of the helicopter had sustained substantial impact damage, and the left cockpit area was partially crushed. The right horizontal stabilizer was crushed while the left stabilizer had minor damage. The remainder of the fuselage and tail boom remained largely intact with the major components (engines, main transmission, main rotor, and tail rotor) still installed in their normal positions. The skid gear had been partially torn from the fuselage after becoming hooked on a tree during the initial impact.

The main rotor hub was found intact with the 2 main rotor blades still attached. One main rotor blade was missing the outer  $\frac{2}{3}$  with 92 inches of the blade tip embedded in the ground approximately 35 feet northeast of the main rotor mast. The second main rotor blade was largely intact with the leading edge spar in one piece from the blade root to the blade tip.

A deformation on one side of the mast was measured at 0.055 inches deep where the mast had made significant contact with the static stop. The opposite side showed that contact had been made with the other static stop. The mast deformation observed is consistent with a mast bump,<sup>12</sup> which is the result of blade flapping in a low-G condition.

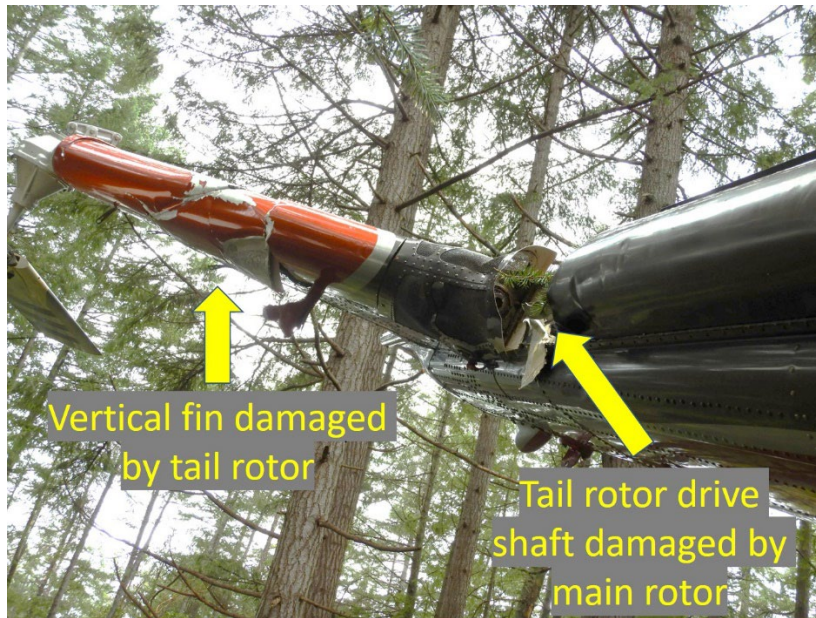
Figure 6. Damaged tail boom (Source: TSB)

The tail rotor was attached to the tail boom and found intact (Figure 6). It was suspended over a cliff without any surrounding obstructions. Investigators observed the following damage indicating that the tail rotor was free-spinning during the flight:

- Both tail rotor blades had damage on the trailing edges near the blade tips.
- The vertical fin had 2 impact marks that were consistent with the impact of the tail rotor blade trailing edges.
- The tail rotor driveshaft cover was severed 15 inches from the aft end and the tail rotor aft driveshaft was severed 15 inches from the aft end. This is consistent with the main rotor blade striking the tail rotor driveshaft.

In this occurrence, the main rotor blades made contact with the tail rotor drive system, disabling the tail rotor driveshaft ahead of the intermediate gearbox and leaving the helicopter with a loss of tail rotor thrust. The missing pieces of the tail rotor driveshaft cover and driveshaft were not recovered.
