AIR TRANSPORTATION SAFETY INVESTIGATION REPORT A21Q0024

COLLISION BETWEEN SLING LOAD AND TAIL ROTOR

Héli-Express Inc.
Airbus AS350 B2 (helicopter), C-GHEX
Les Escoumins, Quebec, 1.5 NM NNE
11 May 2021

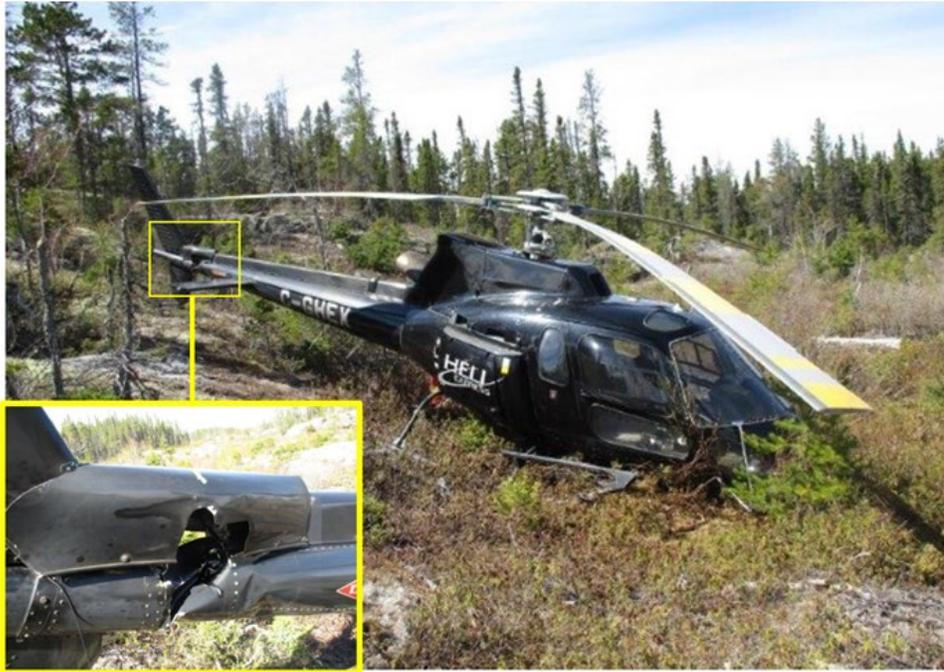
Figure 3. Photo of the wreckage, with inset image showing a magnified view of the damage to the tail (Source: Sûreté du Québec)

The aircraft made a hard landing on rugged terrain with sparse patches of low vegetation. It was found standing on its skids. The landing gear had collapsed and was deformed by the force of the impact (Figure 3).

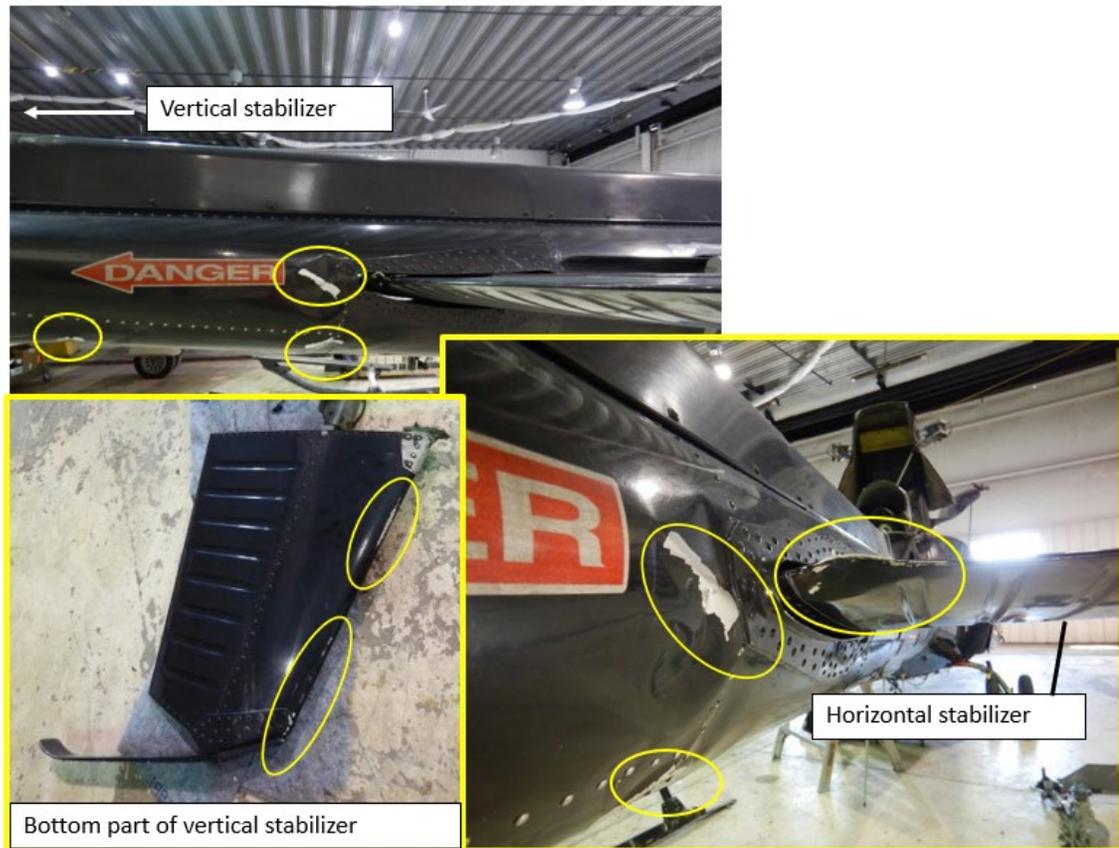
Figure 4. Photos showing the damage to the tail boom and horizontal and vertical stabilizers (Source: TSB)

The tail rotor and gearbox were missing from the end of the tail boom. The right horizontal stabilizer was curved at the trailing edge, near the tail boom, over approximately 4 inches. Also, impact marks and scratches were visible in several locations along the right side of the tail boom, between the horizontal stabilizer and vertical stabilizer, and along the bottom part of the leading edge of the vertical stabilizer (Figure 4).

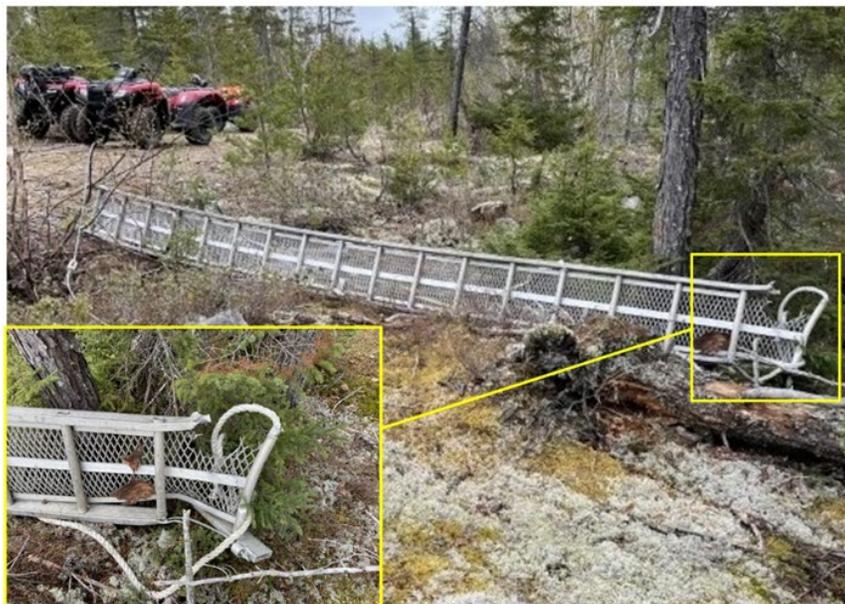
Figure 5. Photo of the damaged platform, with inset image showing magnification of the damaged end (Source: Hélic-Express)

The tail rotor and gearbox were found approximately 70 feet from where the platform fell after it was released by the pilot. The platform was found to be substantially damaged at one end. The lifting straps were still attached (Figure 5).

The platform (model LG18, serial number C17-C15-8-1) had been manufactured in March 2021 in accordance with engineering drawings designed to meet GLR's needs. It was approximately 18 feet long and weighed approximately 121 pounds. The damage to one end was caused by the impact of an object hitting it from underneath.

An analysis of the marks observed on the leading edge of one of the tail rotor blades confirmed that it hit the platform in an upward motion.

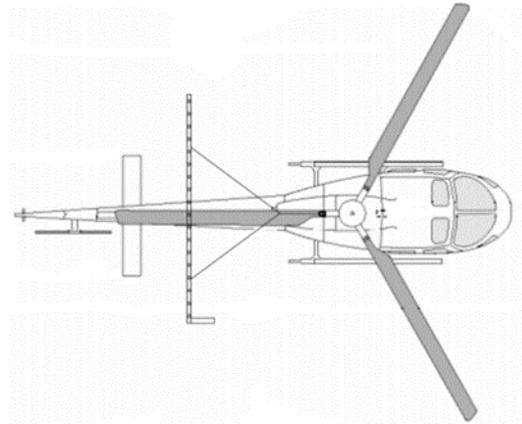
Figure 6. Illustration showing the view from the top of the helicopter with the platform perpendicular to the helicopter's longitudinal axis (not to scale) (Source: TSB)

Figure 6 shows a configuration where the platform is perpendicular to the helicopter's longitudinal axis, with the strap attachment points on the platform perfectly symmetrical. According to calculations, in this configuration, the maximum distance that could be reached by any part of the platform is 128 inches from the cargo hook. The configuration assumes symmetrical drag factors, which was not the case for the occurrence platform. It was found attached asymmetrically (one strap was attached 51 inches from the tip, the other 39 inches from the other tip). Therefore, the symmetrical configuration shown in Figure 6 would not be representative of the typical flight attitude of the occurrence platform.

These 3 configurations assume that the platform is parallel to the horizontal plane, which was not the case in this occurrence. By applying all the factors (drag, helicopter speed, etc.), it was estimated that the closest the platform would have been to horizontal was 24° to the horizontal plane of the helicopter, as it would have been in the first configuration (perpendicular platform, shown in Figure 6).

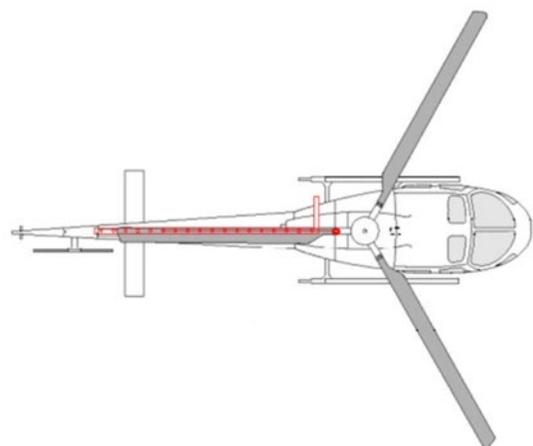
Figure 7. Illustration showing the view from the top of the helicopter with the platform on the helicopter's longitudinal axis (not to scale) (Source: TSB)

Figure 7 shows a configuration where the platform is on the helicopter's longitudinal axis. According to calculations, in this configuration, the maximum distance that could be reached by any part of the platform is 200 inches from the cargo hook. Knowing that the damage was approximately 10 inches from the tip of the platform, the distance between the cargo hook and the damage was estimated to be 190 inches. This configuration is unlikely because it was determined that extreme instability and aerodynamic drag imbalance would have been required for the platform to be in this position. Nevertheless, this configuration was examined, because it represents the theoretical maximum reach of the platform behind the cargo hook.

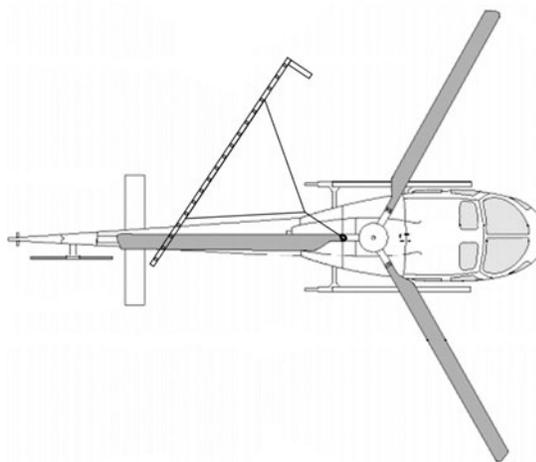
Figure 8. Illustration showing the view from the top of the helicopter with the platform carried at an angle to the helicopter's longitudinal axis (not to scale) (Source: TSB)

Figure 8 shows a configuration where the platform is at an angle (approximately 40° to the tail rotor disk) to the helicopter's longitudinal axis. This configuration is the most probable based on the test carried out in flight before the occurrence. In this configuration, the 2 straps are held taut by the tension of the aerodynamic load. According to calculations, in this configuration, the maximum distance that could be reached by any part of the platform is 170 inches. Knowing that the damage was approximately 10 inches from the tip of the platform, and taking into account the angle, the distance between the cargo hook and the damage was estimated to be 164 inches.

The impact marks on the tail rotor indicate the direction from which the damage was caused. The deformation of the platform clearly shows that the tail rotor struck the underside of the platform at an angle of approximately 40° to the tail rotor's plane of rotation. When the damage is looked at as a whole, for the damage to the platform to be possible, the platform must have been oriented approximately 40° to the direction of flight and offset to the left, which corresponds to the configuration shown in Figure 8.

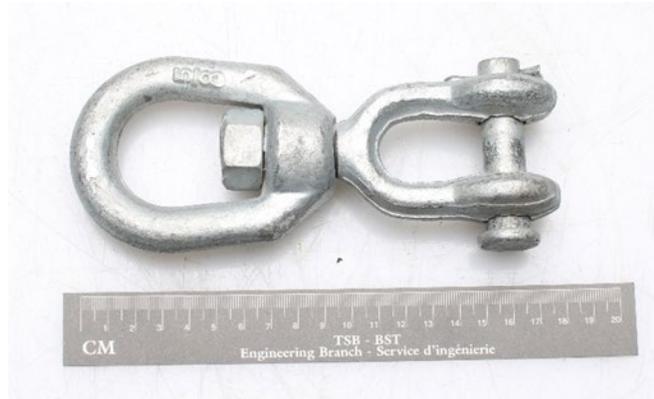
Figure 9. Photo of the Crosby G-403 jaw end swivel used in the occurrence (Source: TSB)

The Crosby G-403 jaw end swivel (Figure 9) used to carry the occurrence platform was designed for cable pulling (to roll out electrical wiring when installing a line above ground or underground, for example), not for lifting a load.⁷ To determine whether this particular swivel allowed the platform to pivot in flight, the TSB laboratory carried out a torque test⁸ on different loads. A load of 82 pounds produced little friction and allowed the swivel to

The platform's tension load while moving in the air at a speed of 65 knots was assessed at 268 pounds. ¹⁰ Given the positioning of the straps found on the platform and the drag experienced by the platform while airborne, an imbalance could be expected. Under these conditions, the torque produced by the aerodynamic forces was from 7.5 to 10 times greater than what was needed to pivot the platform. Consequently, it is highly likely that the platform turned or swung during the occurrence flight.

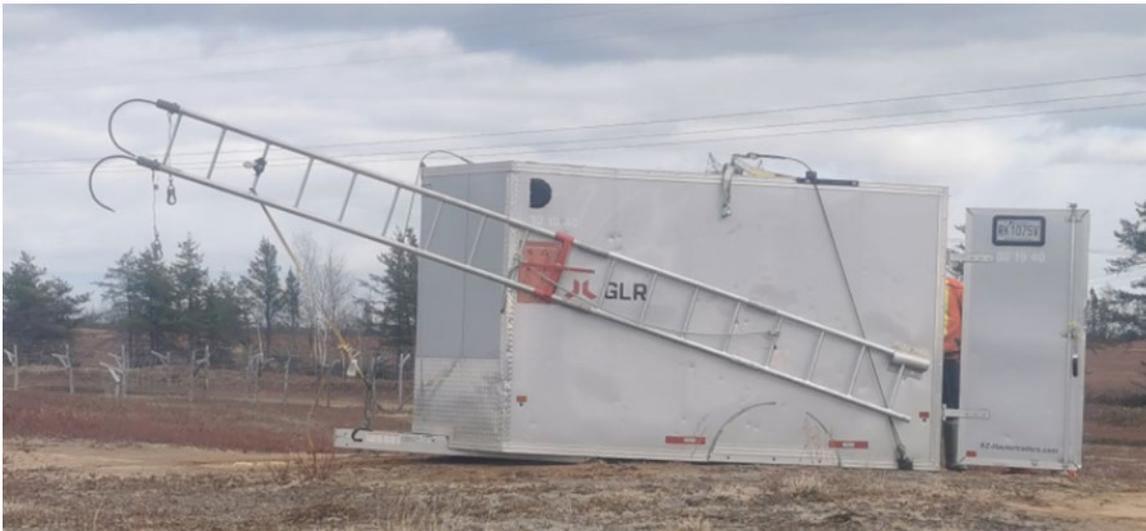
Figure 12. Ladder secured to the side of an equipment trailer (Source: Héli-Express)

Once work began, GLR decided to secure the ladders to the side of equipment trailers to transport them, but the ladders were collapsed and did not extend beyond the trailer. Then, to save time, some workers decided to secure the ladders to the side of the trailers without collapsing them (Figure 12).

The Héli-Express operations manager was later notified of this practice by the occurrence pilot, who felt that this practice was dangerous because the trailer was suspended directly from the cargo hook mounted on the belly of the helicopter. The Héli-Express operations

manager immediately informed the site manager that he did not approve of this method, and said that from now on, ladders needed to be collapsed and stored in the trailers if they were being transported without a sling. GLR, which had adopted this method and deemed it safe and efficient, found this decision frustrating and did not understand the reason for it, especially since the first pilots had accepted it without expressing any particular safety concerns.

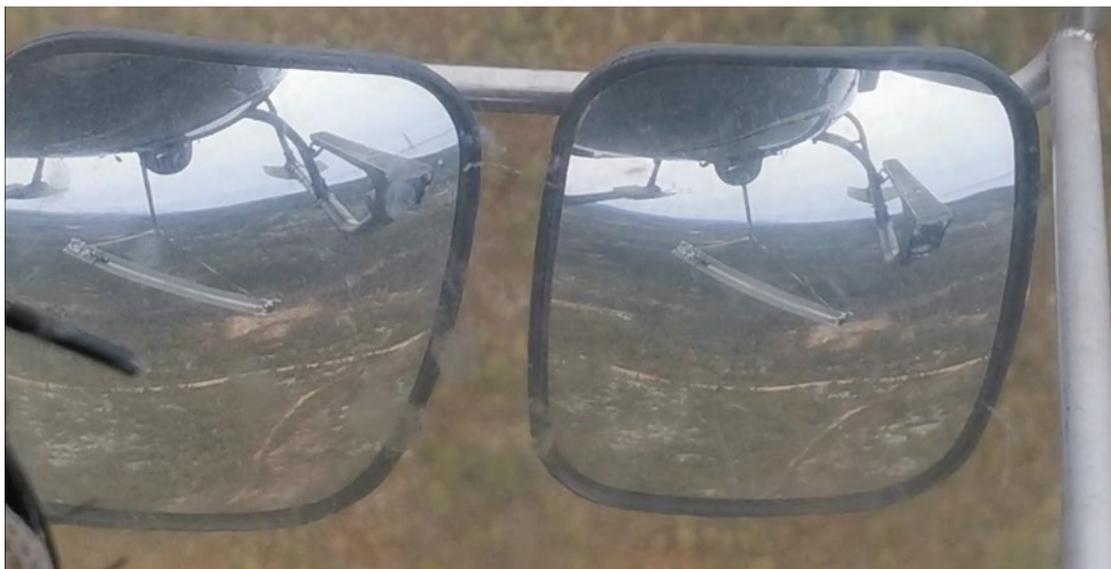
Figure 13. Images reflected in the helicopter's mirrors, showing the position of the platform while being carried horizontally, without a sling, during the test flight (Source: screen shot of a video filmed by the occurrence pilot during the test flight)

Having observed the instability of the platform while it was being transported vertically, the occurrence pilot wanted to find a better way to sling the platform in case the situation happened again. He conducted a test flight, carrying the platform secured horizontally without a sling. He was satisfied with the results of this test. He then contacted Héli-Express's operations manager, informed him of the method chosen to transport a platform or ladder, and sent him a video filmed during the test flight (Figure 13). GLR and the loadmaster were informed of the decision and how the straps should be installed. No concerns were raised.

After this decision, platforms were transported horizontally on at least 2 occasions without incident. Only a slight oscillation was observed on takeoff when the helicopter was carrying a platform, but it was quickly stabilized by increasing speed.
