AIR TRANSPORTATION SAFETY INVESTIGATION REPORT A21Q0097

CONTROLLED FLIGHT INTO TERRAIN

Synergy Aviation Ltd.
Guimbal Cabri G2 (helicopter), C-GSYN
Wachigabau Lake, Quebec
08 October 2021

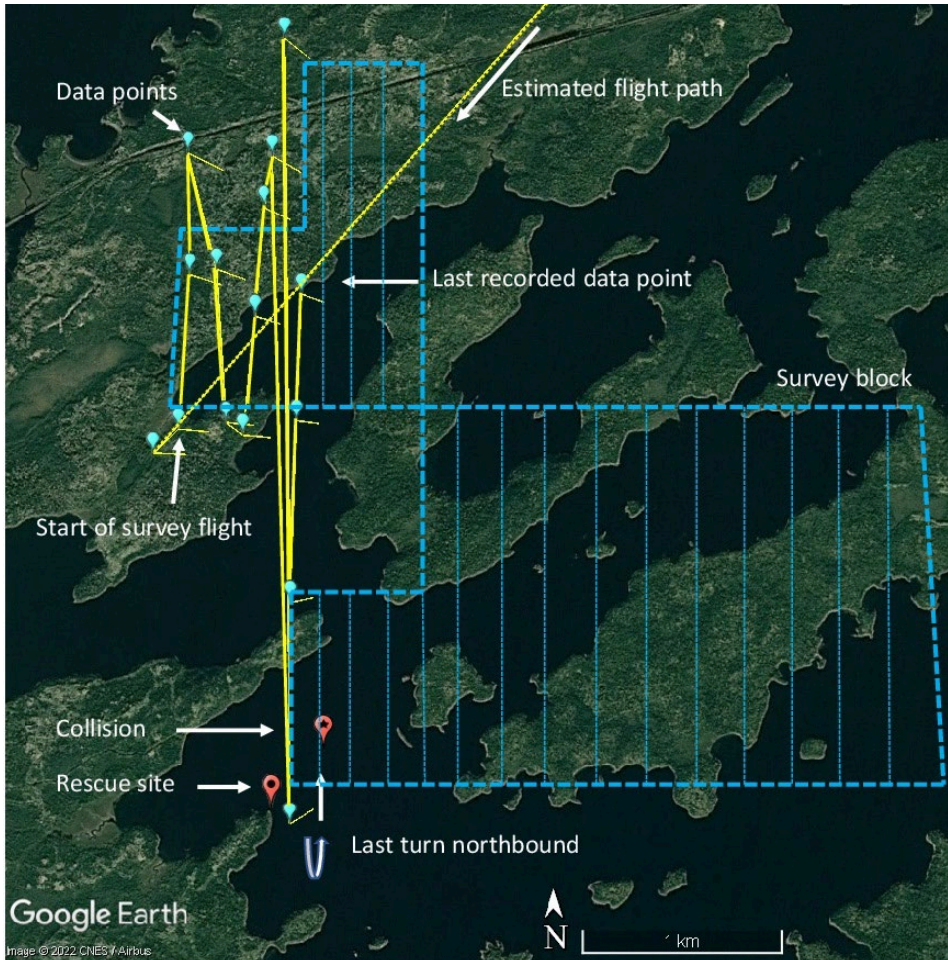
Figure 1. Recorded data points and estimated flight path* (Source: Google Earth and Spidertracks data, with TSB annotations)

* Due to the tight spacing of the survey legs, it is difficult to depict the estimated flight path after the last recorded data point. However, the investigation did confirm that the helicopter kept flying to the southern edge of the block, conducted a turn, and then proceeded northbound.

At 1144, the pilot had completed a left turn over water approximately 1200 feet from the western shoreline and was beginning to fly a northbound leg. The pilot manoeuvred the helicopter to correct the track being flown to ensure proper alignment and lateral spacing on the leg. During this course correction, the helicopter descended, struck the surface of the lake, and overturned. The emergency flotation equipment did not activate, and the float containers did not inflate; the cockpit immediately flooded with water and the helicopter began to sink.⁵ The pilot's PFD automatically inflated underwater while he was still wearing his 4-point lap strap and shoulder harness. Despite the pilot's initial shock and surprise, and even though his mobility was restricted with the inflated PFD, he was able to unbuckle and

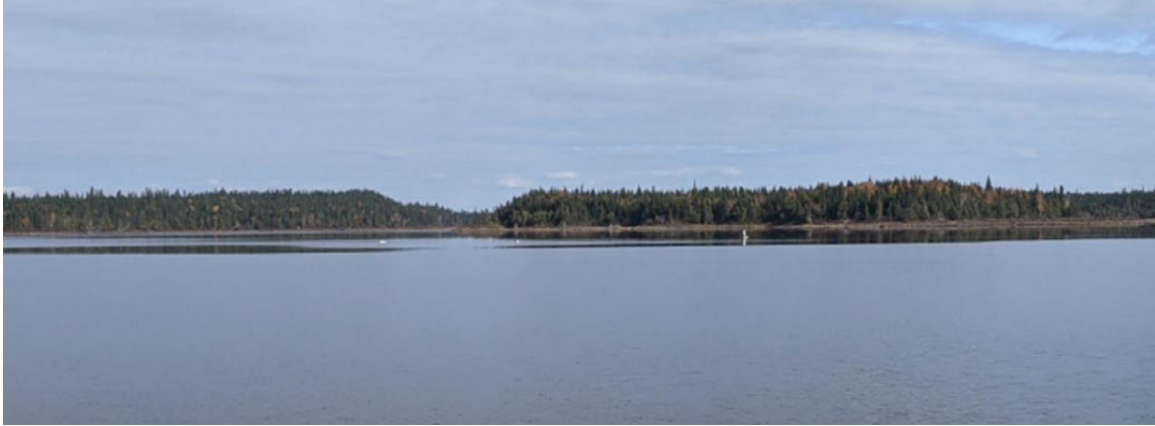
At the time of the occurrence, there was no fog in the vicinity of Wachigabau Lake, the winds were calm, and the visibility was unlimited. Due to the calm winds, glassy water conditions were present. The U.S. Federal Aviation Administration (FAA) provides the following caution with respect to calm wind conditions: “the smooth water surface presents

A photo taken by the occurrence pilot approximately 1 hour after the accident shows clouds, good visibility, and a smooth reflecting water surface with patches of glassy water (Figure 5).

Figure 5. Photo of the crash site from shore, taken at 1243 (Source: Occurrence pilot)

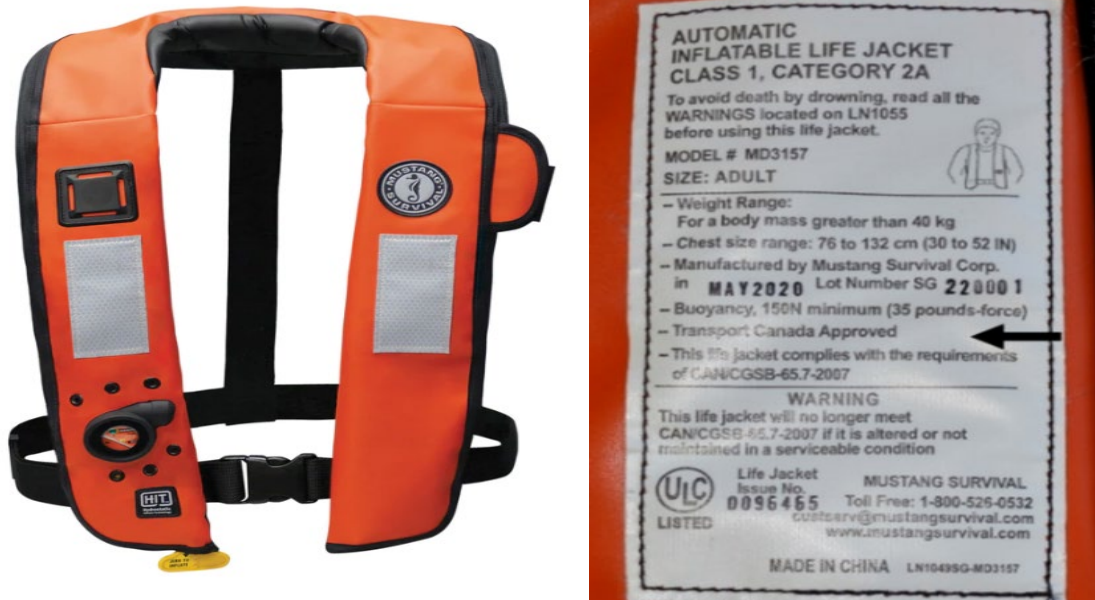
Figure 6. Photo of the type of personal flotation device worn by the occurrence pilot (left) and its identification tag (right) (Source: Mustang Survival, with TSB annotations)

Once it was inflated, the PFD, which was positioned under the shoulder harness, exerted considerable pressure on the pilot's chest, making the shoulder harness feel tighter; the inflated PFD also pushed up against the back of his helmet, pushing his chin down into his chest. Despite the pressure applied by the inflated PFD, the pilot was able to conduct a successful egress.

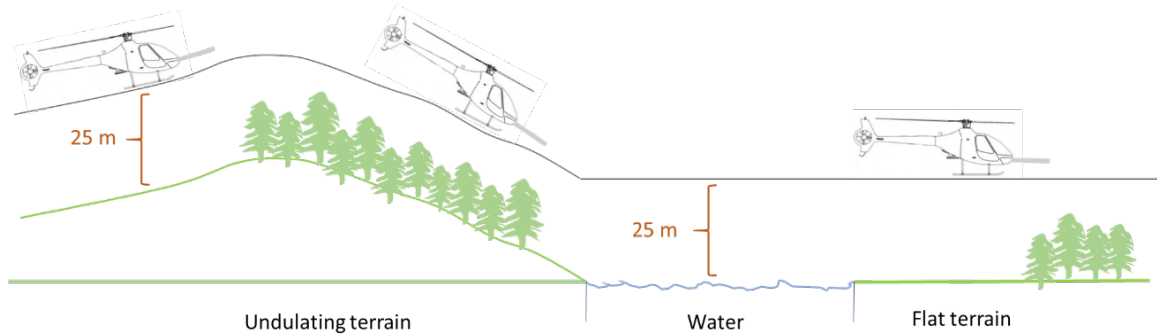
Figure 7. Expected flight profile for contour flying (Source: TSB, with helicopter sketch from Hélicoptères Guimbal, Cabri G2 Flight Manual)

In this occurrence, an example of an accepted unsafe practice was not flying a consistent contour profile over terrain, which resulted in flying below the operational height required for the survey flights.
