# AIR TRANSPORTATION SAFETY INVESTIGATION REPORT A22O0118

## COLLISION WITH OBSTACLE ON TAKEOFF

Privately registered  
Piper Aircraft Corporation PA-28-180 (Cherokee), C-FYSZ  
Canton Aerodrome, Ontario  
13 August 2022

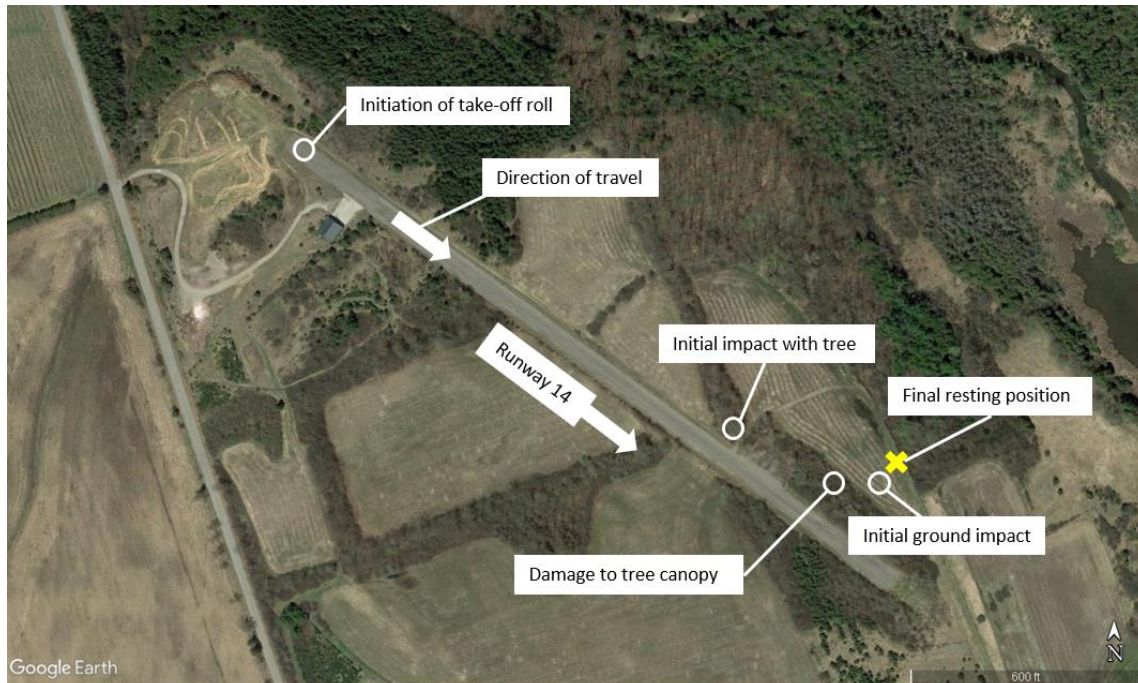
Shortly after becoming airborne, when the aircraft had travelled approximately 1400 feet down the runway and was at a height of approximately 26 feet above ground level, the left wing struck a tree located approximately 40 feet to the left of the runway centreline. Then, the aircraft was seen to veer to the left before disappearing from view. The aircraft then struck multiple additional trees before colliding with terrain,<sup>2</sup> and came to rest approximately 220 feet to the left of the runway centreline (Figure 1).

Figure 1. Map showing the accident sequence (Source: Google Earth, with TSB annotations)

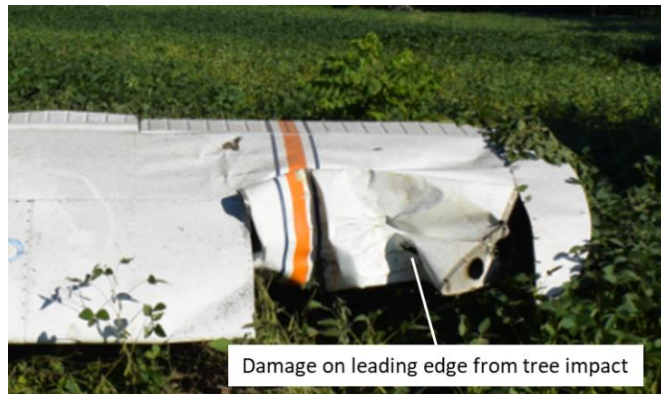
There were signs of tree strikes along both wing leading edges, the most significant of which was on the outboard leading edge of the left wing, approximately 2 feet inboard from the wing tip (Figure 2).

Figure 2. Photo of the damage to the left wing (Source: TSB)
