AIR TRANSPORTATION SAFETY INVESTIGATION REPORT A22P0061

COLLISION WITH TERRAIN

Privately registered
Cessna 172P, C-GGSN
Qualicum Beach Airport, British Columbia
24 July 2022

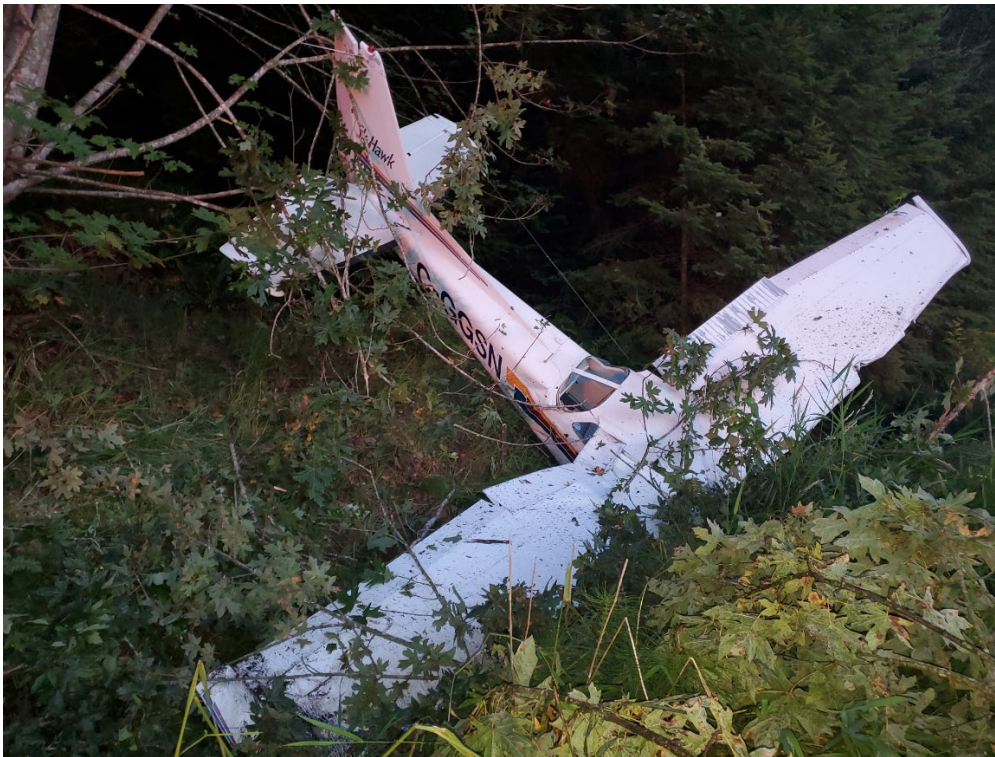
The pilot had been manoeuvring to join the downwind leg for Runway 29, but opted to conduct an emergency landing on Runway 11 and announced his intention on the airport's mandatory frequency. The pilot initiated a left turn, reduced throttle, added full flaps, and entered a forward slip in a steep descent. At 1938:28, the aircraft briefly contacted the surface of Runway 11 beyond Taxiway C (at which point less than 1850 feet of runway remained) and became airborne again. The pilot initiated a go-around and increased the throttle to full power, raised the flaps, and the aircraft entered a climb. Approximately 19 seconds after the initial touchdown, the pilot initiated a steep right turn immediately before reaching tree-covered, down-sloping terrain, and the aircraft began a rapid descent in a right bank and nose-down attitude. The pilot declared a MAYDAY on the airport's mandatory frequency and the aircraft impacted terrain in the trees along the edge of a farmer's field (Figure 1).

Figure 1. Accident site, approximately 1880 feet east-southeast of the end of Runway 11 (Source: Parksville Fire Department)

The aircraft initially contacted trees at approximately 22 feet AGL. It came to rest on the sloped bank on a west-southwest heading, at a 62° nose-down attitude in a water-filled ditch that was approximately 12 to 24 inches deep.

The forward fuselage was significantly deformed from the impact and 3 of the 4 engine mounts were severed. The remainder of the aircraft was largely intact; however, the right-wing strut had separated from the fuselage and the right landing gear had rotated 180°. Both wing flaps were found retracted. The propeller was embedded in the ditch with 1 blade significantly bent aft and no damage to the second blade. This type of damage is consistent with the engine producing low power or not operating on impact. Continuity of the flight and engine controls was confirmed.

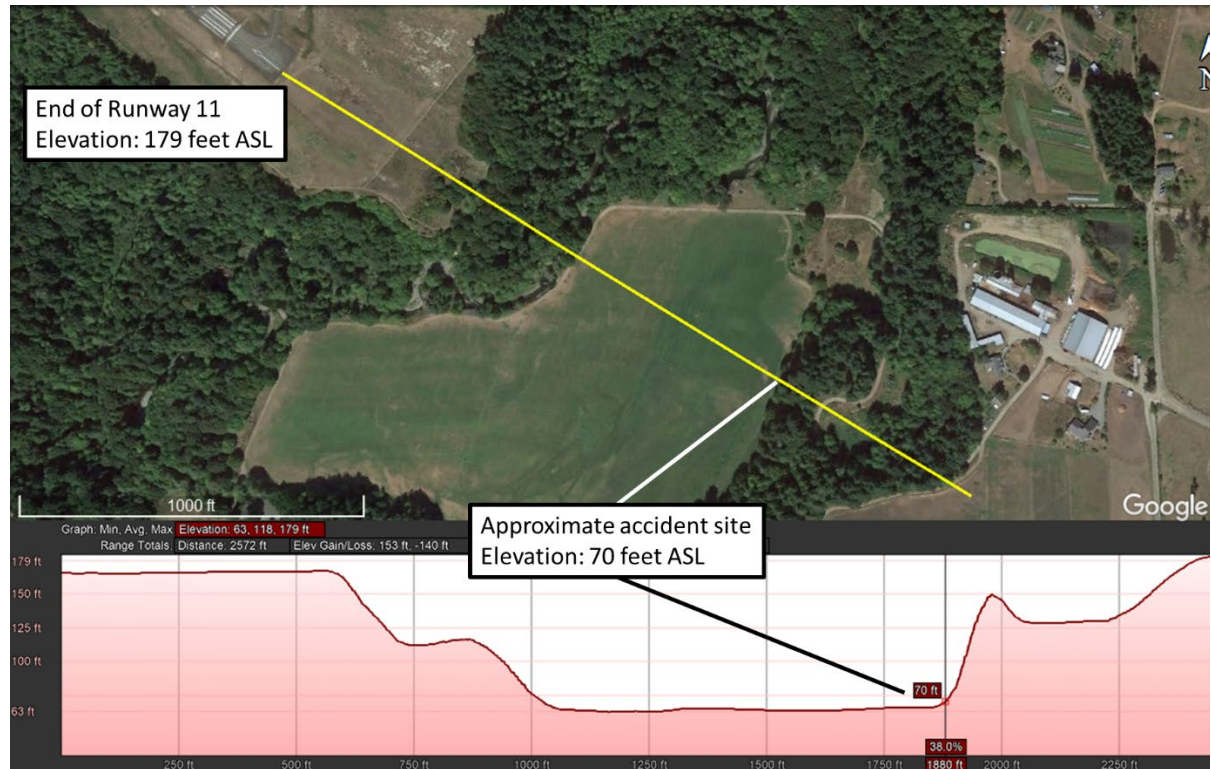
The aircraft was found approximately 1880 feet from the end of Runway 11, at the edge of a privately owned farmer's field that is approximately 100 feet below the runway elevation (Figure 2).

Figure 2. Map showing the approximate accident site and elevation profile between the end of the runway and the field (Source: Google Earth, with TSB annotations)

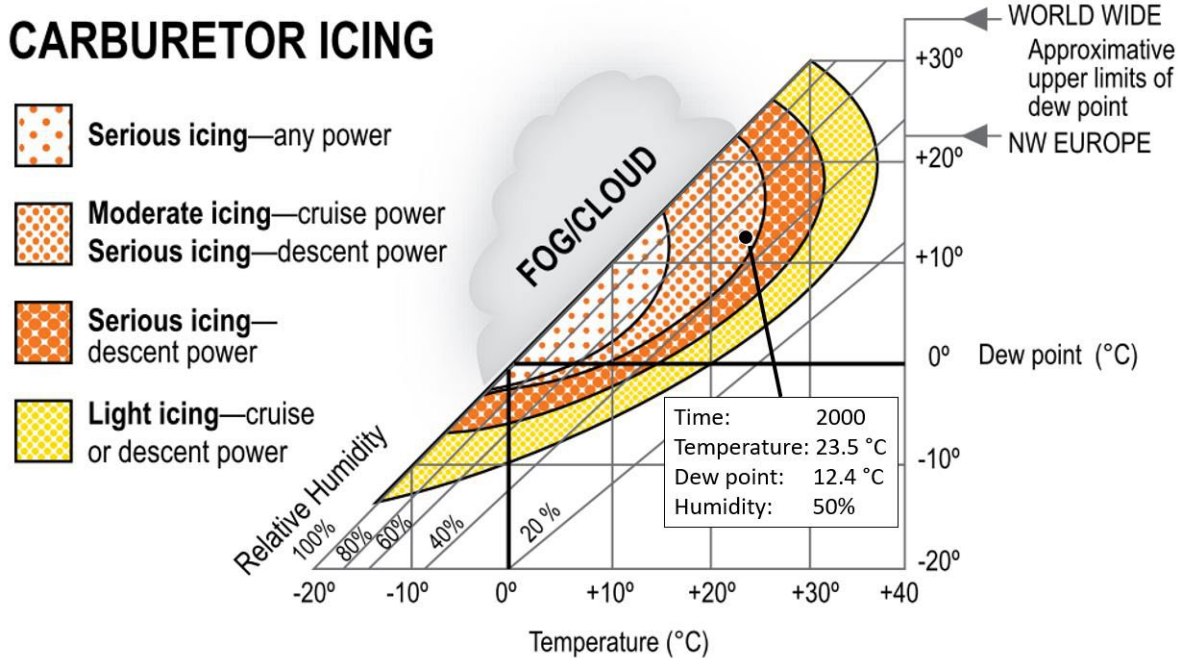
The *Transport Canada Aeronautical Information Manual* provides guidance material and a reference chart for weather conditions that can induce carburetor icing (Figure 3). The formation of carburetor ice can occur at all engine power settings and can vary with specific engine installations.

Based on the weather conditions recorded closest to the time of the occurrence at CAT4, carburetor icing was charted as moderate icing during cruise power and serious icing during descent power.

Figure 3. Chart providing weather conditions that can induce carburetor icing based on temperature, dew point, and humidity with the CAT4 weather conditions plotted (Source: Transport Canada, TP 14371E, Transport Canada Aeronautical Information Manual (TC AIM), AIR – Airmanship (24 March 2022), section 2.3, figure 2.2, with TSB annotations)

Based on the conditions at the time of the occurrence, there was a potential for serious carburetor icing at descent power. Even though the investigation was unable to determine if carburetor icing was a factor in this occurrence, pilots are reminded that carburetor icing can occur even in warm temperatures. Pilots should follow the guidance in their aircraft's POH with respect to the application of carburetor heat.
