# AIR TRANSPORTATION SAFETY INVESTIGATION REPORT A22Q0126

## COLLISION WITH TERRAIN

Collège d'enseignement général et professionnel de Chicoutimi  
Beech Aircraft Corporation C23 Sundowner, C-GBQI  
Chicoutimi/St-Honoré Airport, Quebec  
21 October 2022

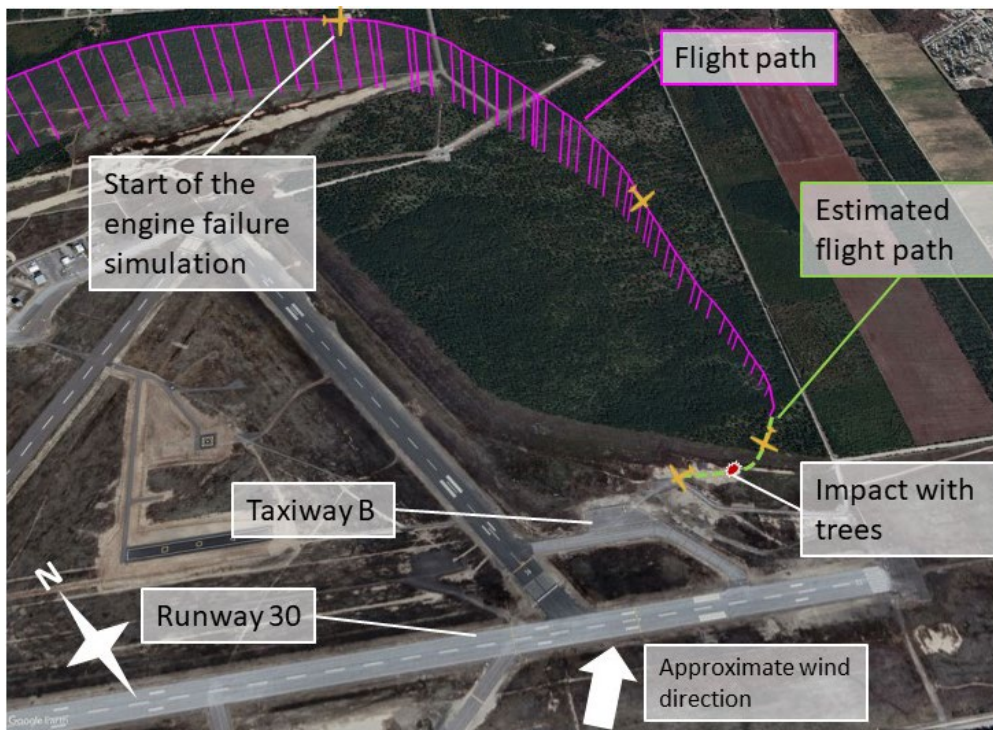
As the aircraft was heading towards Taxiway B, it became evident to the student pilot and the instructor that they were not going to reach the intended landing point. The aiming point was then altered to a cleared gravel area short of Taxiway B. At approximately 1022, the aircraft's right wing contacted small trees and the aircraft collided with terrain in the cleared gravel area (Figure 2). At no point during this simulated-engine-failure exercise was an overshoot initiated by either the student pilot or the CFI.

**Figure 2. Flight track from the start of the simulated engine failure to the point of impact**  
(Source: Google Earth, with TSB annotations)

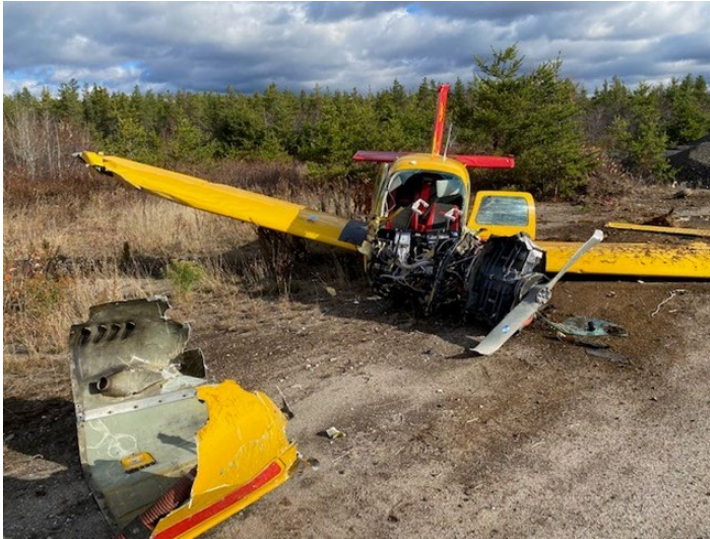
The aircraft came to a rest in a gravel area to the east of Taxiway B. It sustained substantial damage to its nose, wings, and gear (Figure 3). The cockpit survivable space remained intact, and the cockpit doors were useable.

Figure 3. Aircraft wreckage (Source: Third party, with permission)

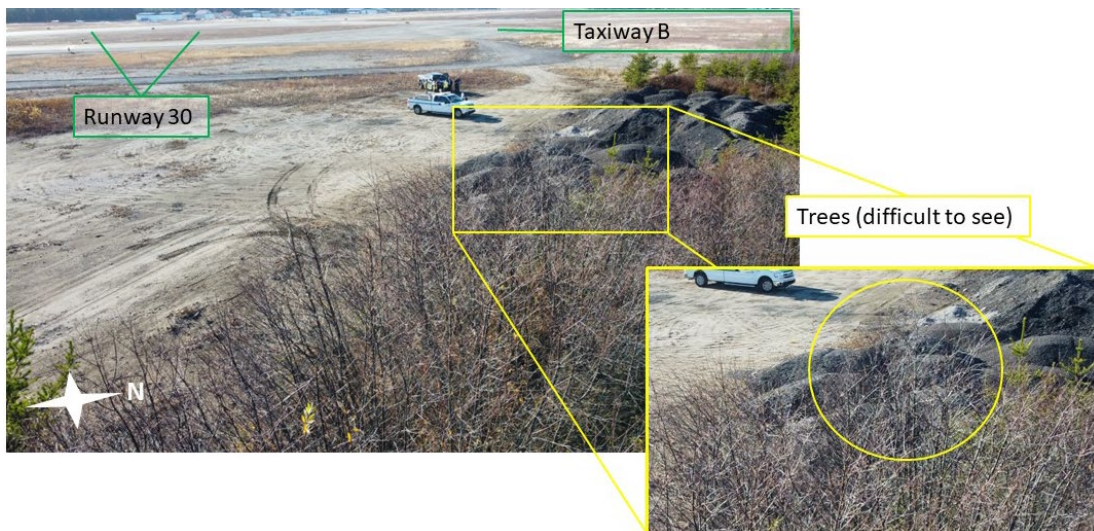
The trees that the aircraft contacted were approximately 20 feet tall and had previously lost their leaves, which made them difficult to see because there was little contrast with the surrounding gravel area (Figure 4).

Figure 4. Area of collision with trees, with a close-up view in inset, showing the lack of contrast between the trees and the background (Source: TSB)

- a policy that sets a minimum altitude of 200 feet AGL for simulated engine failure exercises, unless the approach and landing is to a runway;
- a standard overshoot call; and
- a ban on conducting circuits at 500 feet AGL.
