AIR TRANSPORTATION SAFETY INVESTIGATION REPORT A22C0035

COLLISION WITH OBSTACLE ON APPROACH

Sandy Lake Seaplane Service Ltd.
Cessna U206G, C-GBGJ
Sandy Lake First Nation, Ontario
26 May 2022

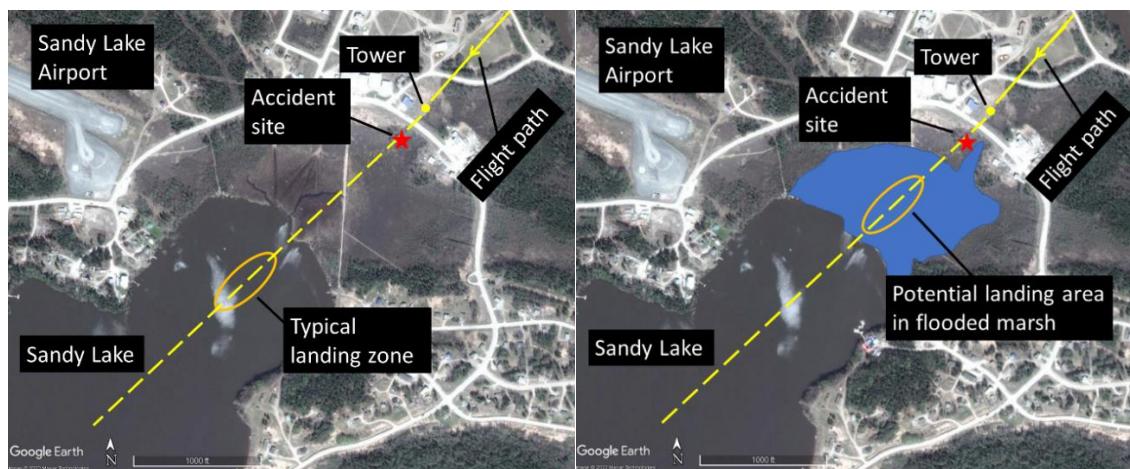
At the time of the occurrence, Sandy Lake had a higher-than-normal water level caused by a greater-than-normal snow melt and a rainy spring. As a result, what is normally a marshy area northeast of the landing area was fully submerged in water (Figure 1). The normal elevation of the lake is 901 feet above sea level (ASL).

Figure 1. Map showing the accident area with normal water levels (left) and water levels on the day of the occurrence (right) (Source: Google Earth, with TSB annotations)

A southwest-bound approach to the typical landing zone at CKE5 requires an aircraft to be flown at a slope angle of greater than 4° to avoid the tower. This equates to a height reduction of 70 feet per 1000 feet travelled horizontally. Should the target landing area be moved 1200 feet further northeast, into the flooded marsh area, an approach flown with a 4° slope would be 84 feet lower than normal when passing the tower.

It is important for pilots to remember that a change in a familiar approach environment can cause obstacles that are not normally an issue to become a factor during landing. Therefore, pilots must remain vigilant when selecting a landing area to ensure a safe distance is maintained from obstacles.
