AIR TRANSPORTATION SAFETY INVESTIGATION REPORT A22C0058

COLLISION WITH TERRAIN

Pembina Air 1999 Ltd.
Rockwell International, Commander Aircraft Division S-2R, C-GOKD
Treherne (South Norfolk Airpark) Aerodrome, Manitoba, 12 NM NE
02 August 2022

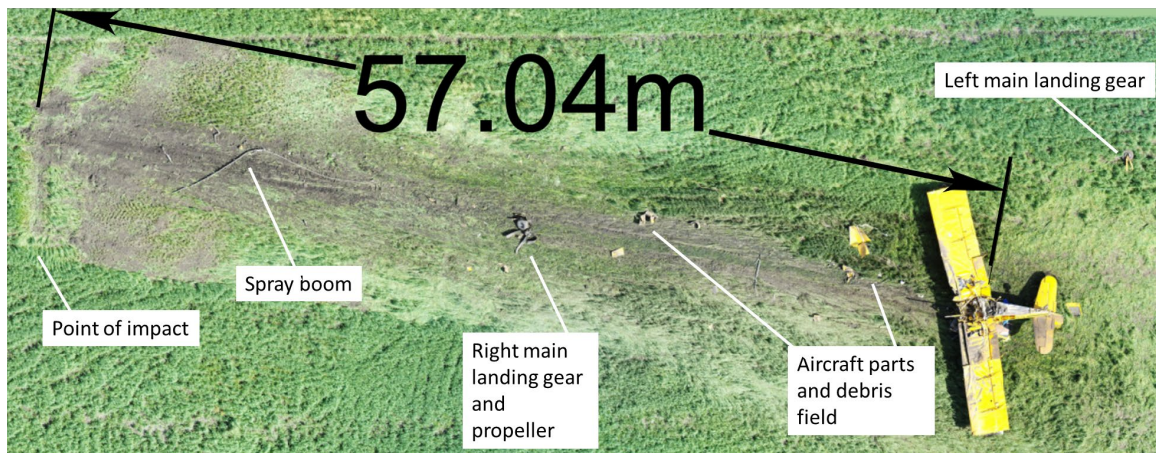
The aircraft collided with soft, level terrain at 49°46'14.80" N, 098°23'58.98" W in a shallow right-wing-low attitude on an easterly heading. Impact marks indicated the wings, landing gear, and propeller contacted the terrain. The aircraft bounced and continued to slide for 57.04 m (Figure 2) before coming to rest with the cockpit, fuselage, and empennage becoming inverted on top of the hopper and engine assembly.

Figure 2. Photo of the wreckage trail (Source: RCMP, with TSB annotations)

All components of the aircraft were present at the accident site. TSB investigators observed signs of fuel spillage and engine rotation at the time of impact. The wreckage trail consisted of the spray boom, propeller, right main landing gear assembly, pieces of cowling, and pieces of fibreglass material. There was no fire. Flight control continuity was verified. There were no signs of a bird strike or wire strike.

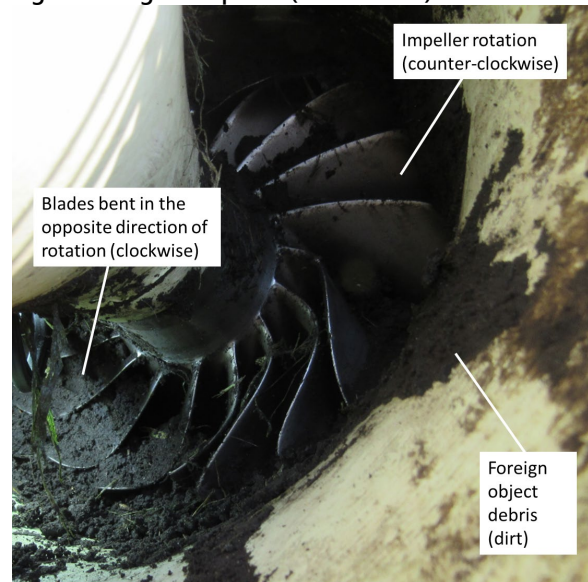
TSB investigators conducted an engine inspection, which revealed that the engine was producing power at the time of impact. The starter generator was removed and the starter generator input shaft was found to be sheared in overload. A visual inspection of the engine inlet revealed that the first stage impeller blades were bent in the opposite direction of rotation (Figure 3). The engine was subsequently sent to Honeywell in Phoenix, Arizona, United States, for an engine teardown inspection, which was attended by a TSB investigator. The inspection confirmed that the engine was producing power at the time of the accident and there were no pre-impact failures.

Figure 3. Engine impeller (Source: TSB)
