# AIR TRANSPORTATION SAFETY INVESTIGATION REPORT A22O0032

## COLLISION WITH OBSTACLE ON APPROACH

Brantford Flying Club  
Cessna 172RG, C-GOFD  
Brantford Aerodrome, Ontario  
21 March 2022

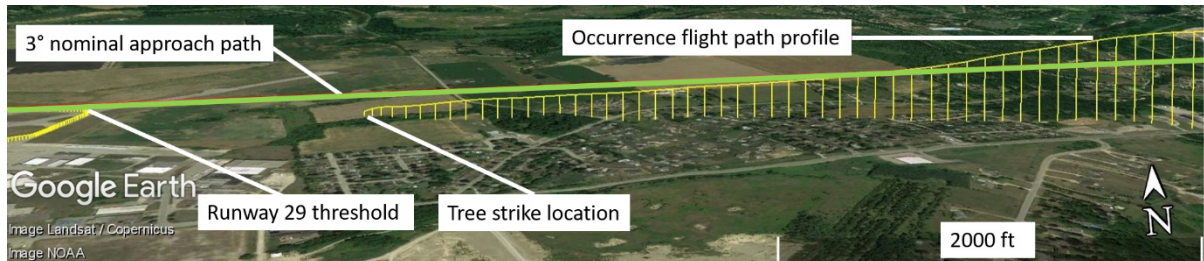
The occurrence pilot turned onto the final approach track approximately 1.4 nautical miles (NM) from the touchdown zone for Runway 29. At this point, the aircraft was slightly above the 3° (nominal) approach path. However, at 1.2 NM from the touchdown zone, the aircraft had drifted below the nominal approach path, and after a short period of parallelling it, the aircraft continued to descend further below it (Figure 1).

**Figure 1. Occurrence flight's approach path profile with the nominal 3° approach path (Source: Google Earth, with TSB annotations)**

At 1716, while the aircraft had a ground speed of approximately 63 knots<sup>3</sup> and was well below the nominal approach path, the left wing struck a tree approximately 70 feet above ground level. Due to the tree strike, the aircraft yawed significantly to the left, pitched up, and spun around before crashing in a field approximately 200 feet past the tree-strike location, and 1920 feet short of the threshold of Runway 29.

Flying an approach using a low flap setting can result in reduced forward visibility and decreased ability to identify obstacles should the aircraft drift below the intended approach path. Pilots are reminded to use flap settings and approach profiles appropriate to the situation and their type of operation.
