AIR TRANSPORTATION SAFETY INVESTIGATION REPORT A22P0057

COLLISION WITH TERRAIN

Tyax Air Service Limited
de Havilland DHC-2 MK. I (Beaver), C-GIYV
Pemberton Aerodrome, British Columbia, 52 NM NNW
17 July 2022

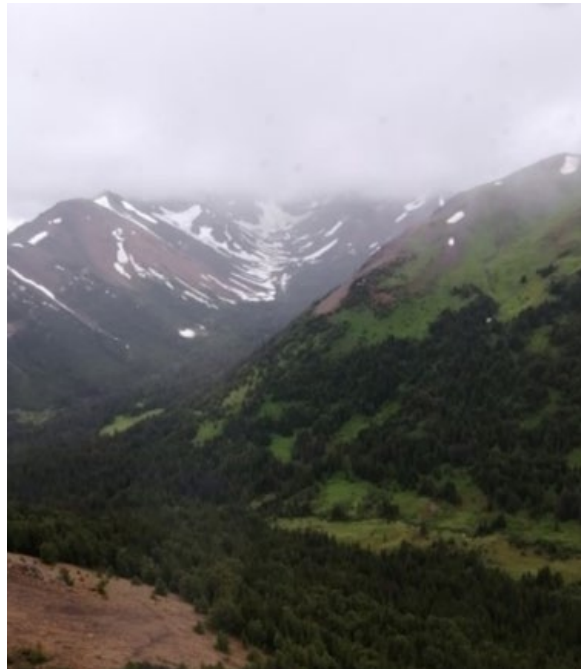
Figure 1. The valley, as observed during the occurrence flight (Source: Third party, with permission)

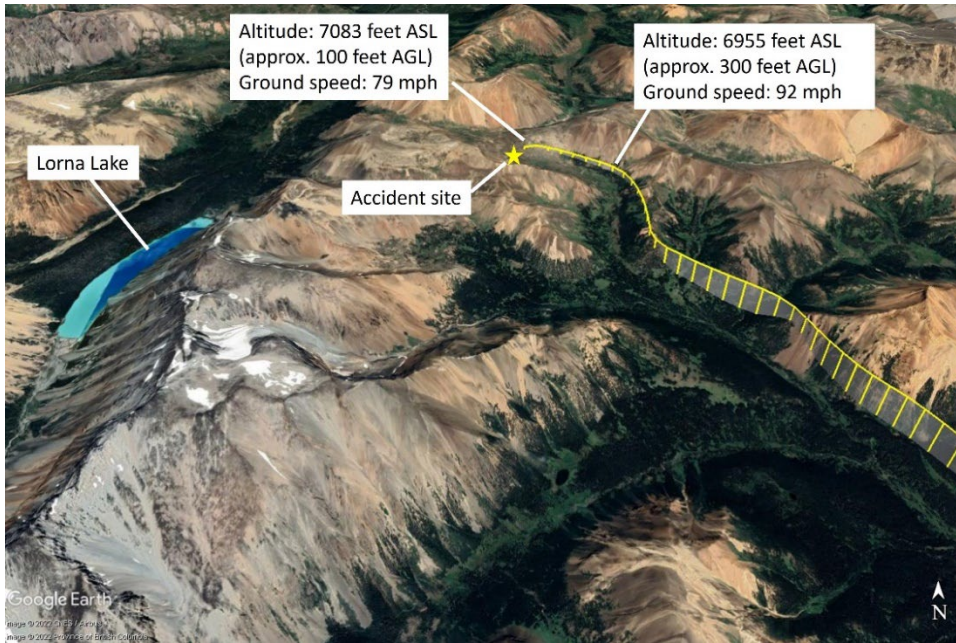
The pilot banked the aircraft to the left. During the left turn, the aircraft's airspeed decreased (Figure 2). The pilot applied full power, the stall warning horn sounded,³ and a few seconds later, at 1041, the aircraft collided with the down-sloping terrain.

Figure 2. Map showing the recorded flight track to the accident site (Source: Google Earth, with TSB annotations)

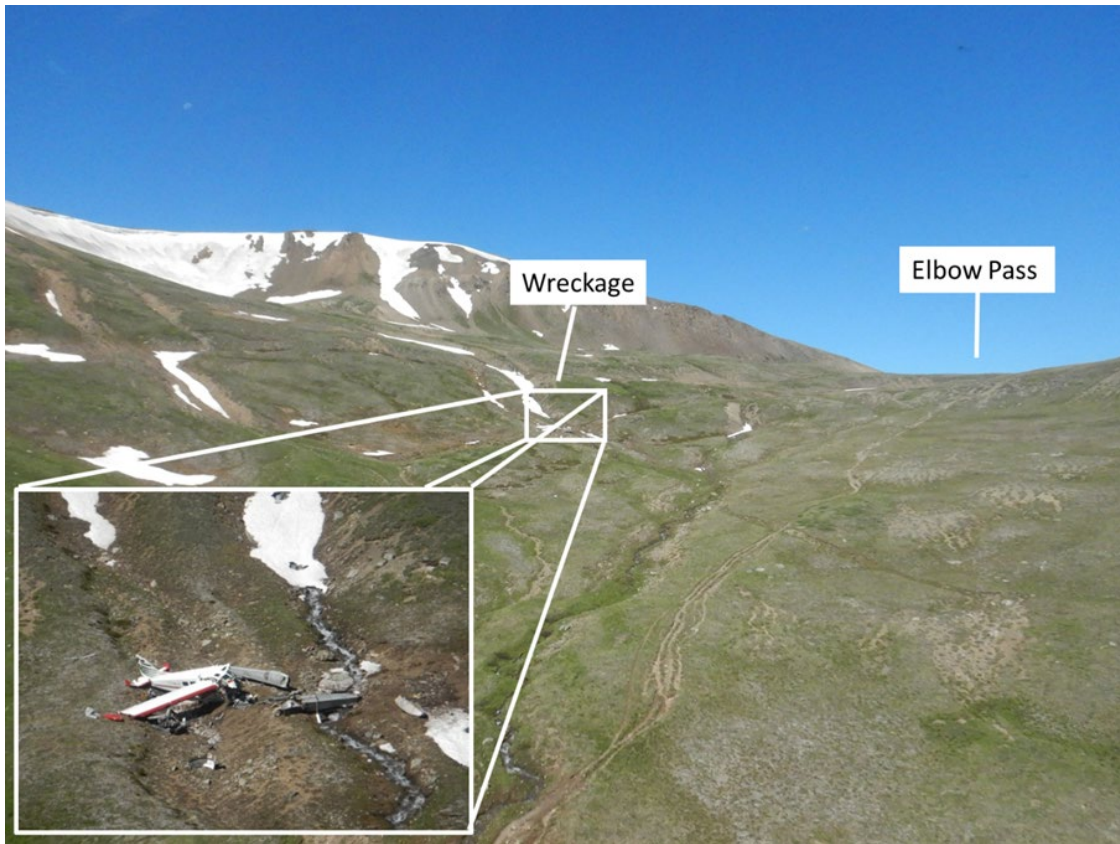
During the collision, the left float struck the ground first, then the aircraft pitched nose down and turned 180° to the left, coming to rest facing the opposite direction of travel, approximately 126 feet from the initial point of impact. Propeller ground scars were visible near the initial impact point. The ground scars and damage to the propellers were consistent with the engine producing power at the time of impact. The floats, left wing, and engine separated from the fuselage (Figure 4).

Figure 4. Photo of the accident site taken from a helicopter flying in the same direction as the occurrence flight, with a close-up of the wreckage in inset (Source of both the main image and inset image: TSB)

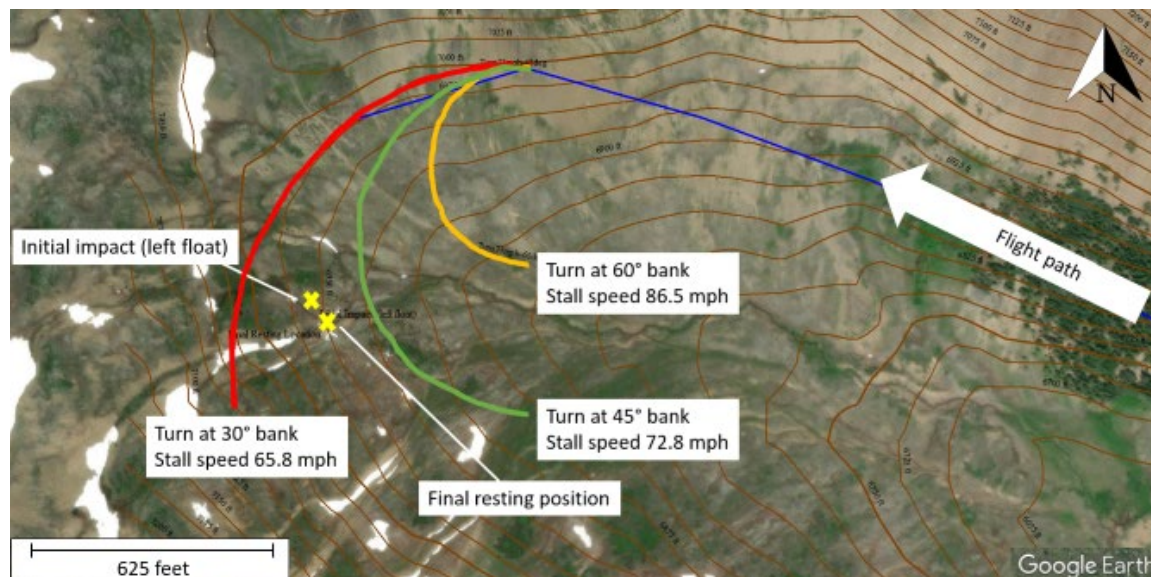
Figure 5. Three flight path scenarios, including 1 successful course reversal (at 45° angle of bank), based on turns conducted with bank angles of 30°, 45°, and 60° and at an airspeed of 73.2 mph (Source: Google Earth, with TSB annotations)

The occurrence aircraft was not equipped with a flight data recorder and, therefore, the aircraft's actual angle of bank and airspeed during the course-reversal turn were unavailable.

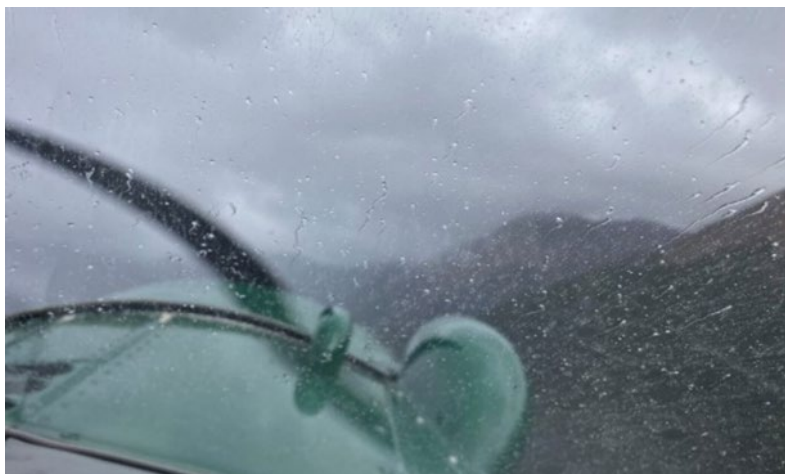
Depending on their size and density, water droplets carried by the relative airflow across windscreens of aircraft unequipped with wiper systems, such as the occurrence aircraft, may obscure the pilot's forward view (Figure 6). This obscured view prompts the pilot's need to visually process windscreen

Figure 6. Rain on windscreen during occurrence flight (Source: Third party, with permission)

contamination to see beyond it and complicates the task of estimating the aircraft's height above ground and distance from cloud. The visual processing of the windscreen contamination requires the use of cognitive resources and adds to the time required for effective aircraft handling and timely decision making while manoeuvring in confined areas.

While entering the valley leading into Elbow Pass, the aircraft was operating in VFR conditions below an overcast layer of cloud and in precipitation. Photographs taken on the day of the occurrence show precipitation on the aircraft windscreen.
