AIR TRANSPORTATION SAFETY INVESTIGATION REPORT A23O0155

RUNWAY EXCURSION

Thunder Airlines Limited
Mitsubishi MU-2B-60, C-GYUA
Wawa Aerodrome (CYXZ), Ontario
27 November 2023

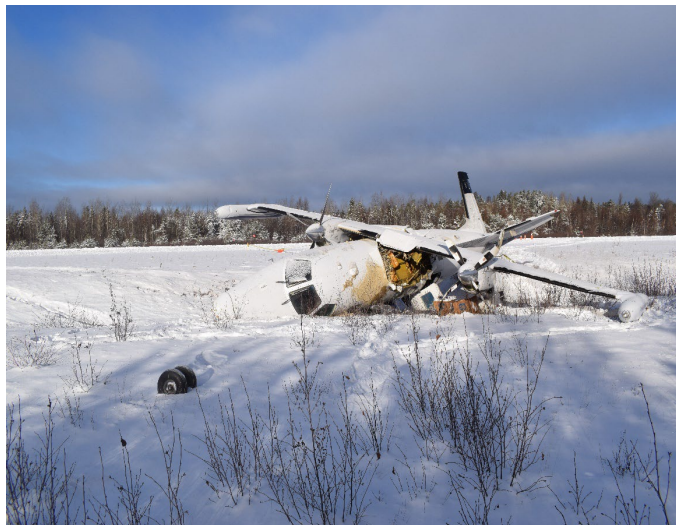
Figure 1. Accident site (Source: TSB)

After leaving the runway surface, the aircraft continued to slide for another 171 feet before coming to rest in a drainage ditch, about 78 feet from the runway edge, and approximately 1600 feet from the threshold of Runway 03.

During the impact with the drainage ditch, the aircraft's nosewheel was torn off and the aircraft rolled over onto its left side, causing the one-piece wing to be lifted upwards. The wing detached from the fuselage but rested on top of it (Figure 1).

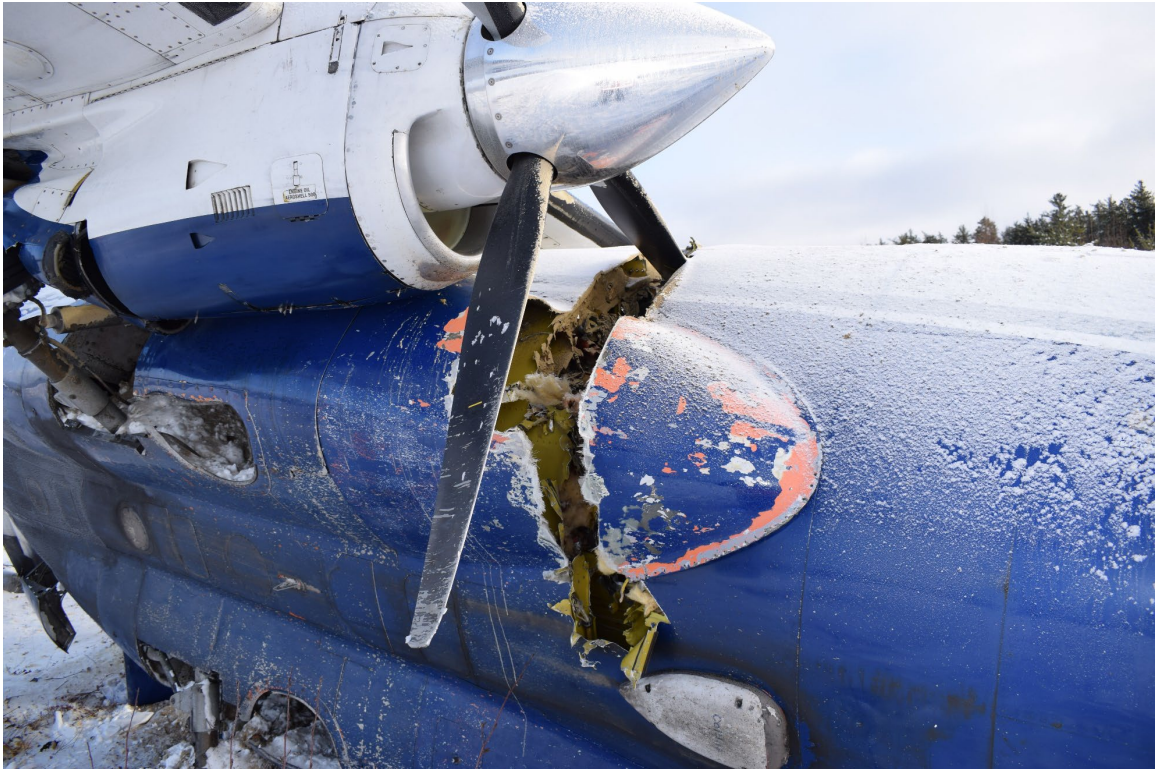
Figure 2. Damage to the fuselage (Source: TSB)

The emergency exit on the right side of the fuselage was damaged and blocked by the wing. The outboard ends of the right engine propeller blades penetrated the fuselage by about 18 inches, cutting an extensive gap into the fuselage (Figure 2).
