AIR TRANSPORTATION SAFETY INVESTIGATION REPORT A23P0061

COLLISION WITH TERRAIN

Privately registered
Quest Kodiak 100, C-GKTX
Tofino/Long Beach Airport, British Columbia, 60 NM NW
20 June 2023

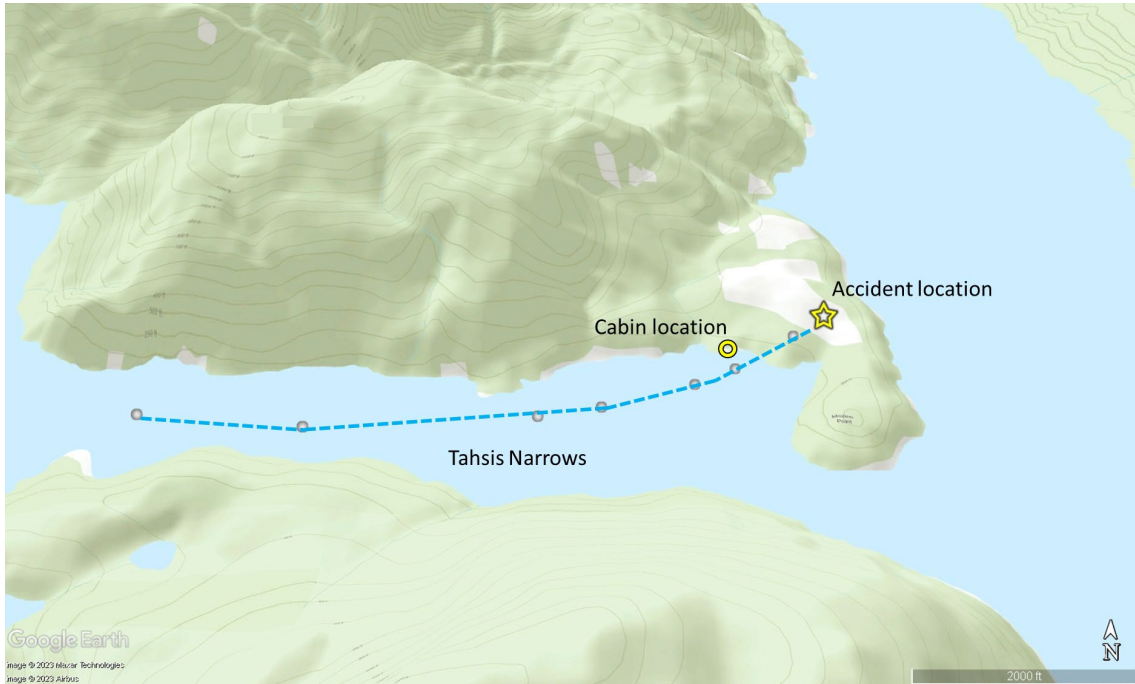
The aircraft followed an inlet (Tahsis Narrows) toward the destination and continued for a straight-in landing on the water, near the cabin (Figure 1).

Figure 1. Map showing the aircraft track, with cabin and accident locations (Source: Google Earth, with TSB annotations)

On initial touchdown, both floats touched the surface of the water simultaneously. The aircraft bounced and, as the aircraft approached the surface of the landing area the 2nd time in a level attitude, the left float reportedly made contact with either a boat wake or object.² The force of the contact resulted in the aircraft bouncing to a height of approximately 30 feet and banking to the right.

The pilot initiated a go-around. At 1337, during the initial climb over land, the aircraft contacted trees and then impacted the terrain.

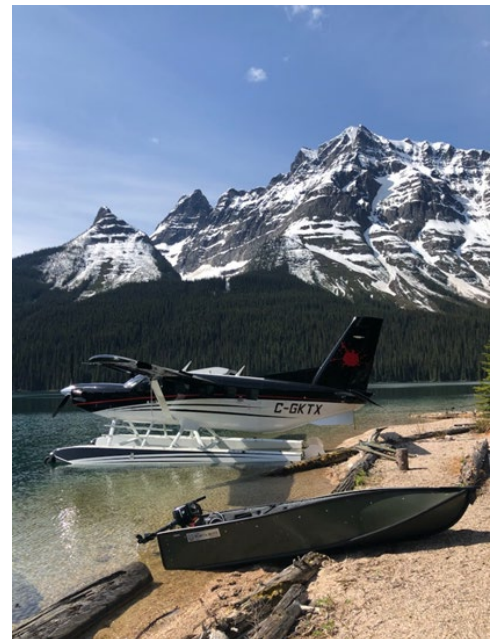
The Quest Kodiak 100 is a high-wing, single-engine turbine aircraft (Figure 2). The occurrence aircraft was manufactured in 2009. It was equipped with Aerocet Twin 6650 amphibious floats and powered by a Pratt & Whitney PT6A-34 engine.

Figure 2. Occurrence aircraft (Source: Third party, with permission)
