AIR TRANSPORTATION SAFETY INVESTIGATION REPORT A23W0048

HARD LANDING

Range Helicopters Inc.
Airbus Helicopters AS350 B2 (helicopter), C-FAVX
Edson Airport (CYET), Alberta
04 May 2023

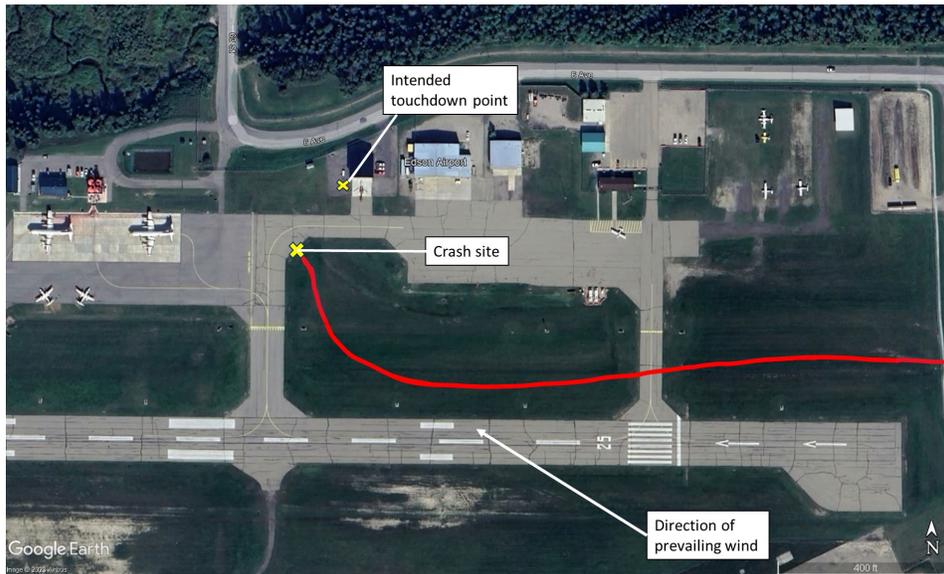
Figure 1. Occurrence helicopter's flight path to Edson Airport (Source: Google Earth, with TSB annotations)

On 04 May 2023, the Range Helicopters Inc. (Range Helicopters) Airbus Helicopters AS350 B2 helicopter (registration C-FAVX, serial number 4242) was conducting a return flight to Edson Airport (CYET), Alberta, from a forest firefighting staging area located approximately 49 nautical miles (NM) to the east. When the helicopter was 5 NM east of CYET, a flight of 4 Canadair CL-215T aircraft was approaching the airport from the west and intending to land on Runway 07, which was active at the time. It was reported that the wind was strong and gusting from the east-southeast. The occurrence pilot's usual approach to the Range Helicopters hangar at CYET involved passing to the south of the town of Edson, Alberta, and then approaching the airport from the west. Upon hearing the intentions of the flight of CL-215T aircraft, the pilot, not wanting to delay the group's arrival, decided to approach the airport downwind and to the north of Runway 07, between the runway and the taxiway, with the intent of conducting a tight right turn to align the helicopter into the wind (Figure 1).

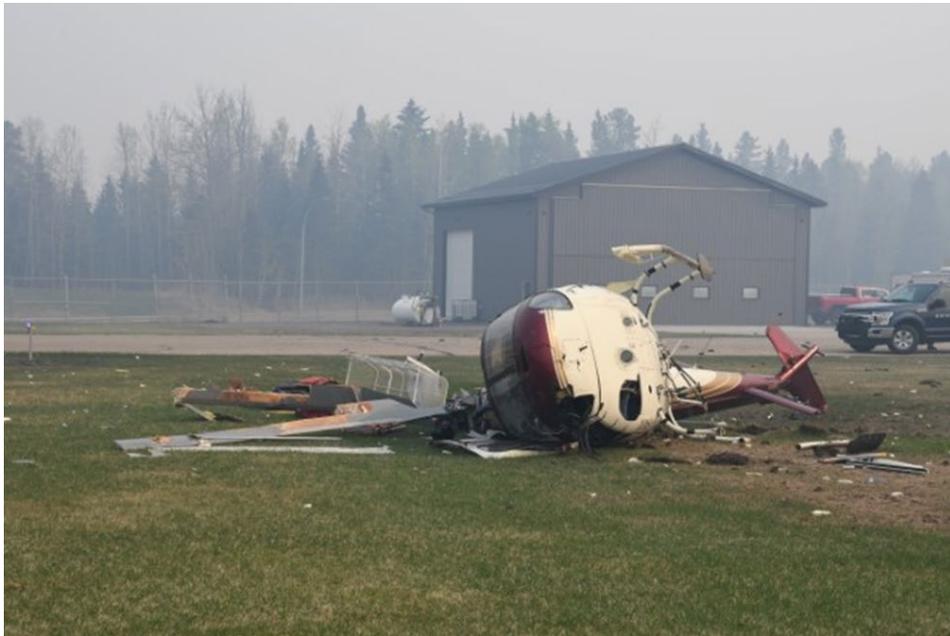
Figure 2. Accident site looking north (Source: TSB)

The helicopter struck the ground between the runway and the taxiway in a tail-low attitude, causing the tail rotor assembly to fracture. The helicopter then rotated to the right and struck the ground forcefully enough to break the right skid. It then rolled onto its right side, and the main rotor came into contact with the ground, dragging the fuselage around in an approximate 100° arc in a counterclockwise direction. The right-forward cabin side pillar fractured, but the cabin maintained its overall shape. The engine and transmission broke free of some of their attachment points but stayed mainly in the powerplant bay. A fuel line fractured, and there was a fuel spill, but no fire (Figure 2).
