**MARINE INVESTIGATION REPORT**  
**M08C0024**

**GROUNDING**

**BULK CARRIER *ALGOMARINE***  
**BRUCE MINES, NORTH CHANNEL**  
**LAKE HURON, ONTARIO**  
**28 MAY 2008**

Report Number M08C0024

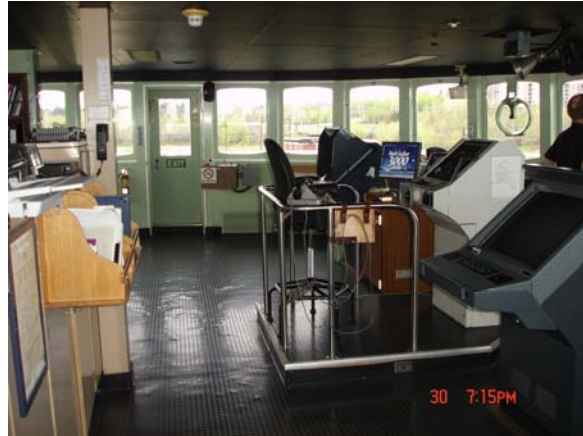
**Photo 2.** Steering station No. 1, with an ECS display to the left

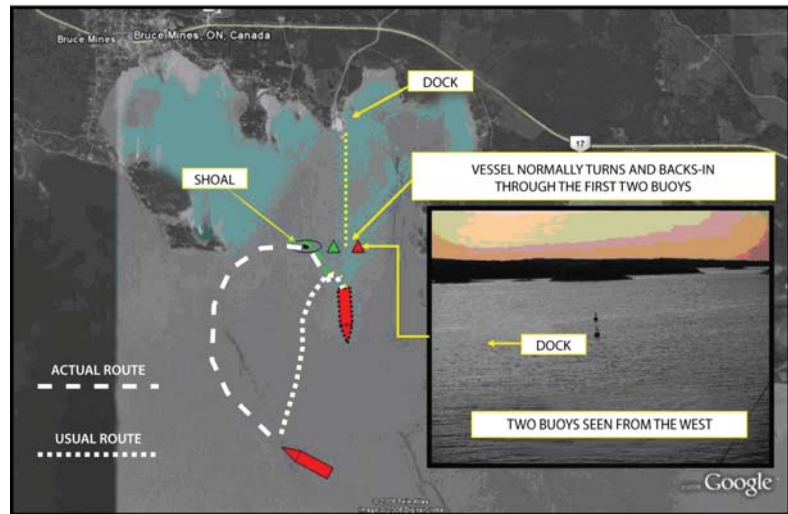
At 0545, the master sighted the channel entrance buoys to the east and, using them as a visual reference, ordered 35° starboard helm. Vessel speed was between 6.5 and 7 knots. At 0546, the master asked the OOW to keep the vessel turning to starboard. He then left the bridge to conduct ship's business. There was no formal handover of the con. Moments later, the wheelsman indicated that the vessel was slowing in its turn to starboard. The OOW responded by giving the engine/pitch a "kick" ahead.

At 0548, the alarm went off on the vessel's depth sounder for approximately 30 seconds. The bridge team, however, was unfamiliar with the sound of the alarm and took no action before 0549, when the vessel ran aground on a charted but unmarked shoal on a heading of 090° True (T).

**Photo 3.** Approximate track of the vessel with photo of buoys (inset)
